SITE OBSERVATION REPORT - RAWP Implementation – Day 171

PROJECT No.:	170390001	**CLIENT:**		**DATE:**	Tuesday, March 14, 2026
PROJECT:	141 3rd Street	Third Street Owner LLC and 155 Third St., LLC		**WEATHER:**	Windy/Clear, 31 – 46^{0}/F Wind: SSW @ 1.0 – 4.4 mph
LOCATION:	Brooklyn, New York			**TIME:**	6:45 a.m. – 3:45 p.m.
BCP SITE ID:	C224336

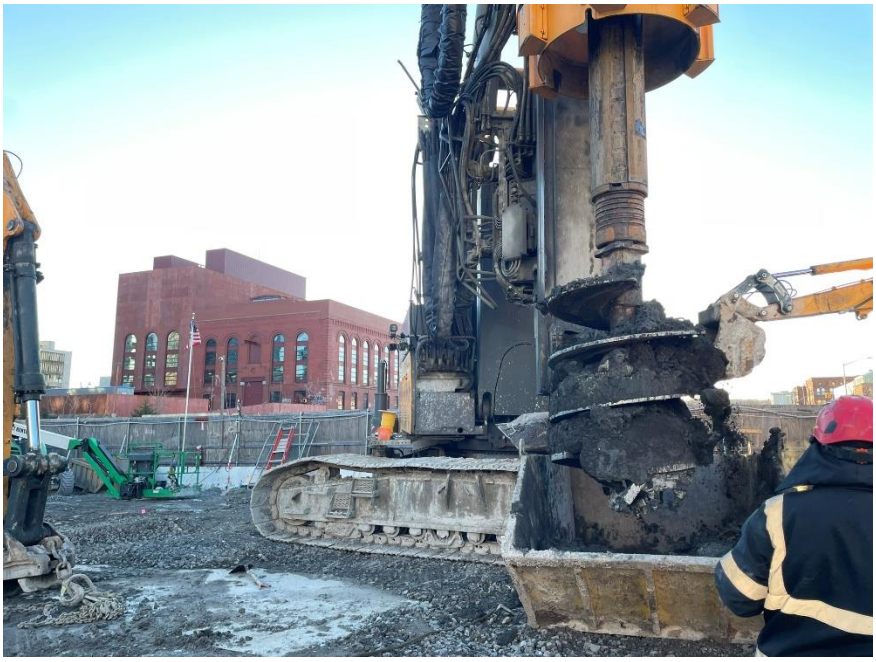
- Extracted soil/fill was temporarily staged on polyethylene (poly) sheeting adjacent to each work area. Langan screened the extracted soil/fill for evidence of environmental impacts using visual, olfactory, and instrumental (PID) methods. A petroleum-like odor was observed and a maximum PID reading of 6.8 parts per million (ppm) was recorded. New Leaf applied ATMOS AC645 odor/vapor suppressing foam to exposed soil/fill during extraction and stockpiling.

Photo 1: New Leaf spraying Atmos® AC-645 odor/vapor suppressing foam on stockpiled soil/fill in the eastern part of the site (facing northeast).
