SITE OBSERVATION REPORT - RAWP Implementation – Day 172

PROJECT No.:	170390001	**CLIENT:**		**DATE:**	Wednesday, March 18, 2026
PROJECT:	141 3rd Street		Third Street Owner LLC and 155 Third St., LLC	**WEATHER:**	Partly Cloudy, 23 – 44^{0}/F Wind: SSW @ 0.7 – 11.1 mph
LOCATION:	Brooklyn, New York			**TIME:**	7:00 a.m. – 3:45 p.m.
BCP SITE ID:	C224336

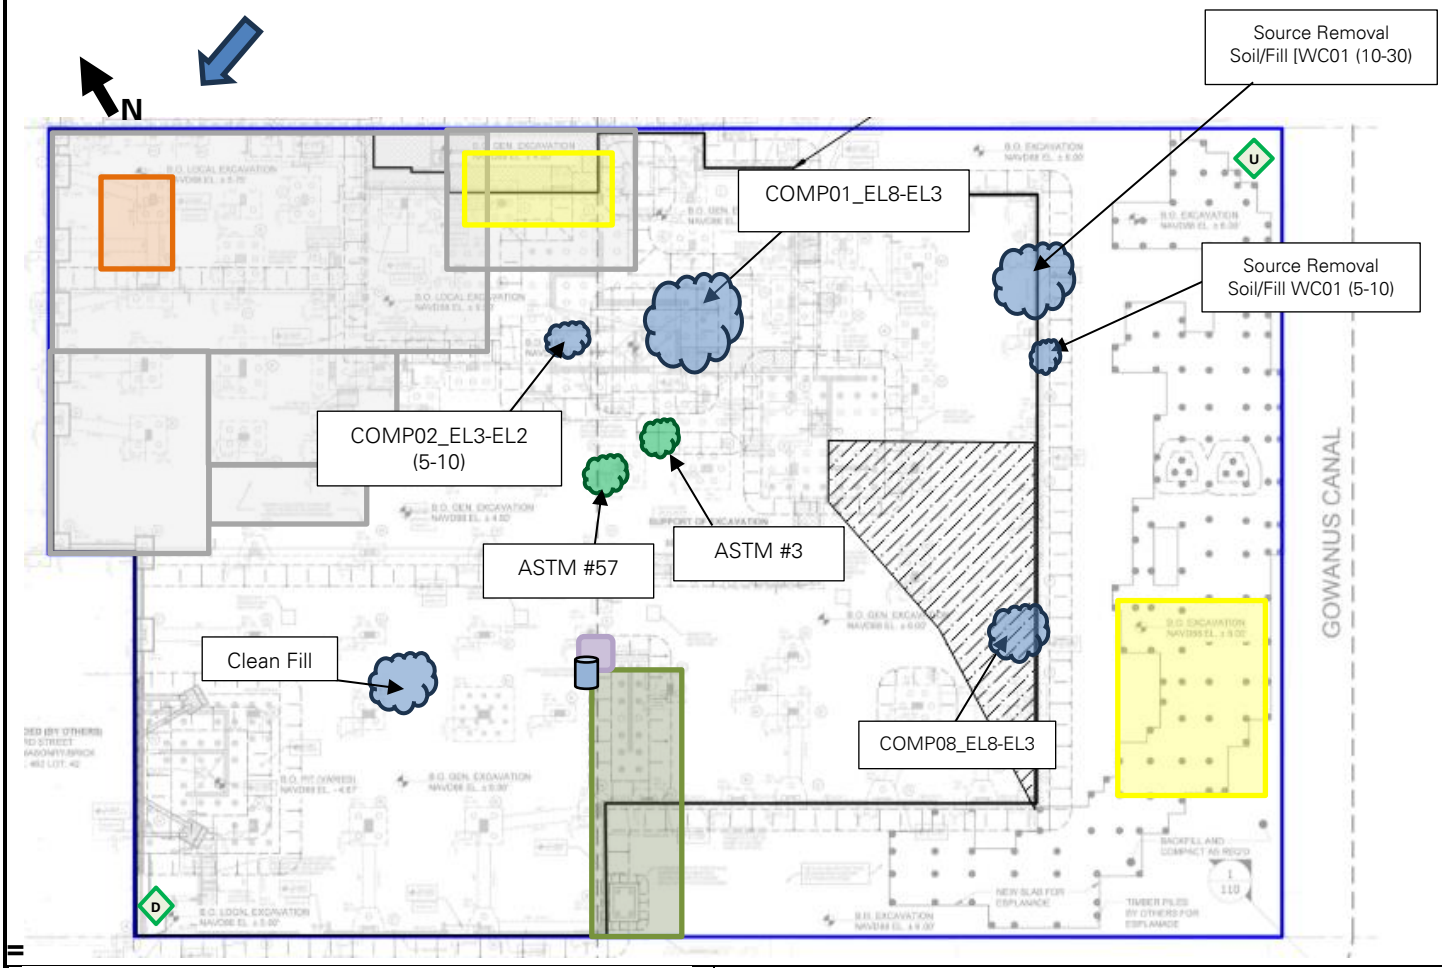
Photo 1: New Leaf excavating in the southeast part of site (facing northeast).

Photo 2: New Leaf backfilling imported clean fill in the northwestern part of site (facing north).
