DAILY STATUS REPORT

Langan Project No:	100688803	Project:	12074 Flatlands Avenue p/o Lot 1	Date:	10/08/2024
NYSDEC BCP Site No:	C224353			Time:	06:15 – 16:00

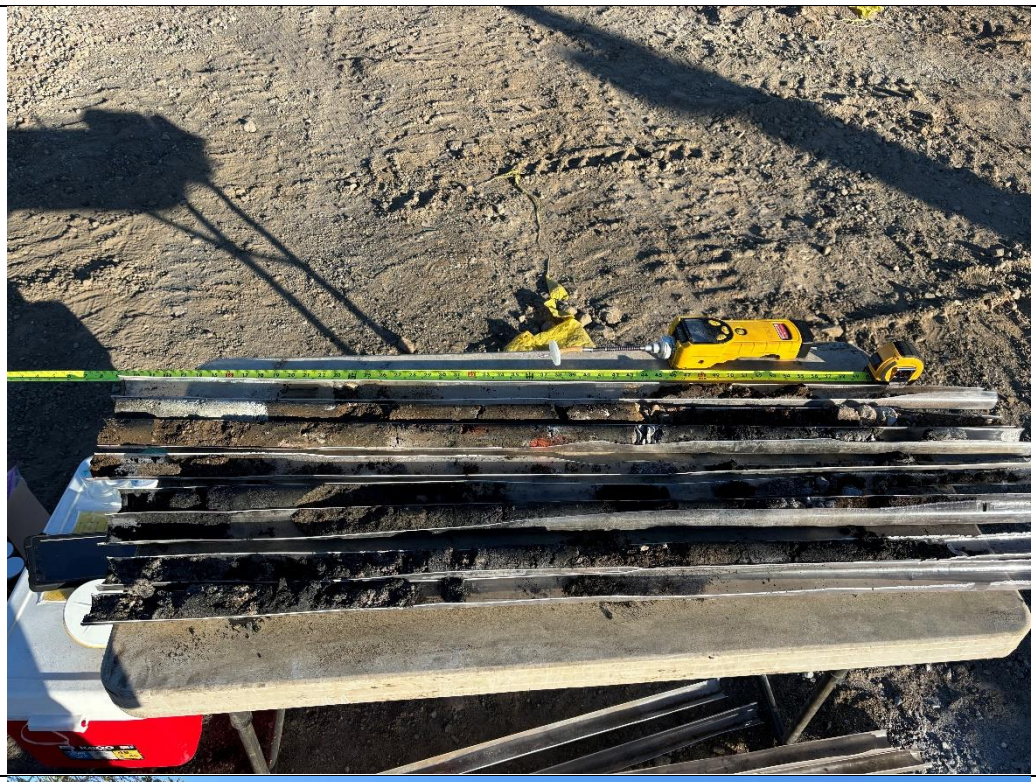
Photo 3 – View of soil cores obtained from soil boring LSB201.
