Phase I Environmental Site Assessment

824 Metropolitan Avenue
Brooklyn, New York

EBI Project No. 1115005479

July 28, 2015

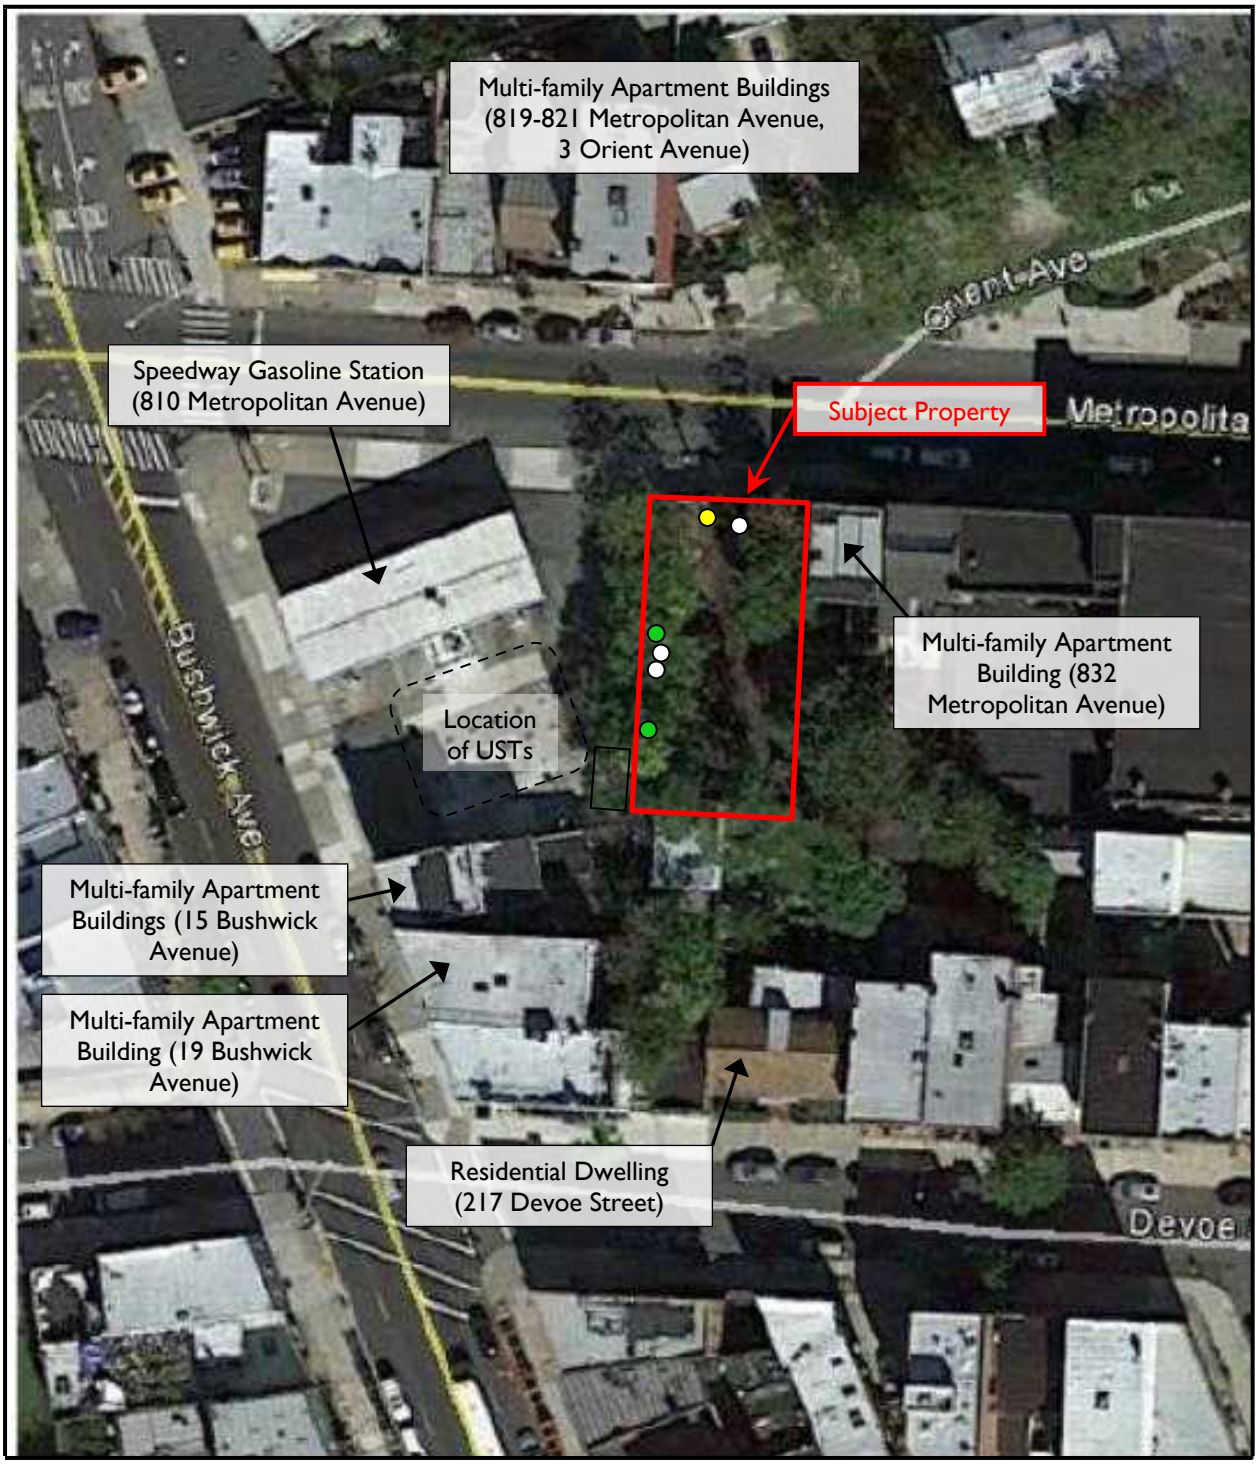
FIGURE 3 – SITE PLAN

- 55-gallon drum, unidentified contents
- 30-gallon drums, unidentified contents
- 55-gallon drums, empty
