February 21, 2007

Re: ***Update to the Subsurface Investigation Report***
Citgo Service Station at 169 Third Avenue, Brooklyn, NY
NYSDEC Spill#: 95-06588

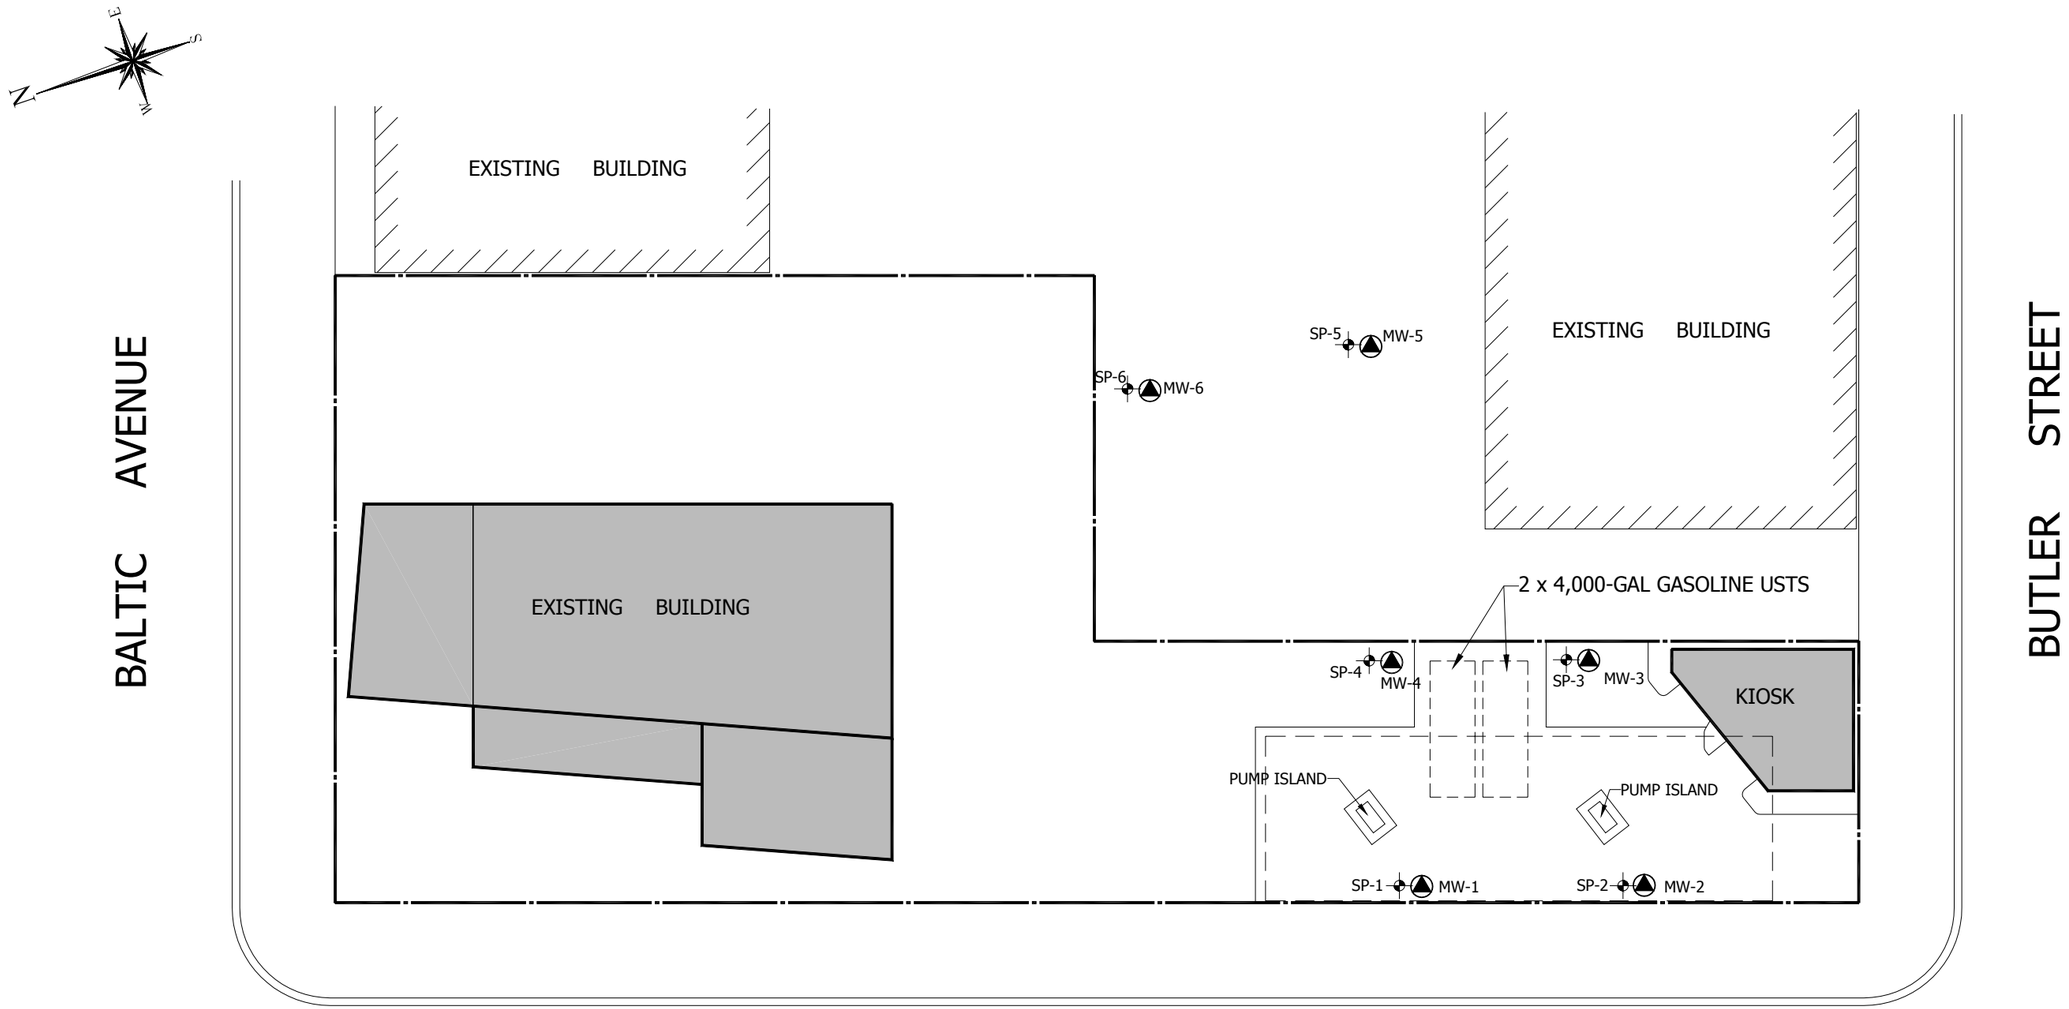
PROJECT #	06-210
PLATE #	01

On February 14, 2007, Impact Environmental installed two (2) soil probes, identified as SP-5 and SP-6, on the Site as part of this investigation. The locations of SP-5 and SP-6 can be referenced with **Plate 1**. Subsurface probes were sited using a Geoprobe hydra system. Continuous subsurface soil sampling was conducted into the groundwater interface. The soil samples were field screened using a photo ionization detector (PID) for the presence of hydrocarbons. However, the field screening failed to identify any evidence of soil contamination, accordingly, the sample from the soil-groundwater interface depth were selected for laboratory analysis. The soil probe logs are attached to this report. Soil samples were subjected to laboratory analysis via EPA Test Method 8260 for target volatile organic analytes.

The laboratory analysis performed on the soil samples secured from SP-5 and SP-6 failed to detect any concentrations of target volatile organic analytes.

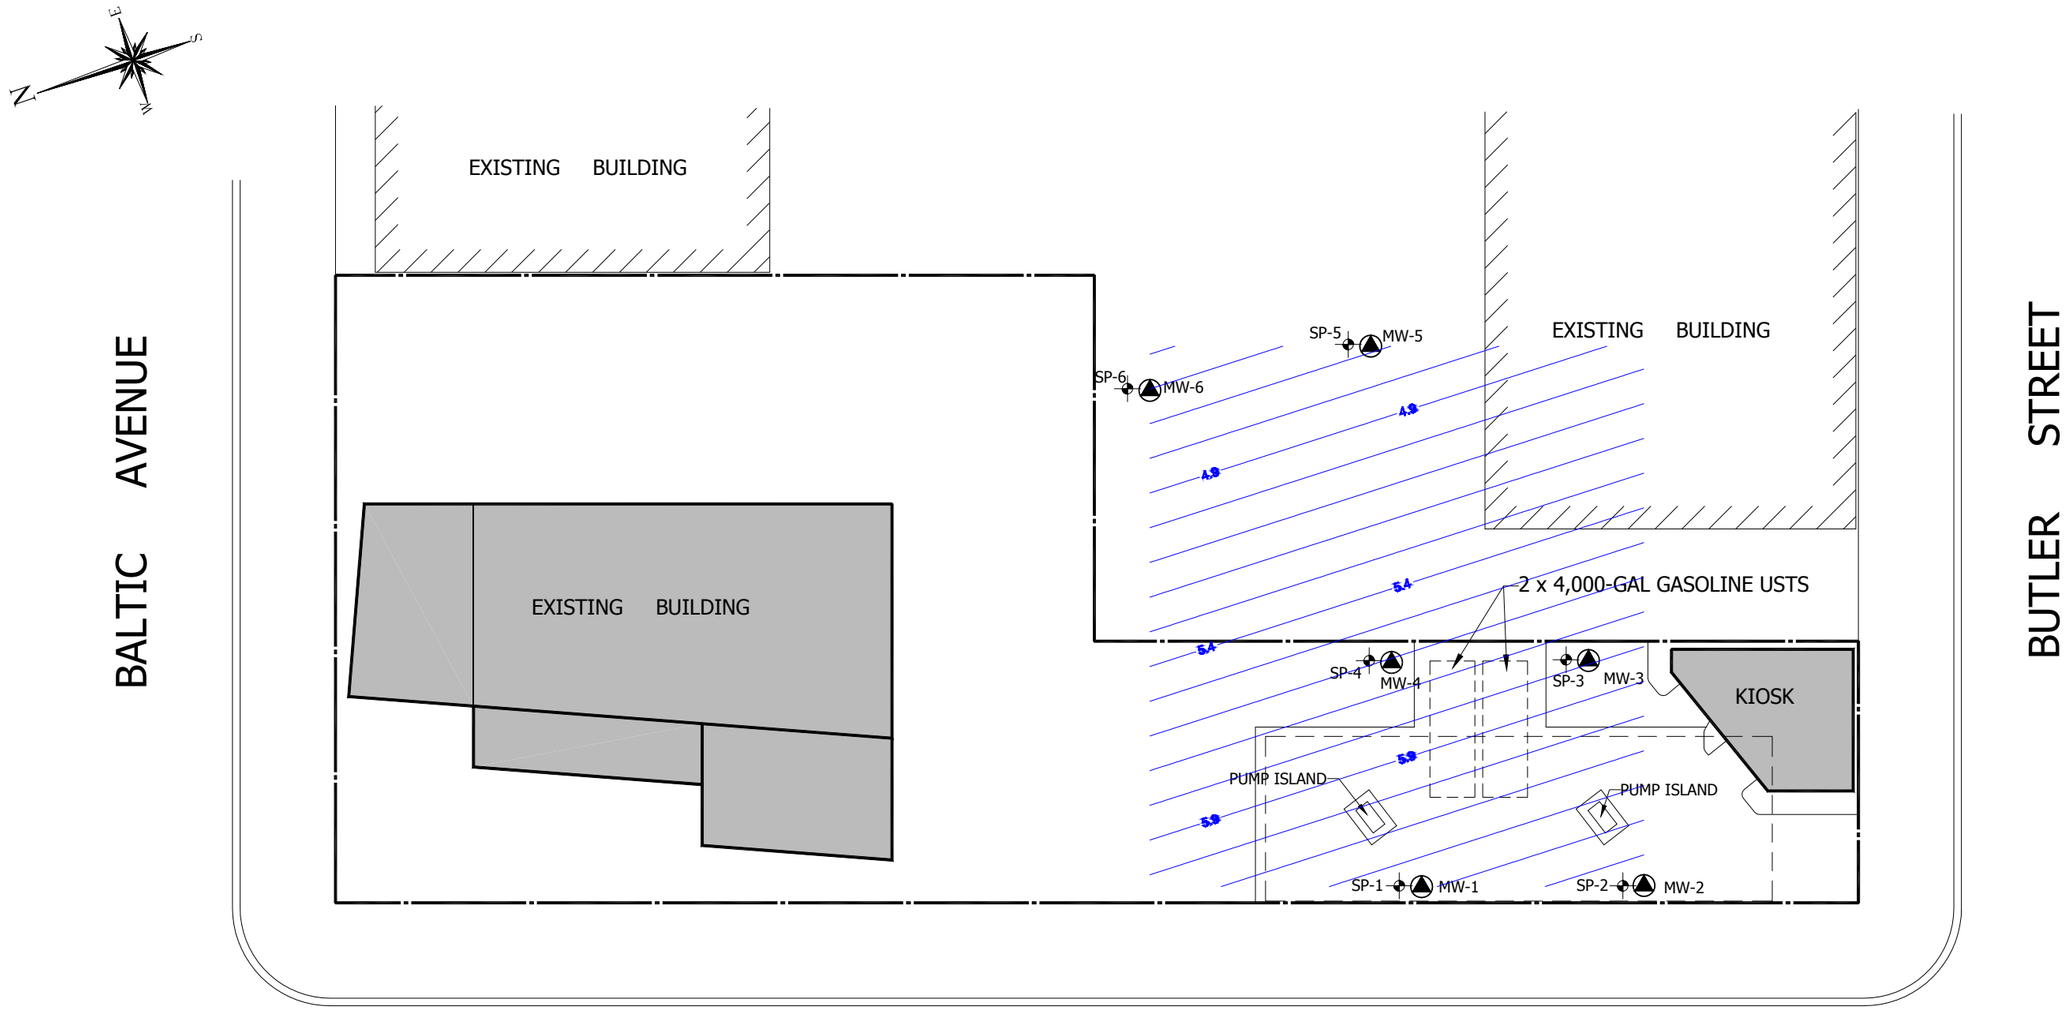
PROJECT #	06-210
PLATE #	02

based as a function of the depth to water and these elevations. The groundwater elevation survey results are represented in **Table 1** and **Plate 2**. Based on the survey results, the groundwater flow direction at the Site is in an East-Northeast direction.
