DAILY FIELD REPORT

Project	Bedford Beverly Brownfield Site	**Report No.**	157
BCP Site	BCP Site No. C224384	**Date**	05/29/2024
Location	2359 and 2360 Bedford Avenue, Brooklyn, NY	**File No.**	0205432
Client	Bedford Beverly Acquisitions LLC	**Temperature**	63-72°F
Contractor	Haley & Aldrich, Maman Contracting (Maman), International Concrete	**Wind Direction**	SW to NE, 9 mph
Weather	Sunny	**Personnel on Site**	E. Nunez
Humidity	65%	**Time on Site**	7:00am to 2:30pm

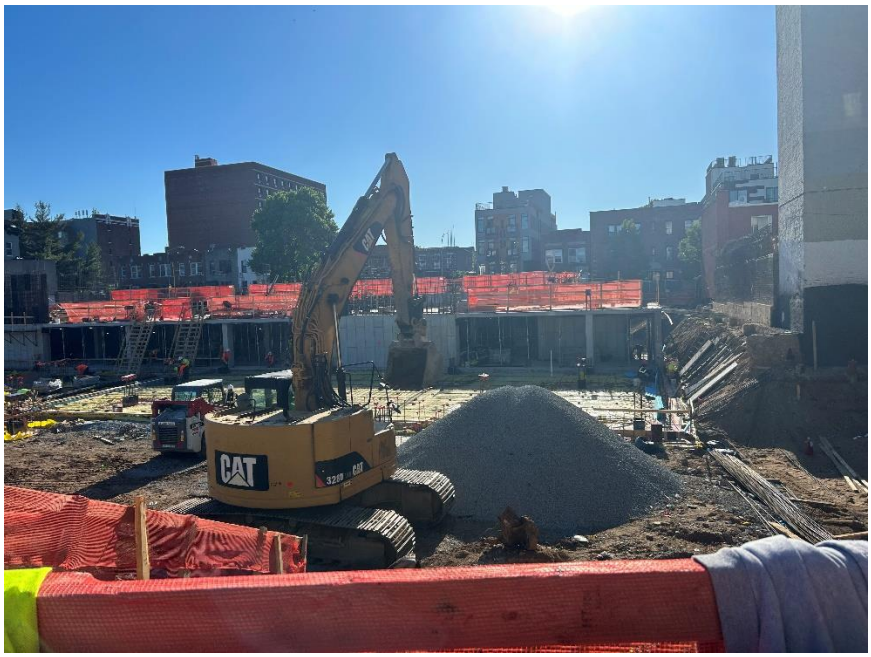
Photo 1: View of site conditions in Lot 14, facing west.
