RND
Services Inc.

Tuesday, November 28, 2006

Re: ***Cooper Tank and Welding***
215 Moore Street
Brooklyn, NY 11206
Groundwater Sampling Report - First Quarter
NYSDEC Spill # 0312904

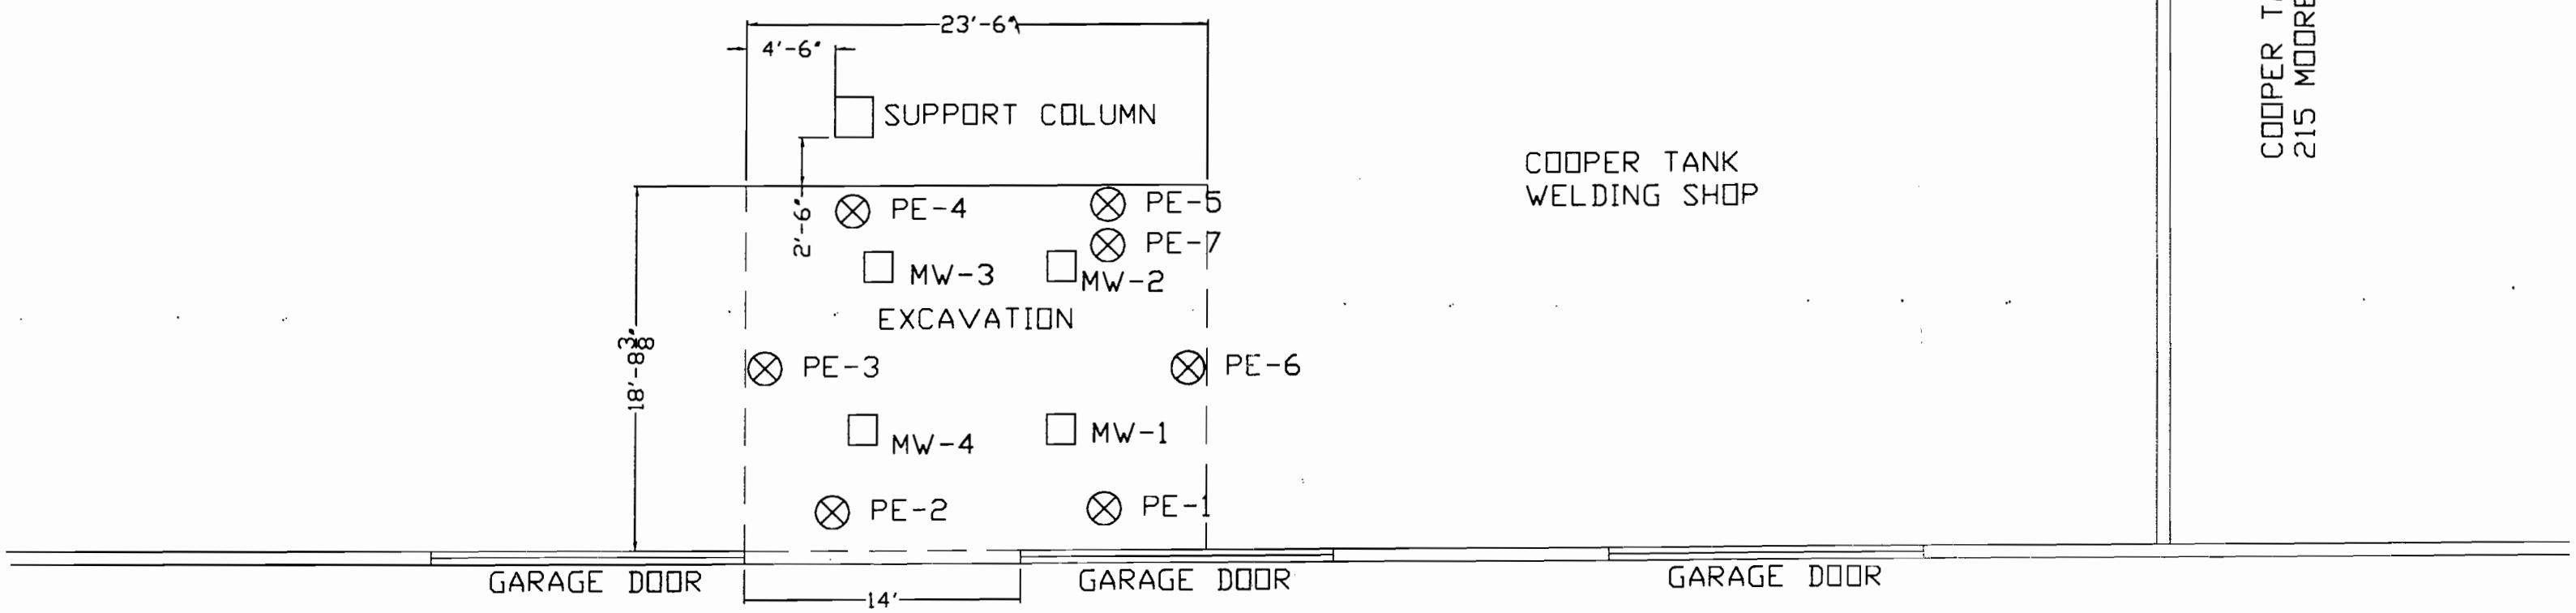
On November 1, 2006 the depth to water was measured for each well using an oil/water interface probe. The depth to water measured for the wells on November 1 is as follows: MW-1 – 5.01' below grade; MW-2 – 5.00' below grade; MW-3 – 4.90' below grade; and MW-4 – 5.11' below grade. No separate phase product or petroleum odor was observed in any of the wells. The average depth to water was slightly higher than that measured during the previous sampling event on April 18, 2006. Depth to water was measured at 4.5' below grade for MW-4 on April 18, 2006. The four (4) wells were purged of three well volumes using a peristaltic pump, Solinst model 410. All purged well water was stored in 55 gallon drums. Sampling was completed using the peristaltic pump for all wells. Tubing was changed after each purging session and sampling event to ensure no cross contamination. Each sample was analyzed for volatile organic compounds (VOC) using EPA Method 8260. The sample results are included in the attached **Table 1** (along with results from previous sampling) and the laboratory data is included as **Attachment 2**. The well locations are shown on **Figure 1**, General Site Plan.
