PHASE I ENVIRONMENTAL SITE ASSESSMENT

Quay Street
Block 2590, Lot 200
Brooklyn, New York

Commencement Date: 24 May 2023
Report Completion: 20 September 2023

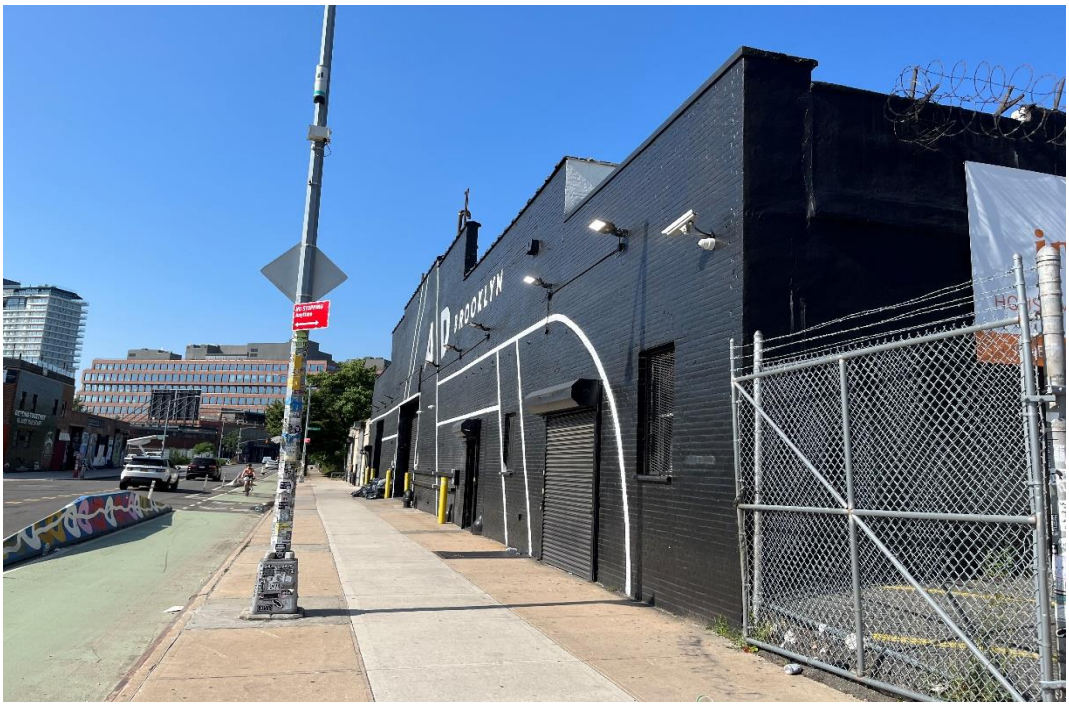
Photo 12: Adjacent property to the east of the subject property, facing southeast.
