PHASE I
ENVIRONMENTAL SITE ASSESSMENT REPORT

May 19, 2018

95-107 Walworth Street, Brooklyn, NY 11205

EBC Project No: TNW1801

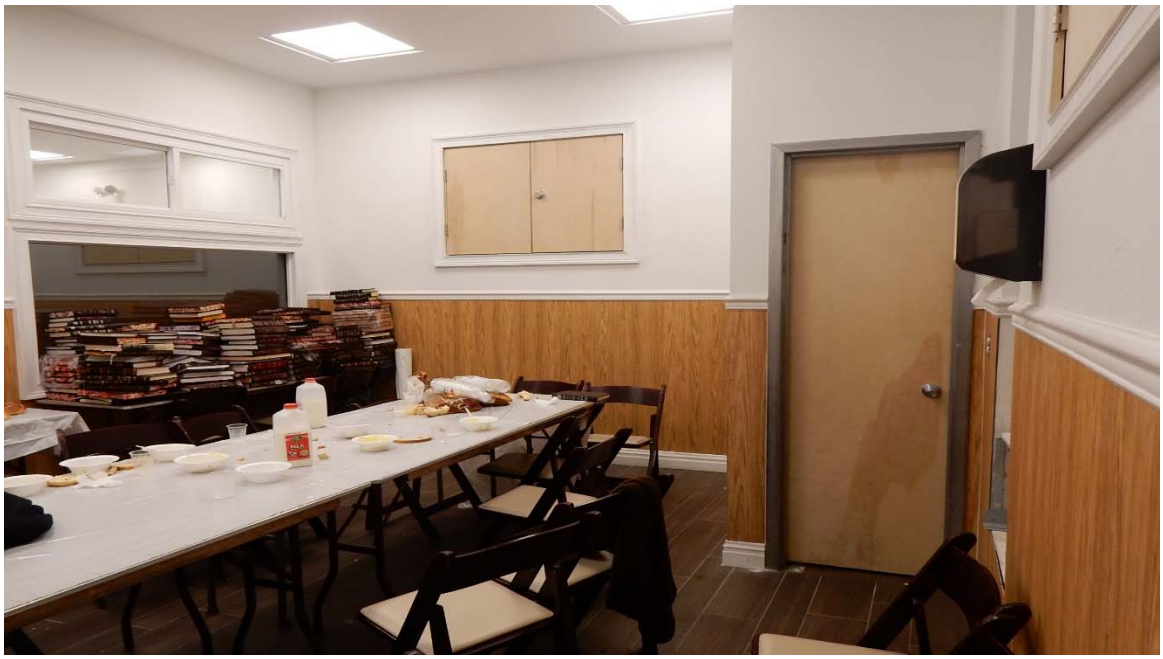
View of the coat room within the 99 Walworth Street building.

View of the dining area within the 99 Walworth Street building.

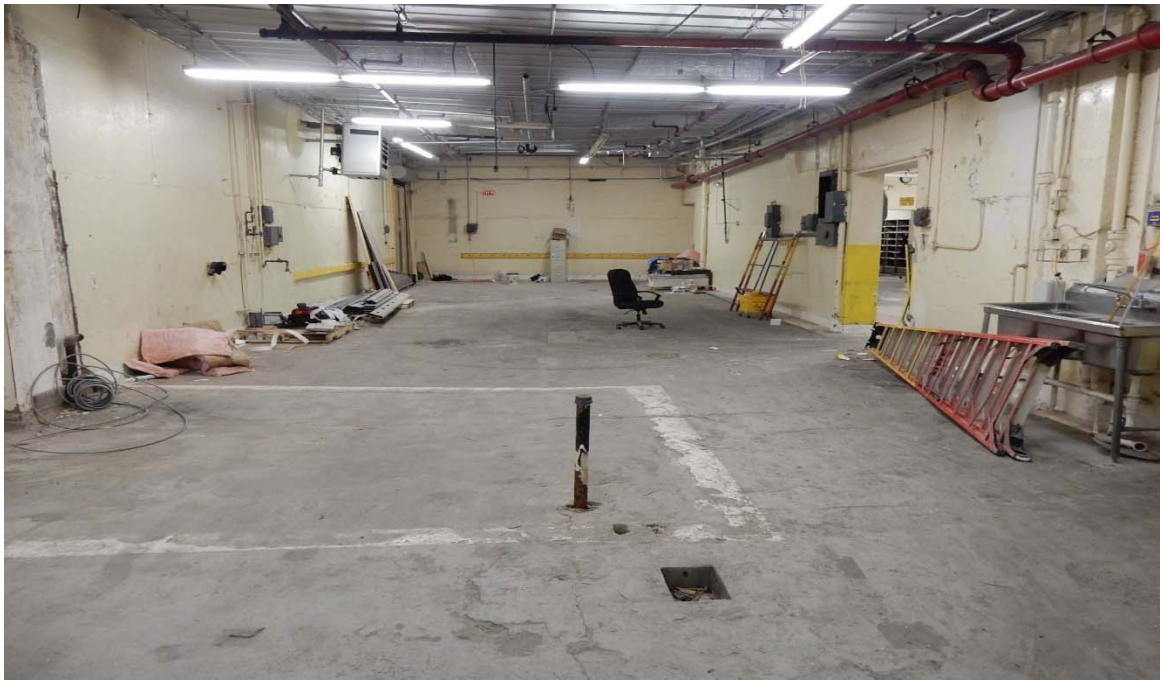
View of the former employee locker room area (2nd floor) within the 98 Walworth Street building.

View of the former production area (1st floor) within the 103 Walworth Street building.
