ASTM PHASE I ENVIRONMENTAL SITE ASSESSMENT
98-114 BERRIMAN STREET DEVELOPMENT
98 BERRIMAN STREET
BROOKLYN, NEW YORK

File No. 0214078-000
September 2025

Subject: ASTM Phase I Environmental Site Assessment
98-114 Berriman Street Development
98 Berriman Street
Brooklyn, New York

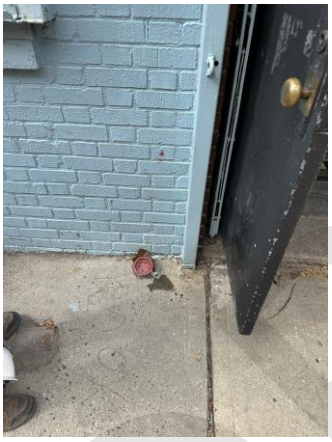
Photo 15: View of fill port from Berriman Street, facing west.

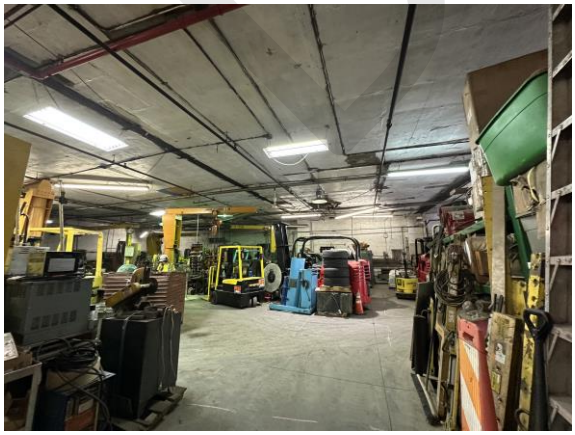
Photo 17: View of building interior, facing north.

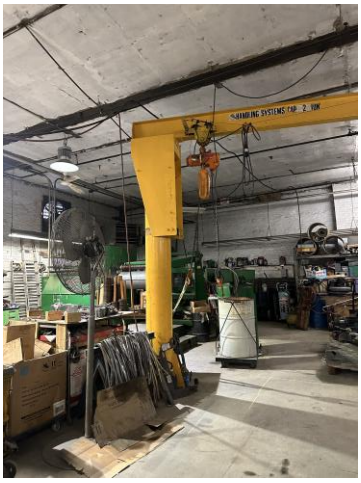
Photo 19: View of hydraulic lift and building interior, facing southwest.

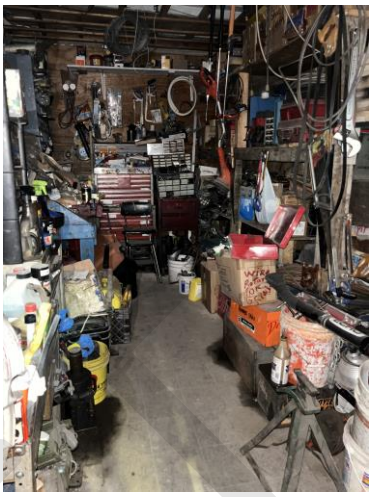
Photo 26: View of supply closet and floor staining within the building of the subject property.
