PHASE I ENVIRONMENTAL SITE ASSESSMENT

CHRISTIAN CULTURAL CENTER
12020 Flatlands Avenue
Brooklyn, Kings County, New York

GO UCL, LLC
432 Park Avenue South, 2nd Floor
New York, New York 10016

Langan Engineering, Environmental, Surveying and Landscape Architecture, D.P.C.
300 Kimball Drive
Parsippany, New Jersey 07054
NJ Certificate of Authorization No: 24GA27996400

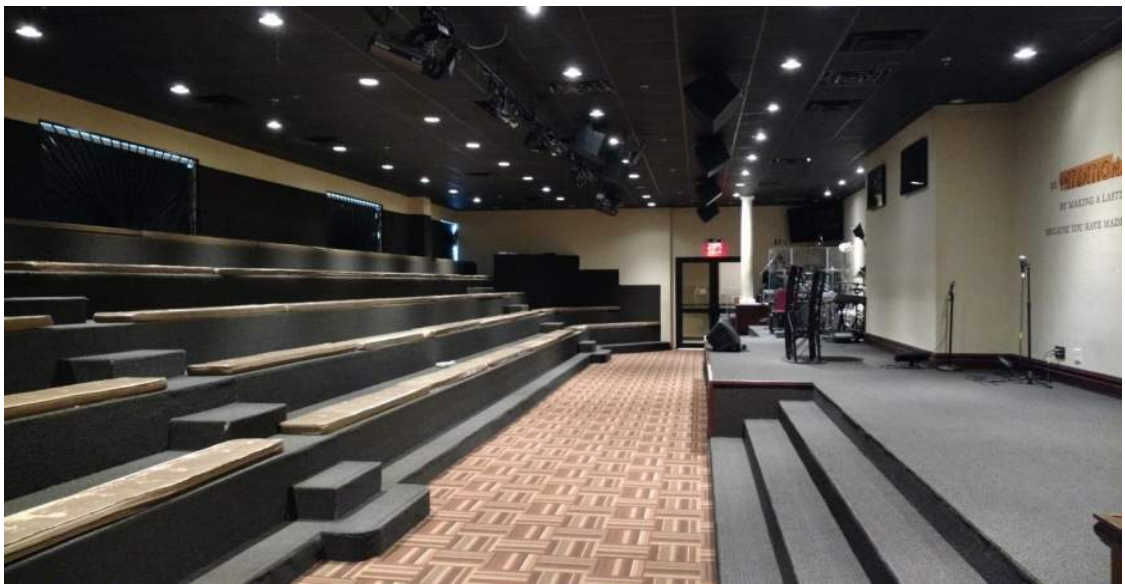
Photo 6: Main sanctuary and auditorium.

Photo 7: Typical smaller sanctuary room.

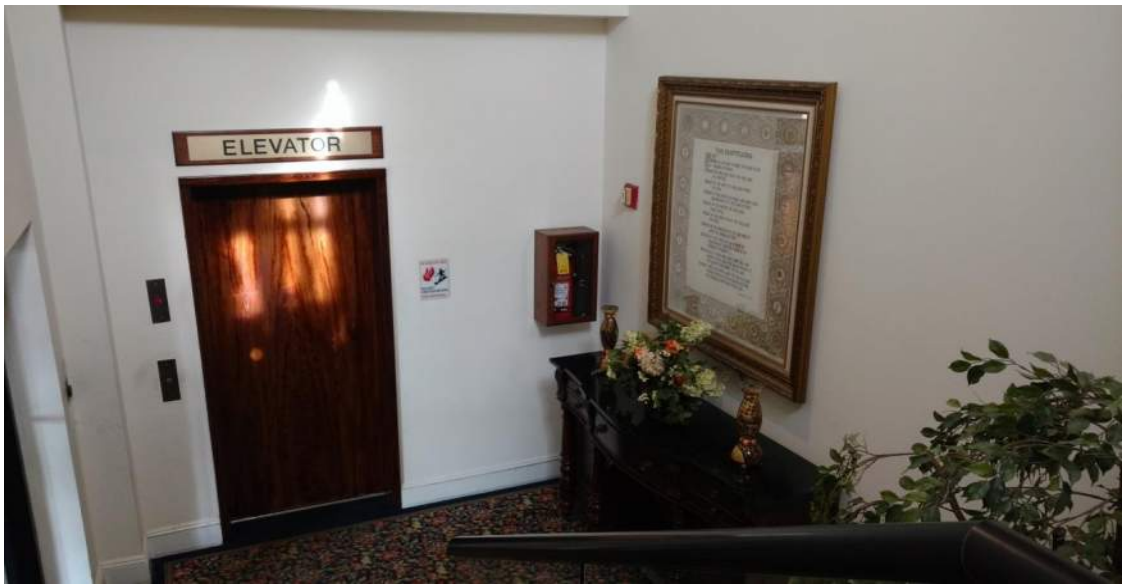
Photo 11: Above-grade hydraulic oil tank and dispenser pump for one of two on-site elevators.

Photo 12: One of two on-site elevators.
