ASTM PHASE I ENVIRONMENTAL SITE ASSESSMENT
296 4TH AVENUE DEVELOPMENT
296 4TH AVENUE
BROOKLYN, NEW YORK

File No. 0206616
October 2022

Subject: ASTM Phase I Environmental Site Assessment
296 4th Avenue
Brooklyn, New York

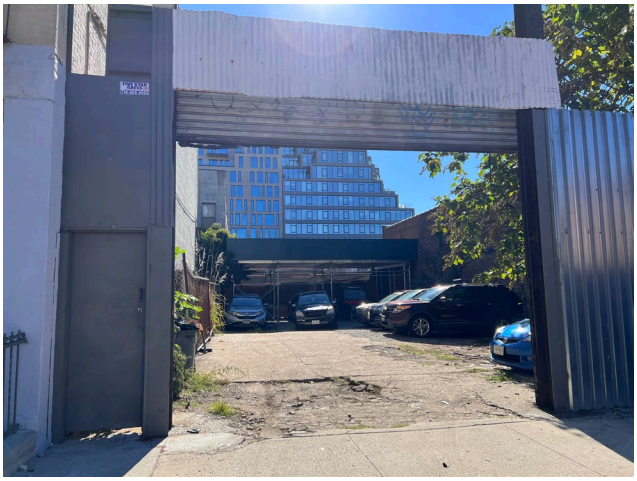
Photo 1: Entrance to Lot 6 on subject property from Denton Place, facing southeast

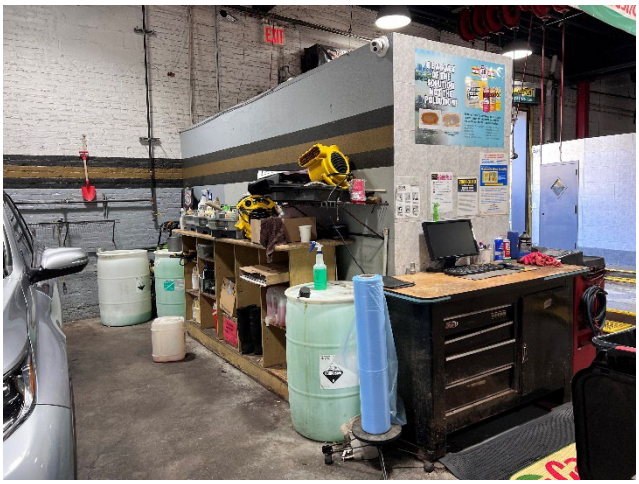
Vehicle maintenance and repair products and chemicals were observed inside of the Lot 1 subject property building. Products used for vehicle repair, such as motor oil, were typically stored on shelves in sealed containers, whereas products intended for maintaining the exteriors of vehicles were typically stored in drums on the ground with no secondary containment. Minor staining was observed on the slab beneath the chemical storage containers and floor drains were observed near the locations where these products and chemicals were stored.

Photo 6: Staining observed inside subject property building on Lot 1, facing northwest

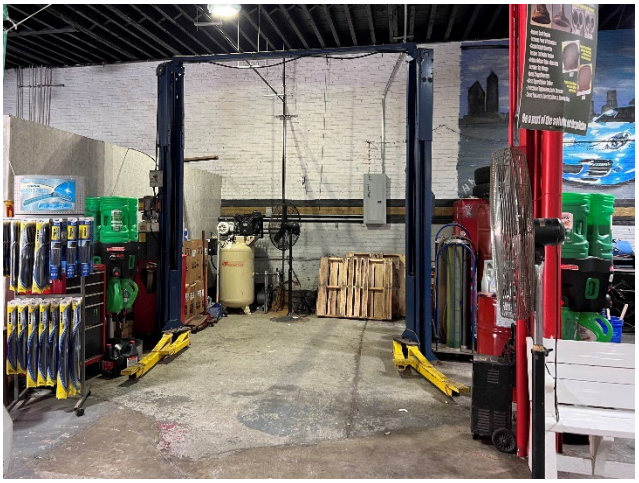
Photo 9: Electric lift inside subject property building on Lot 1, facing northeast
