PERIODIC REVIEW REPORT

For the Property Located at
West 19th Street Development Site, New York, NY

Prepared for
HTRF Ventures, LLC
555 West 18th Street
New York, NY 10011

March 2, 2026

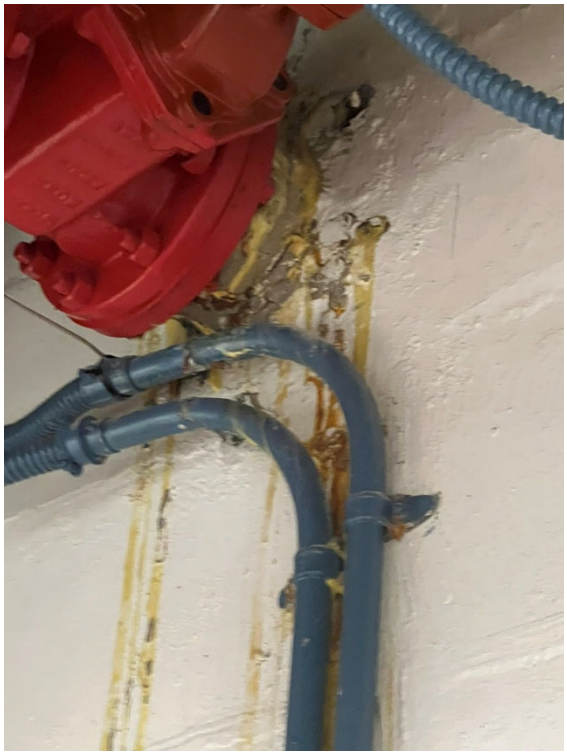
Minor cracking, consistent with observations from previous inspections, was noted in the floor paint underneath the central stairs in the north hallway due to grout injection in a nearby wall. Cracking was noted in the floor paint in the Switch Gear Room and the building manager believes this was due to temperature differences on either side of a foundation footing. No cracks in the concrete slab underneath the floor paint was noted. Integral believes the cracking is surficial damage and is not resulting in vapor intrusion.

Photograph 3. Cracking in Floor Paint in Switchgear Room (February 4, 2026).

Photograph 4. Previous Grout Injection Location Adjacent to Standpipe Penetration in N. Water Meter Room (February 4, 2026).
