WEST 42nd STREET
MANUFACTURED GAS PLANT
SITE HISTORY REPORT

ConEdison

Parsons

AUGUST 2002

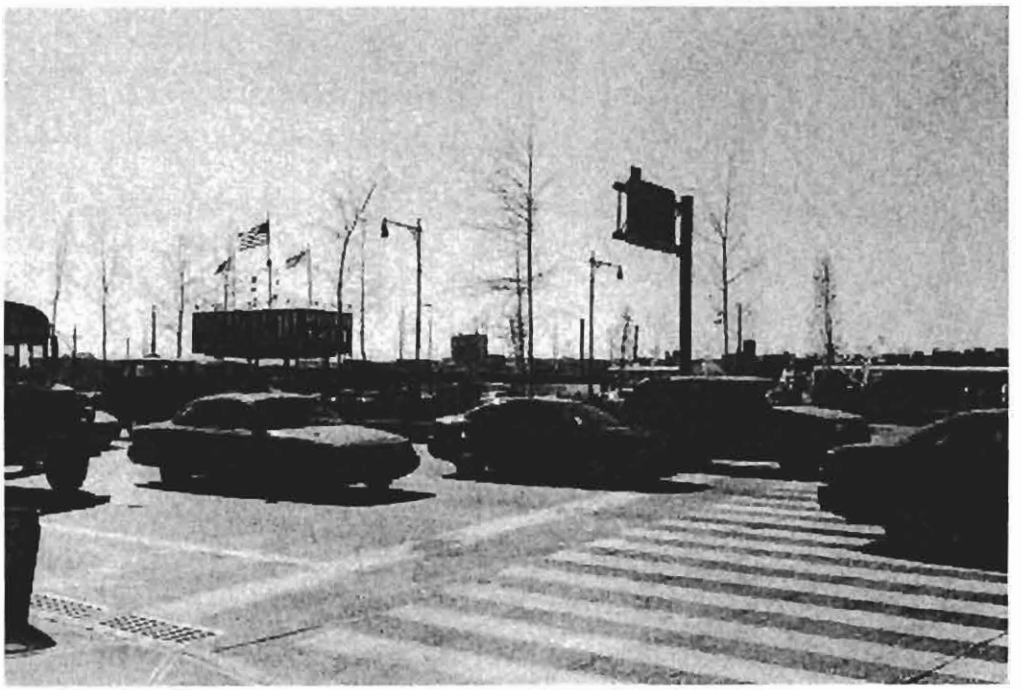
Photo 1

Status as of: 4/10/02
Description: West Side Highway from Block 1089.
Photo by: Julie Abell Horn

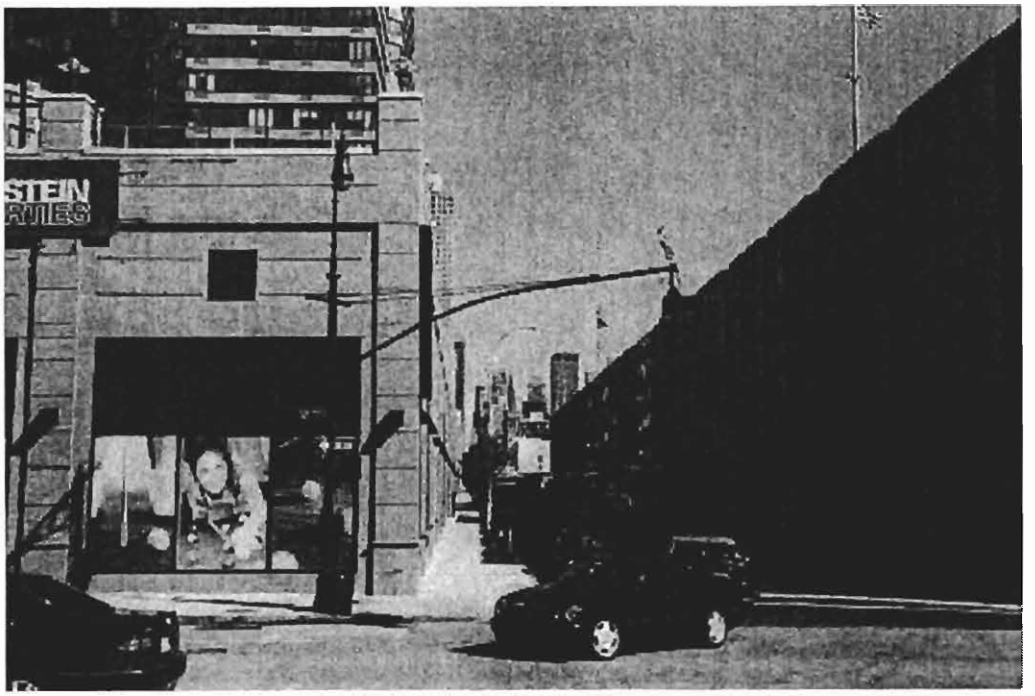
Photo 3

Status as of: 4/10/02
Description: SW corner Block 1089.
Photo by: Julie Abell Horn

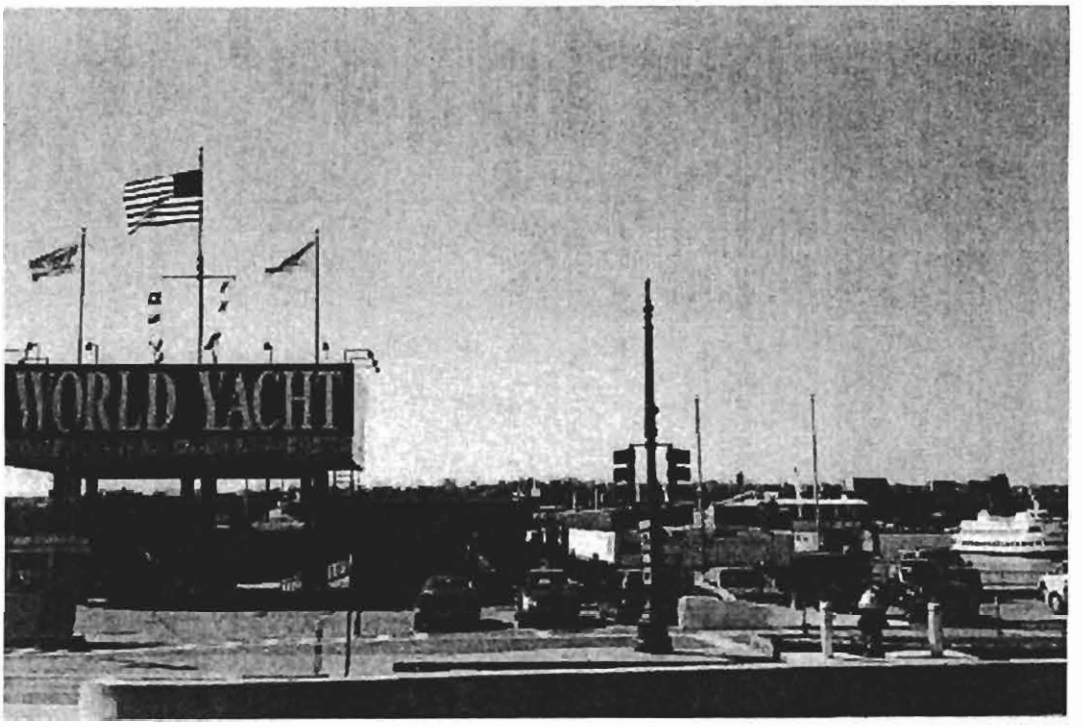
Photo 4

Status as of: 4/10/02
Description: Across West Side Highway from Block 1089.
Photo by: Julie Abell Horn

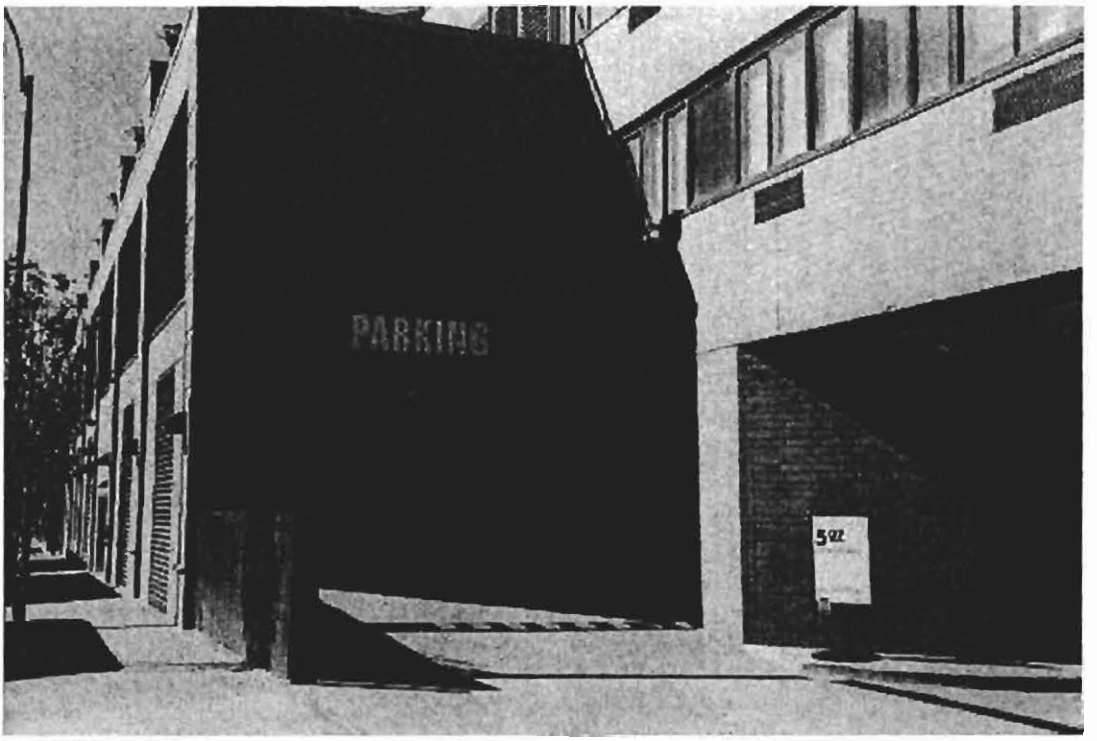
Photo 5

Status as of: 4/10/02
Description: Block 1089, parking lot under high rise apartment building.
Photo by: Julie Abell Horn

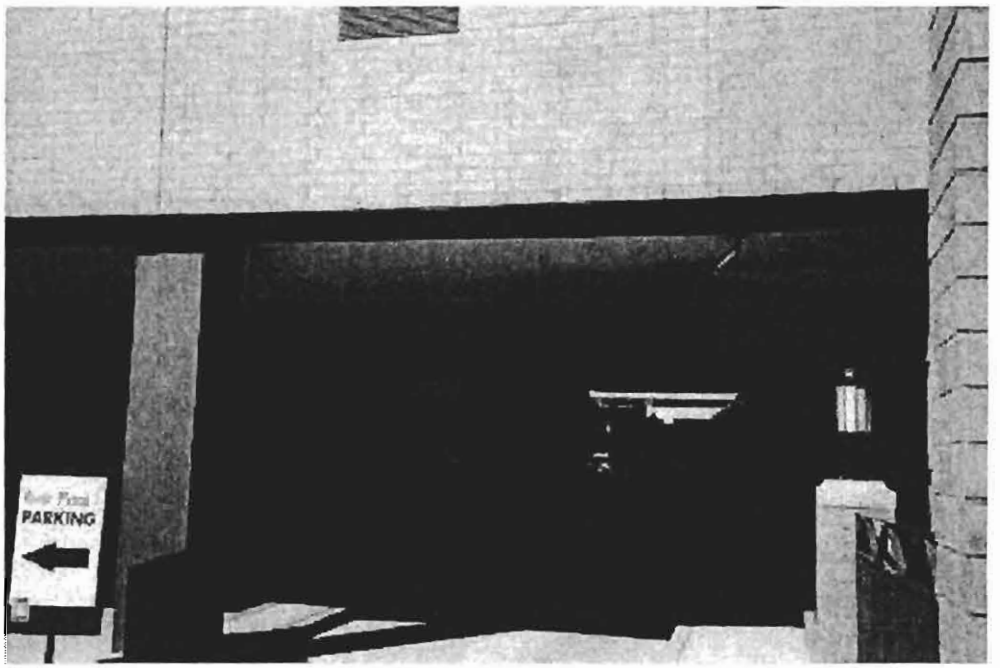
Photo 6

Status as of: 4/10/02
Description: Block 1089, parking lot under high rise apartment building.
Photo by: Julie Abell Horn

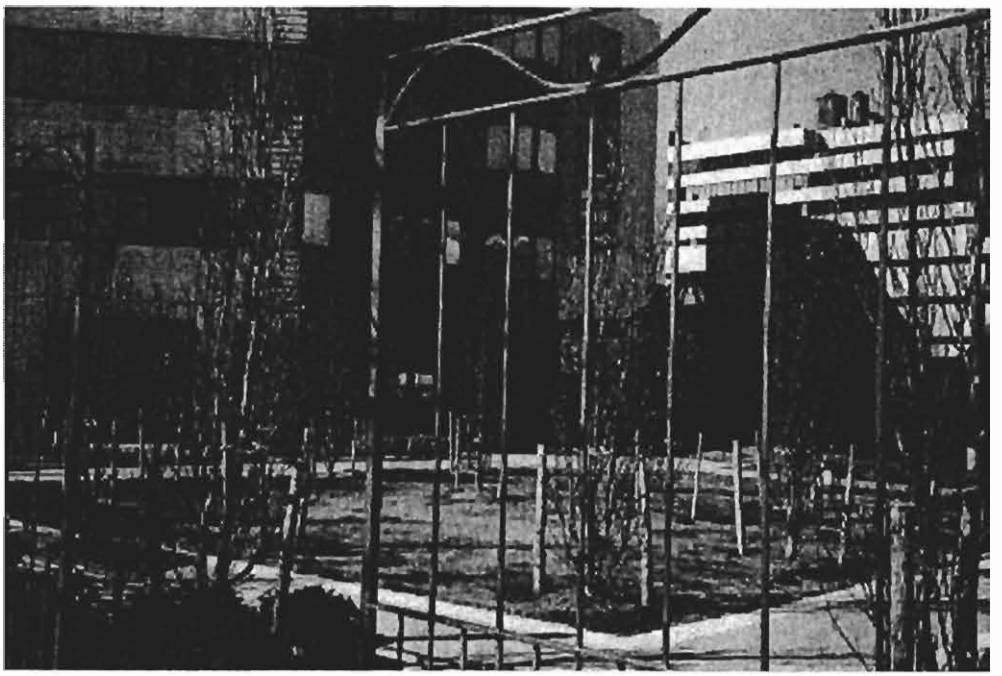
Photo 7

Status as of: 4/10/02
Description: Block 1089, landscaped area east of high rise apartment building.
Photo by: Julie Abell Horn

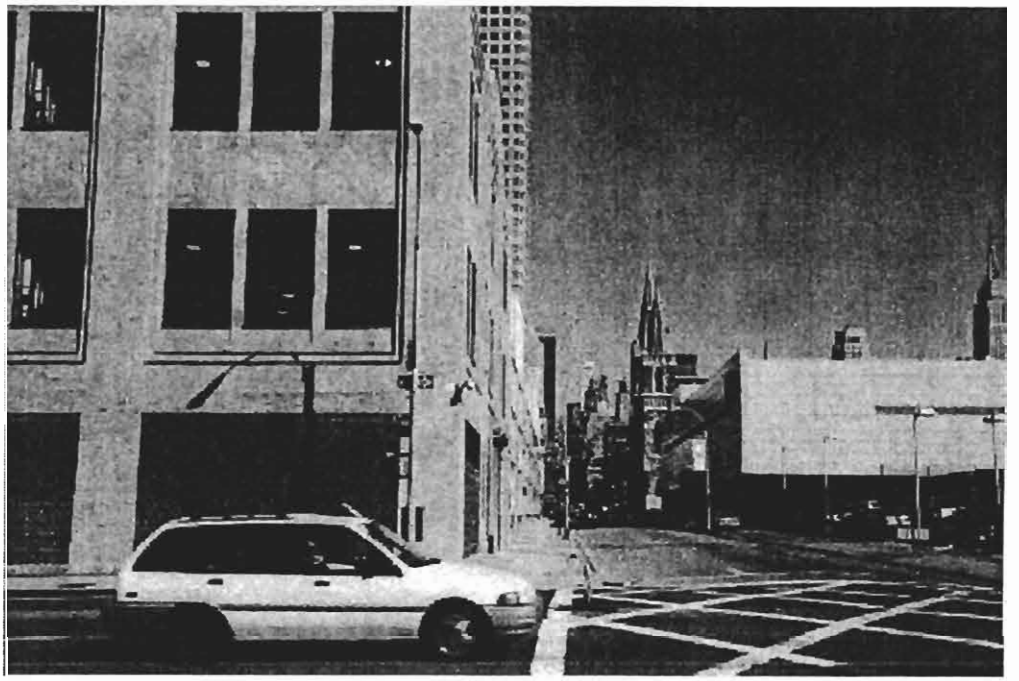
Photo 14

Status as of: 4/10/02
Description: SE corner Block 1070, 41st Street, Con Ed facility.
Photo by: Julie Abell Horn

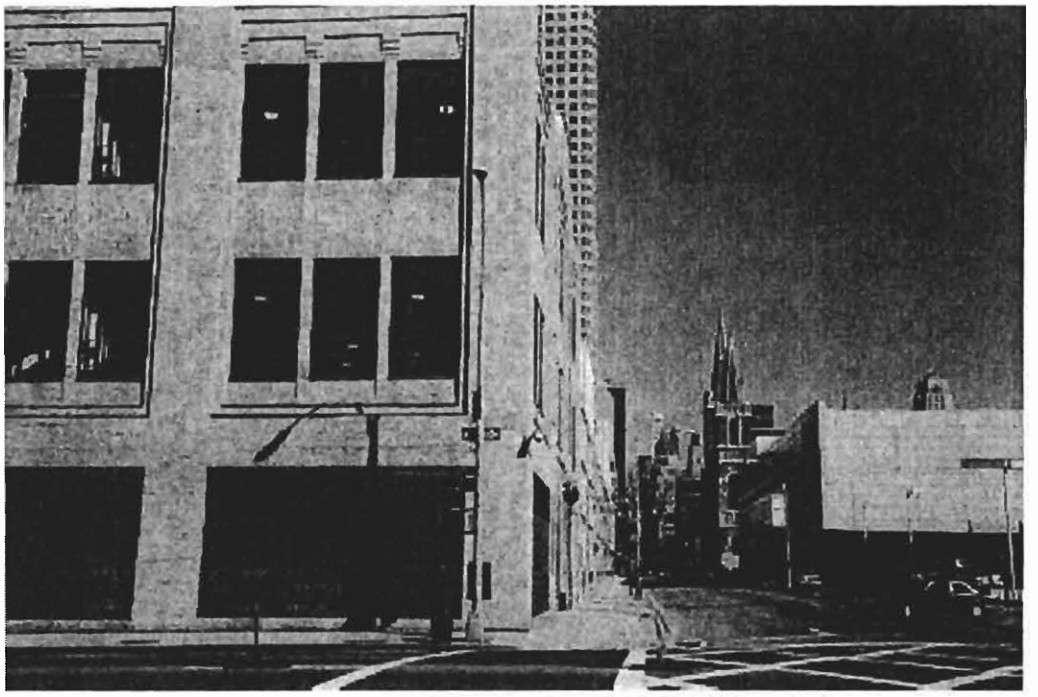
Photo 15

Status as of: 4/10/02
Description: SE corner Block 1070, 41st Street / 11th Avenue.
Photo by: Julie Abell Horn

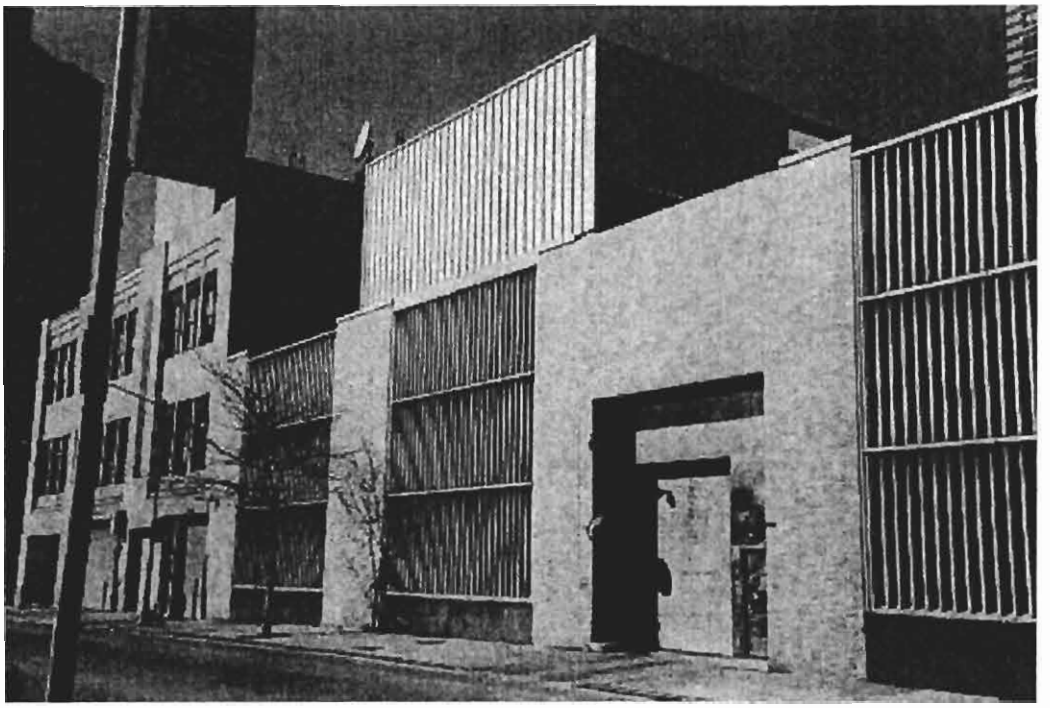
Photo 17

Status as of: 4/10/02
Description: Block 1070, north side of 41st Street, Con Ed facility.
Photo by: Julie Abell Horn

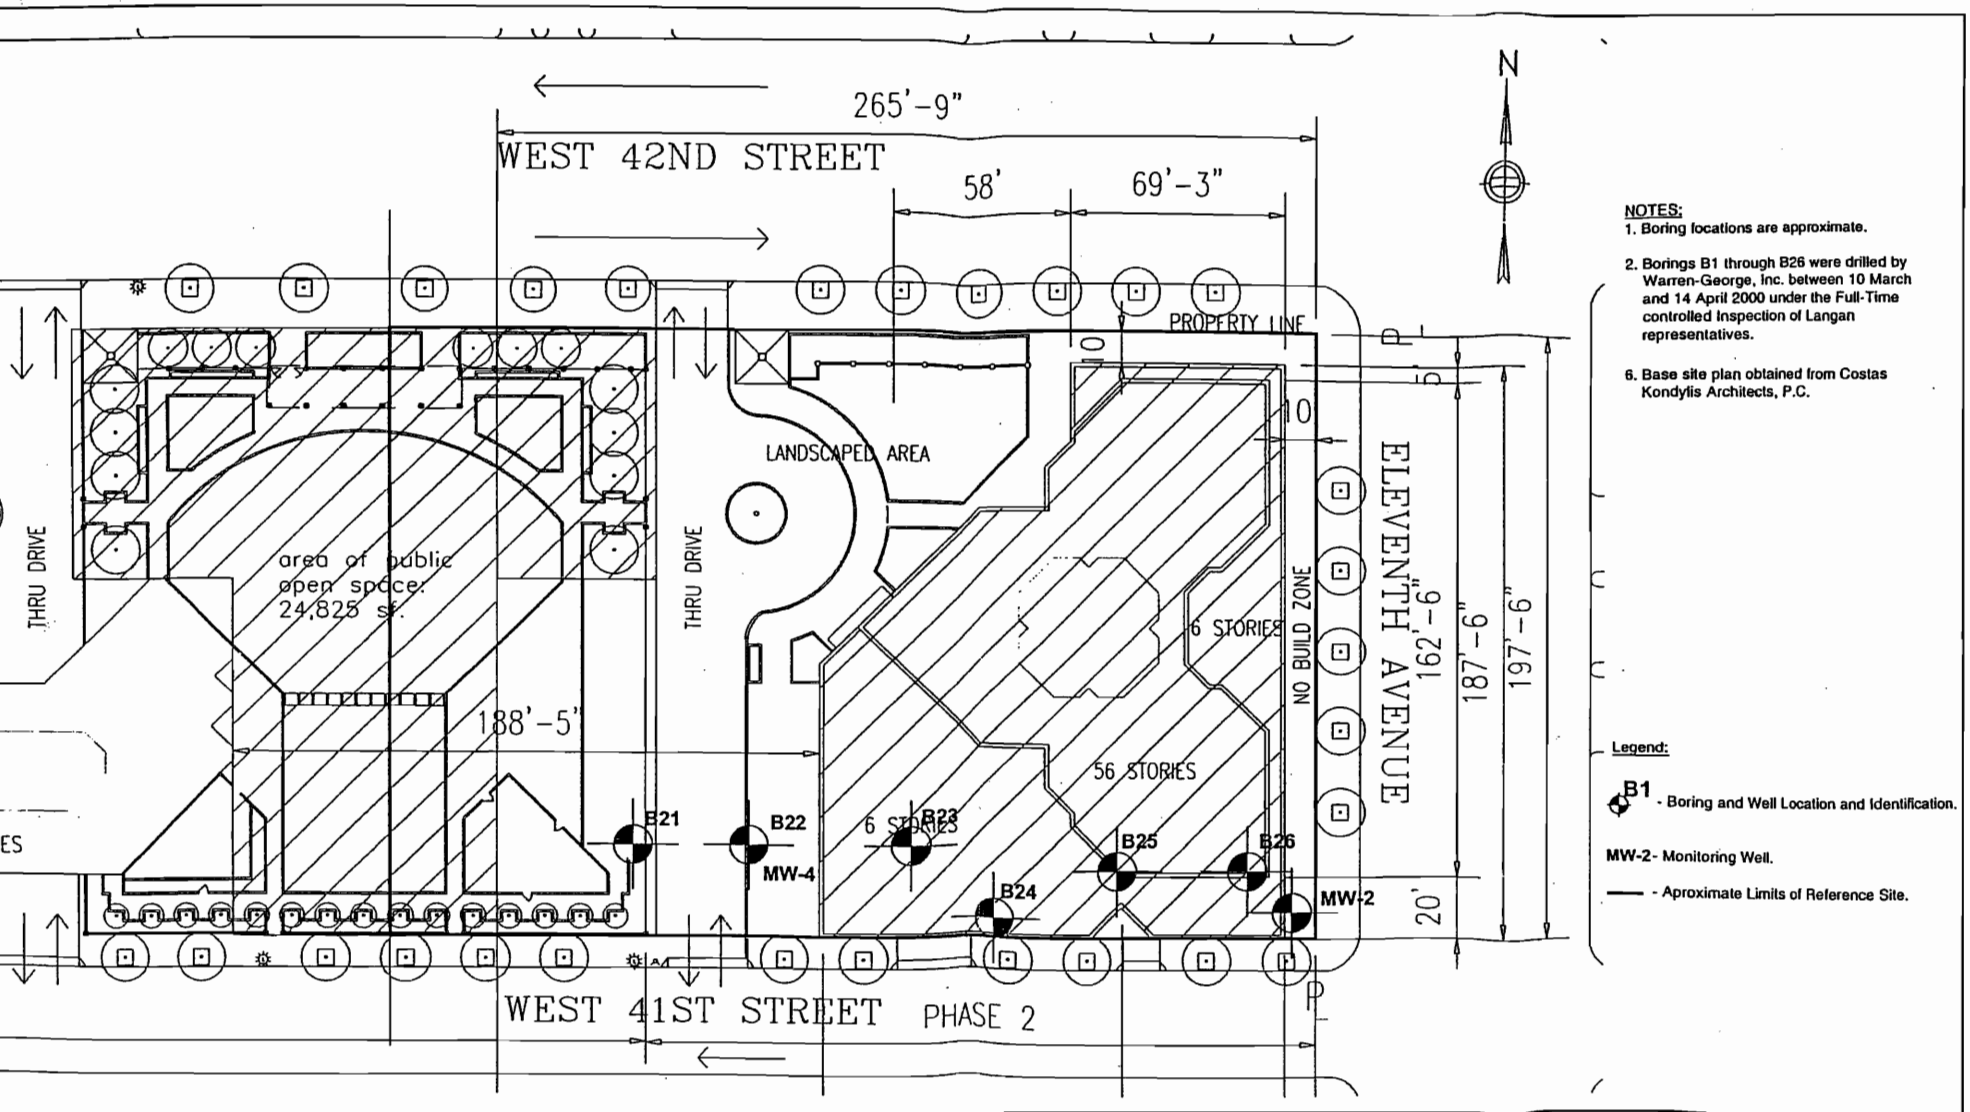
In March 2000, Langan advanced 6 borings (B-21, 22, 23, 24, 25 and 26) into competent bedrock on the 41st Street side of the property. Boring locations are shown on the attached drawing. During drilling of those borings, Langan observed conditions of the soil and collected 6 samples for chemical analysis from depths up to 27 feet below surface grade. Samples were analyzed for volatile and semi-volatile organic compounds in accordance with EPA Methodologies 8021, 8270 and TCLP metals. The results of the sample analysis are summarized and compared with NYSDEC STARS Guidance Values. STARS Guidance Values are the most stringent of NYS requirements for soil and groundwater.

- Stained and odorous material was observed in borings B-25 and B-26.
- No floating product was found in any of the existing or new monitoring wells.
- Four tables are provided showing analytical results for groundwater (Table 1) and Soil (Tables 2-4)

Levels of petroleum-related compounds that exceed NYS Cleanup Objectives and STARS Guidance Values were found in the soil to depth of the deepest boring. Groundwater was found to contain volatile organic compounds, particularly benzene, toluene, ethylbenzene and xylenes, and metals, including copper, lead, mercury and nickel that exceed NYS Ambient Water Quality Standards and STARS Guidance Values. All samples were below TCLP limits for hazardous waste.
