PHASE I ENVIRONMENTAL SITE ASSESSMENT

60 NORFOLK STREET
Manhattan, New York County, New York

Commencement Date: 1 March 2017
Final Report Completion: 24 April 2017

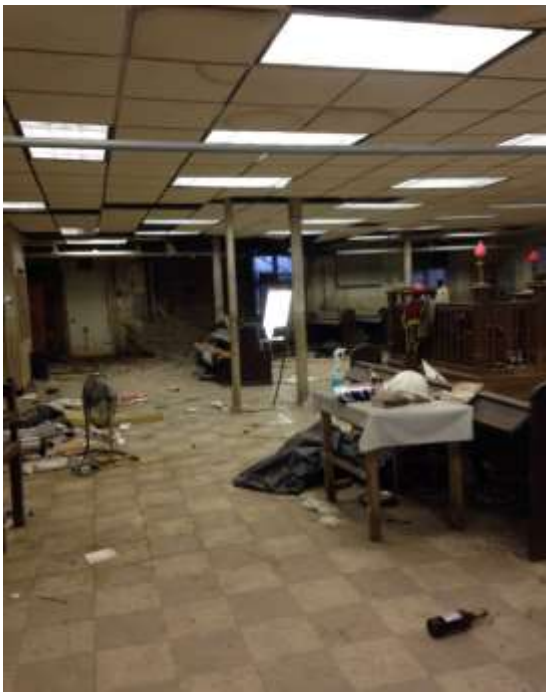
The paint on most of the synagogue building components was identified to be lead-based paint (LBP) and was observed to be in poor condition. Any disturbance of the LBP as part of building renovation must be conducted in accordance with OSHA regulations.

Photo 22: Typical conditions of the interior painted surfaces in the synagogue.
