PHASE I ENVIRONMENTAL SITE ASSESSMENT

375 LAFAYETTE STREET
New York, New York County, New York

Kaufman New Ventures
450 Seventh Avenue
New York, New York

Langan Engineering, Environmental, Surveying,
Landscape Architecture and Geology, D.P.C.
300 Kimball Drive
Parsippany, New Jersey 07054
NJ Certificate of Authorization No: 24GA27996400

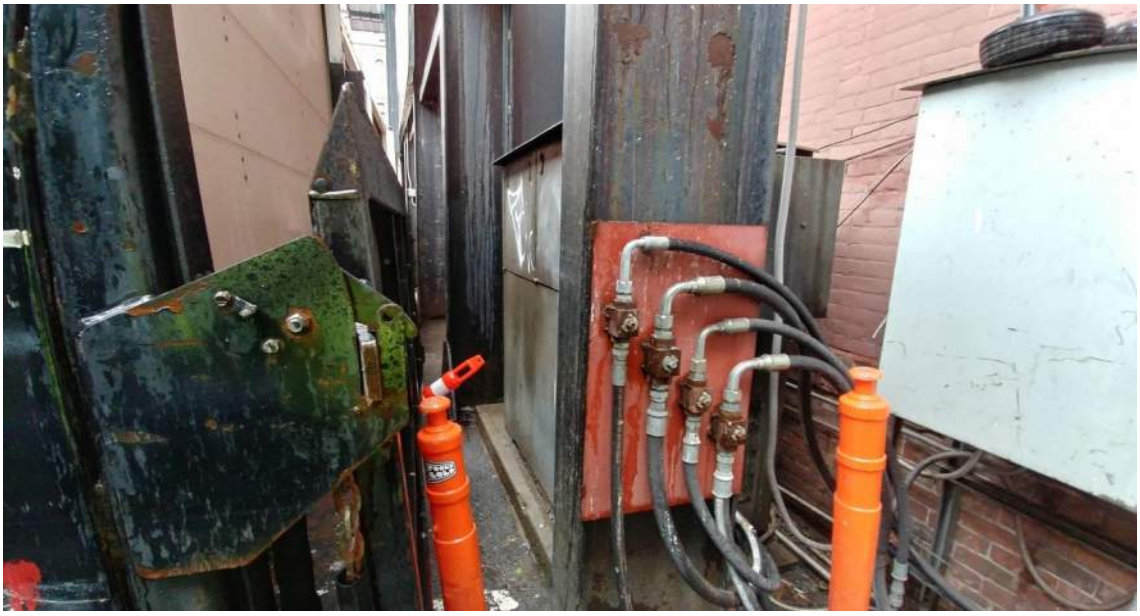
Photo 3: Car parking racks, hydraulic pistons visible on rear, facing east.
