PHASE I ENVIRONMENTAL SITE ASSESSMENT

Fulton
401 West 19th Street, 401 West 18th Street, 427 and 430 West 17th Street
New York, New York 10011

Report Issuance Date: April 21, 2022
Site Reconnaissance Date: April 19, 2022

Hillmann Project Number Z34898

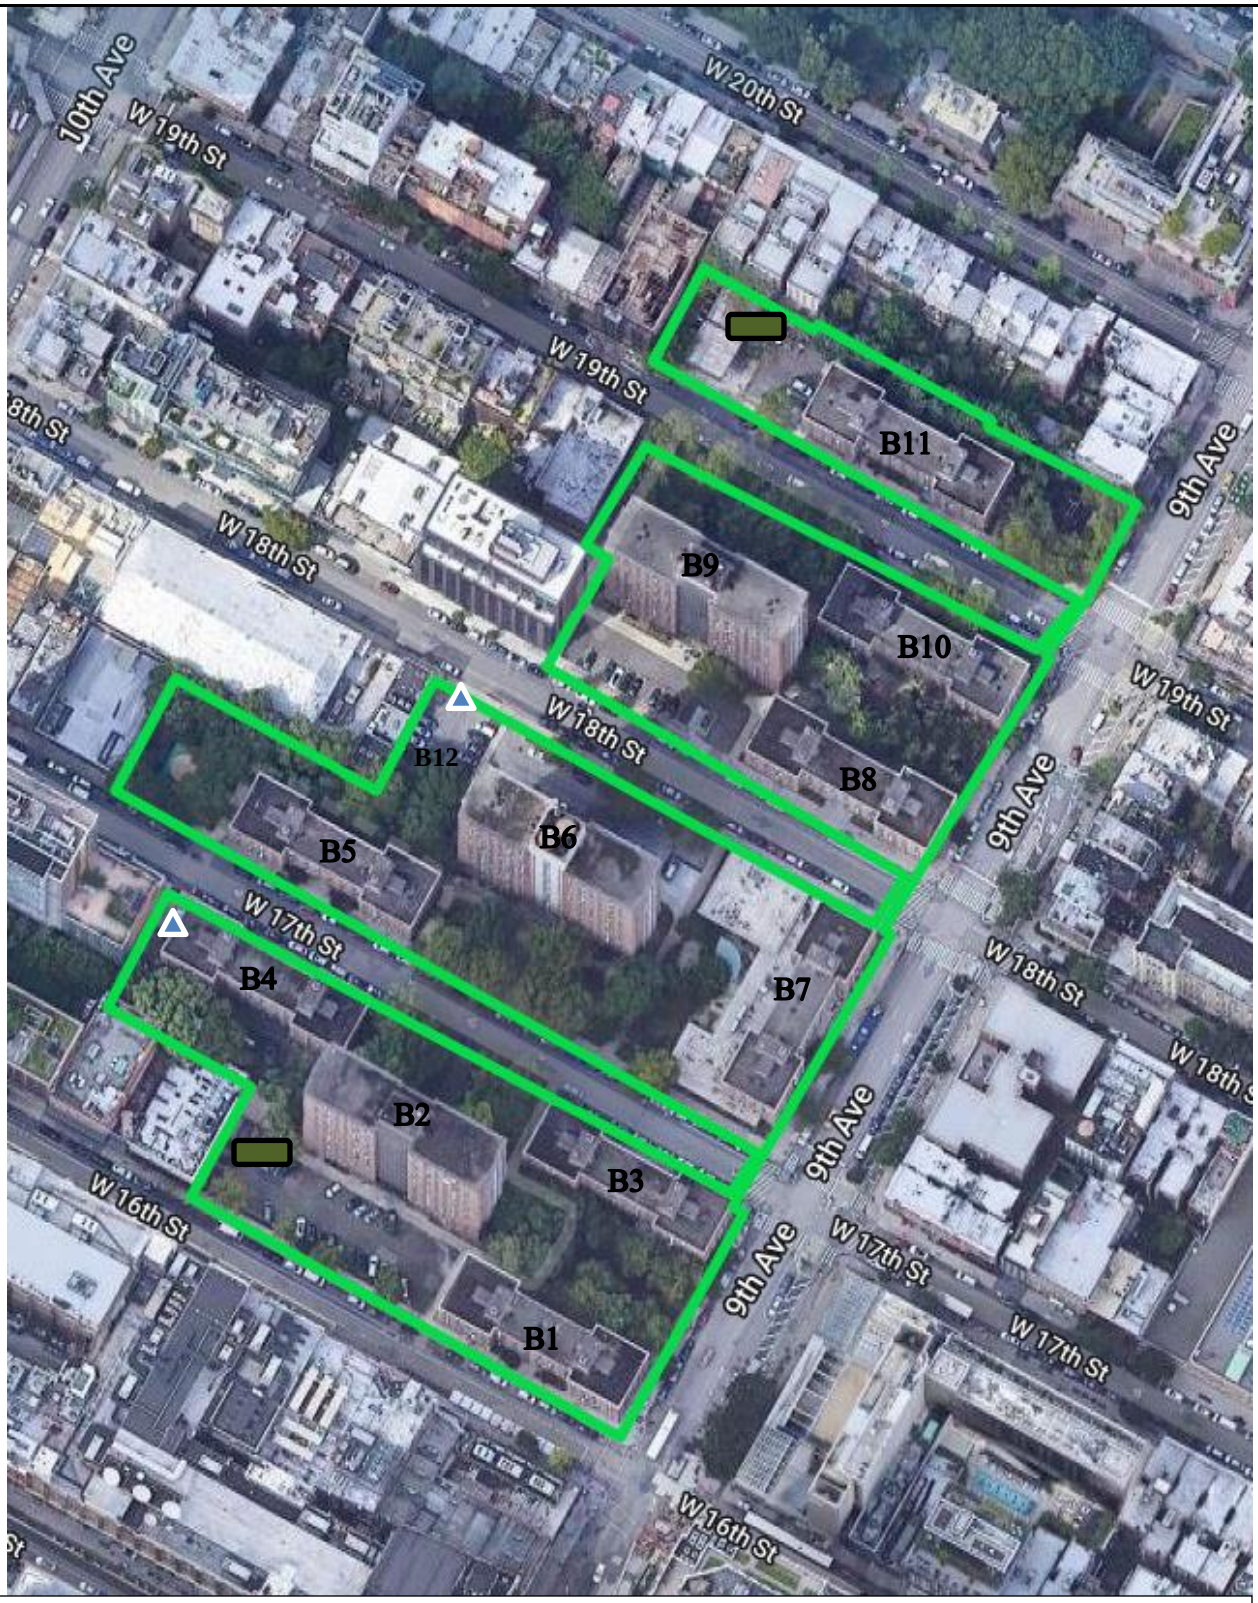
The aforementioned historic uses including a factory, laundry, iron works, motor freight station, auto filling/service stations with multiple gasoline tanks is considered a REC. Two (2) groundwater monitoring wells were observed within the Property north of B12 (two-bay Property garage) and northwest of B4 on the south side of West 18th and West 17th Streets respectively. The trigger for the installation of these wells and their use for sampling/monitoring if any was unknown by the site escort/contact. Hillmann recommends obtaining records of a subsurface investigation (if already performed) or performing a subsurface investigation to determine the presence/absence of impact to underlying environmental media from aforementioned uses and the presence/absence of abandoned underground storage tanks (USTs) in areas not excavated in the 1960's for the construction of the present Property buildings. If the onsite groundwater monitoring wells observed during the site reconnaissance are no longer in use, said wells should be decommissioned in accordance with applicable regulations.

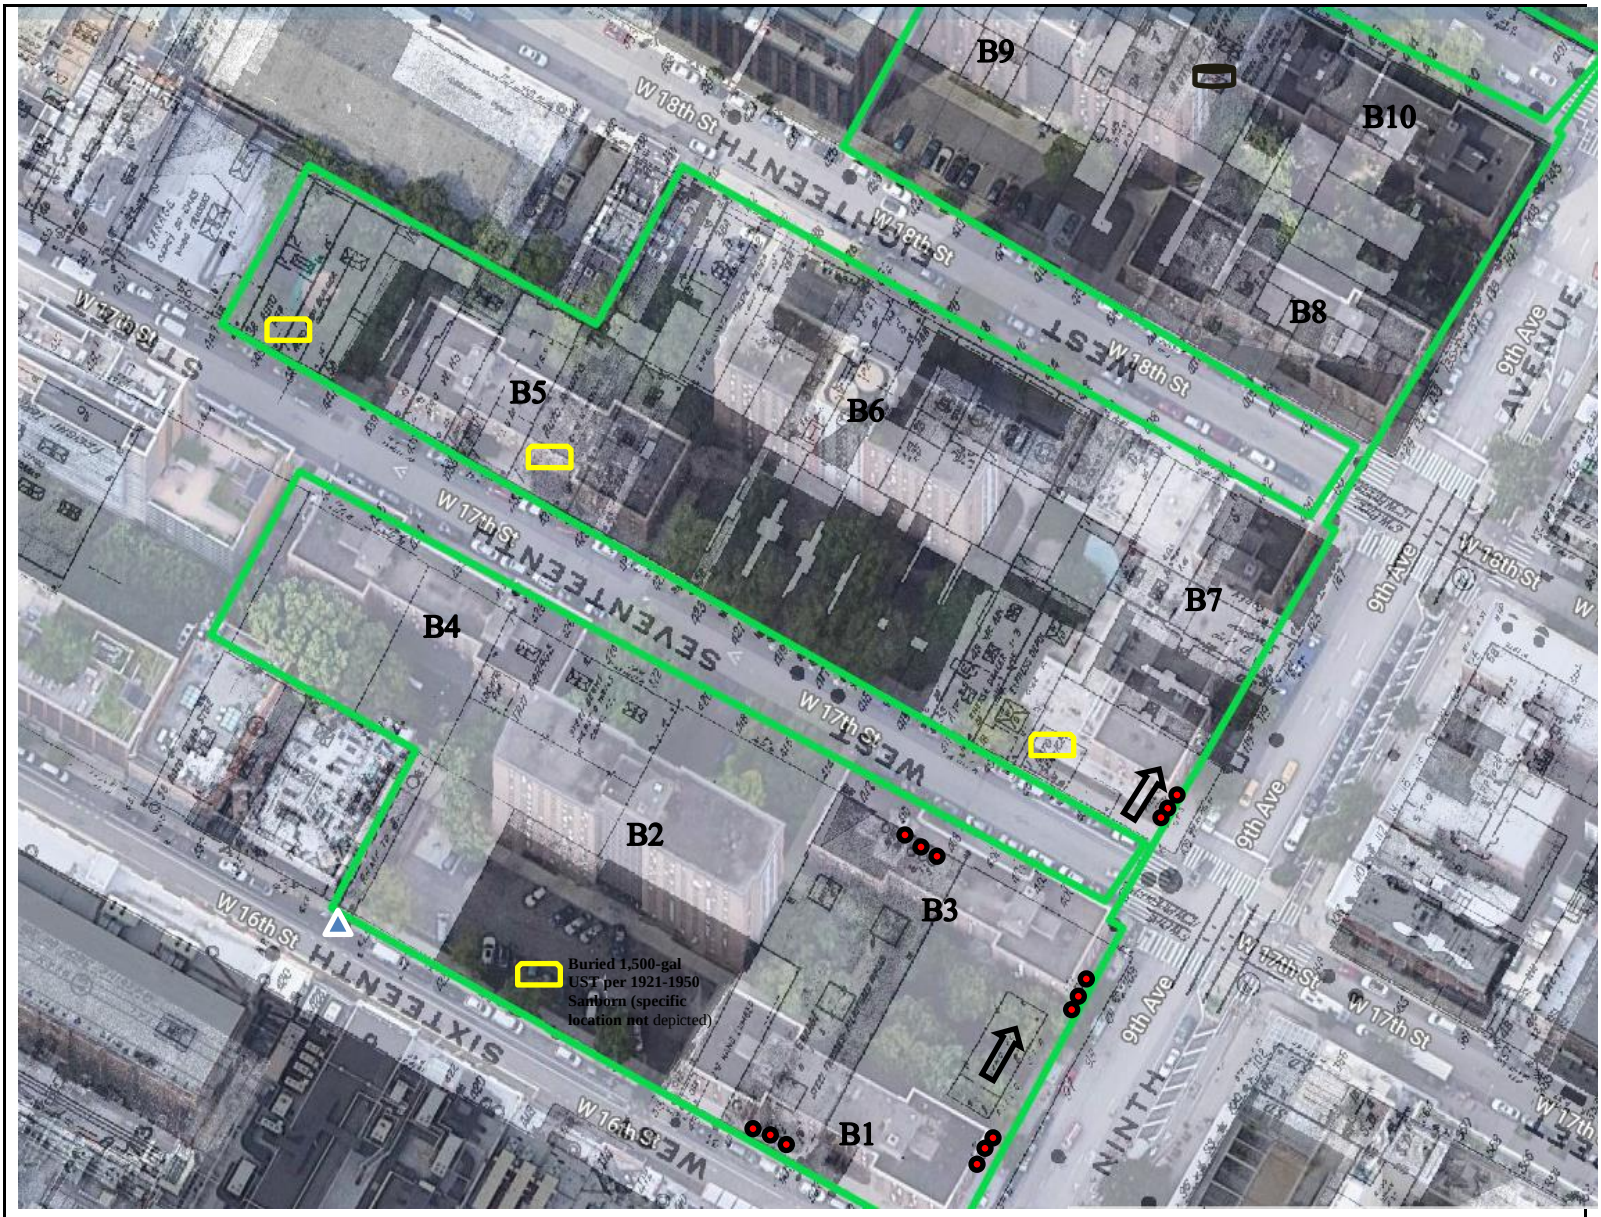
- Filling station (gas station), taxi garage and auto repair with multiple gasoline tanks depicted along ninth avenue between West 16th and West 17th Avenue and along West 16th and West 17th Avenue (see Appendix A figure), and an additional auto filling/service station with multiple gasoline tanks depicted at the northwest corner of 9th Avenue and West 17th Street (near the southern edge of the present Building 7) and auto painting (431-433 West 17th) and repair (443-445 West 17th), a motor freight terminal (410-412 West 19th) in 1950.

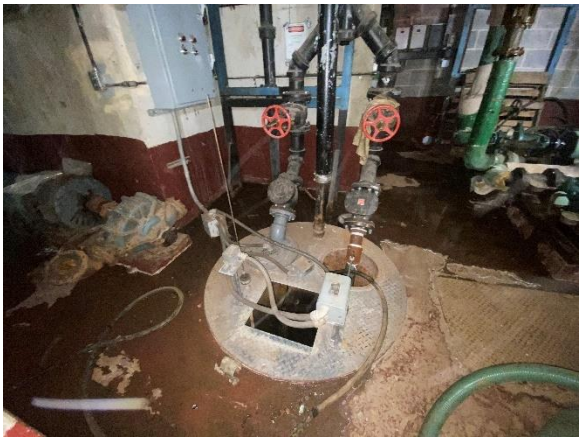
High pressure steam heating piping

Sump

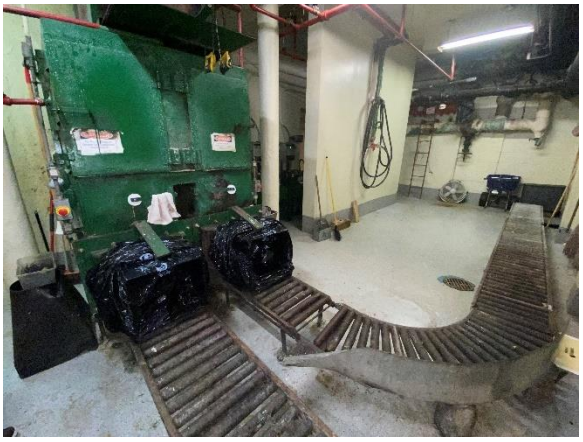
Electric meter

Trash compactor

Floor drain in compactor room
