Queens West Development

Parcel 9

2017 Periodic Review Report and Annual Certification

NYSDEC BCP Number: C241049

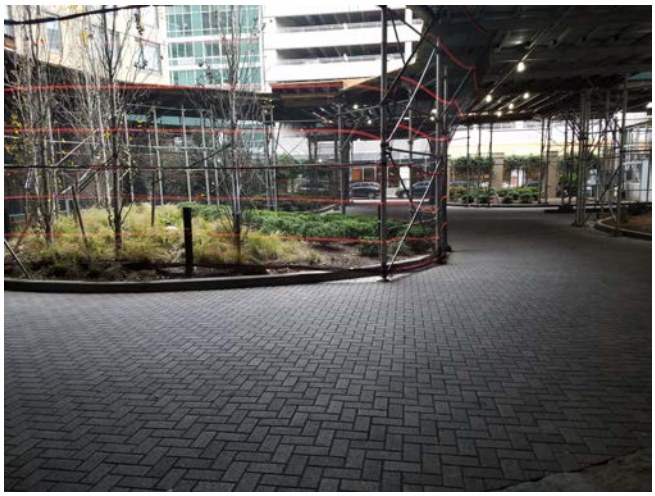
Photo 1: View of typical landscaping and paving in courtyard.

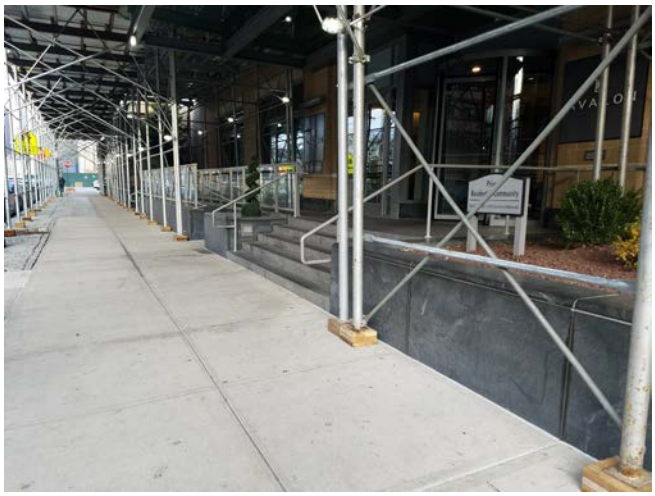
Photo 5: View of typical landscaping and paving along 47th Rd. looking east @ 47th Rd. & 5th St. intersection.

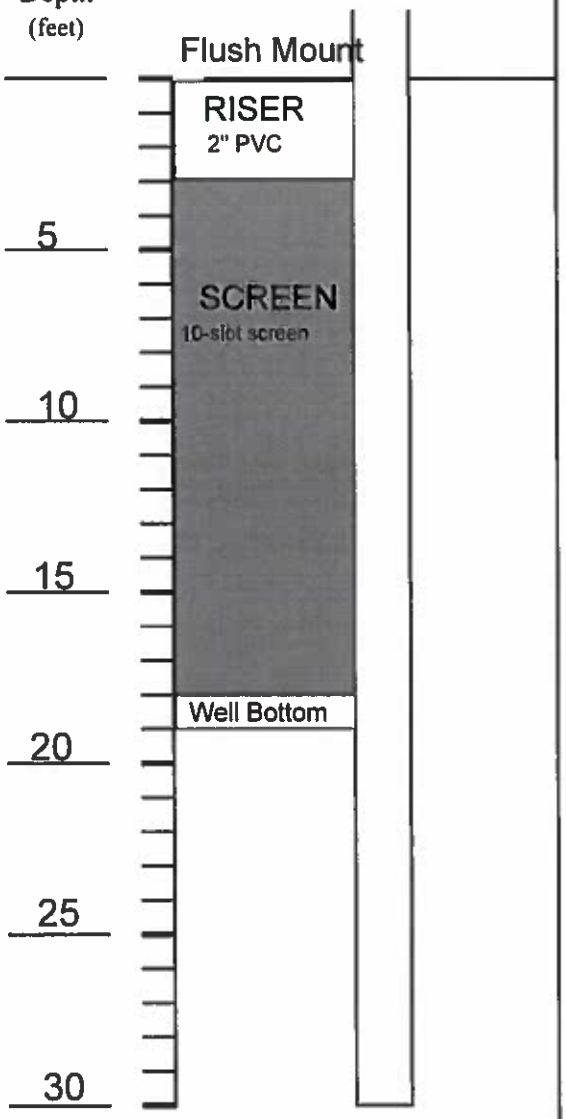
WELL SCHEMATIC*

COMMENTS: Flush mount removed

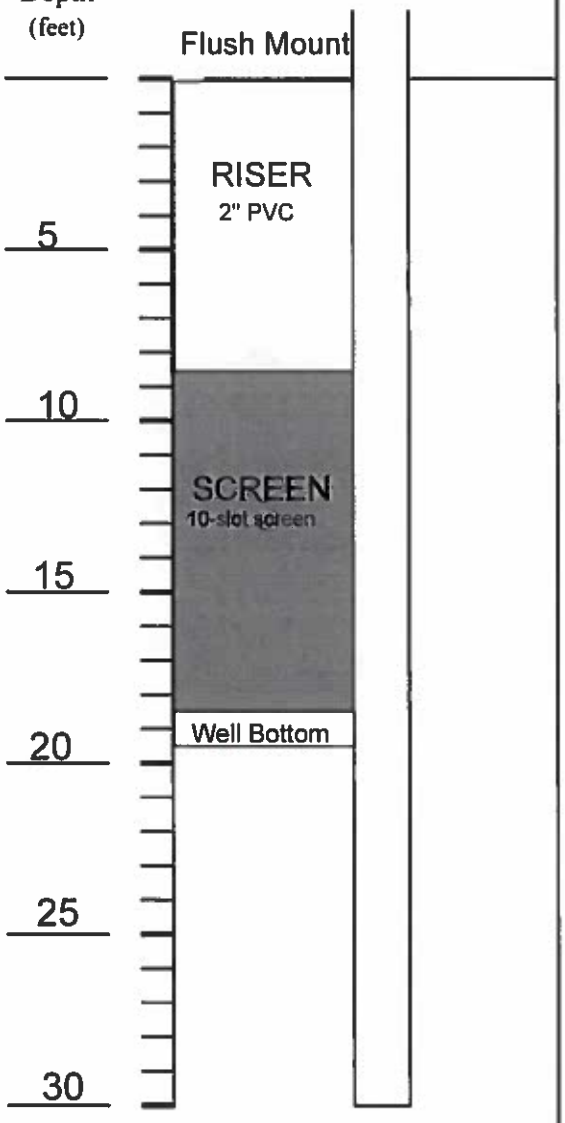
WELL SCHEMATIC*

COMMENTS: Flush mount removed

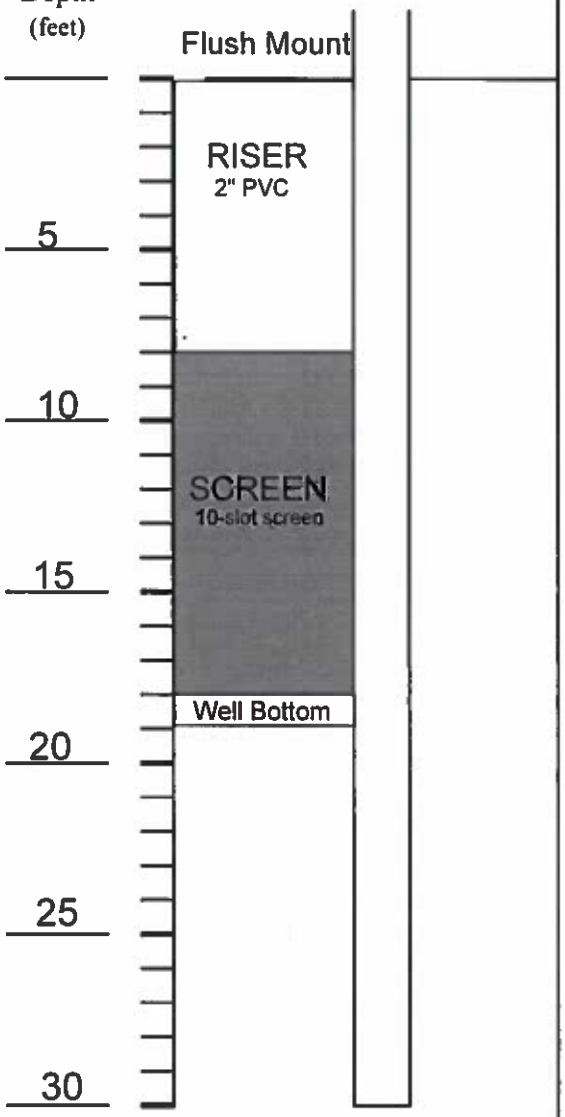
WELL SCHEMATIC*

COMMENTS: Flush mount removed

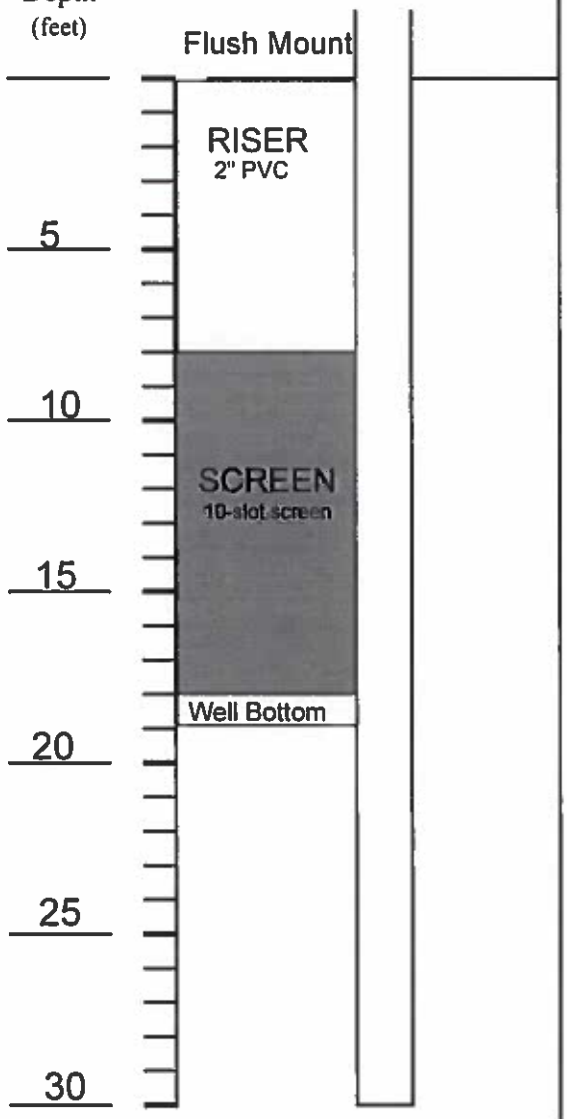
WELL SCHEMATIC*

COMMENTS: Flush mt. removed

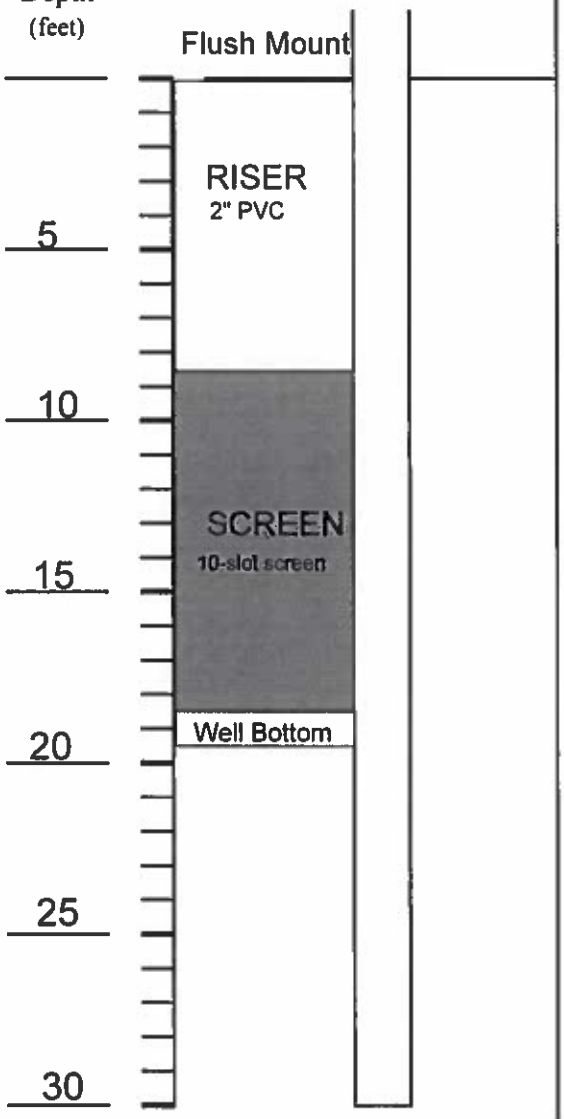
WELL SCHEMATIC*

COMMENTS: Flush mount removed

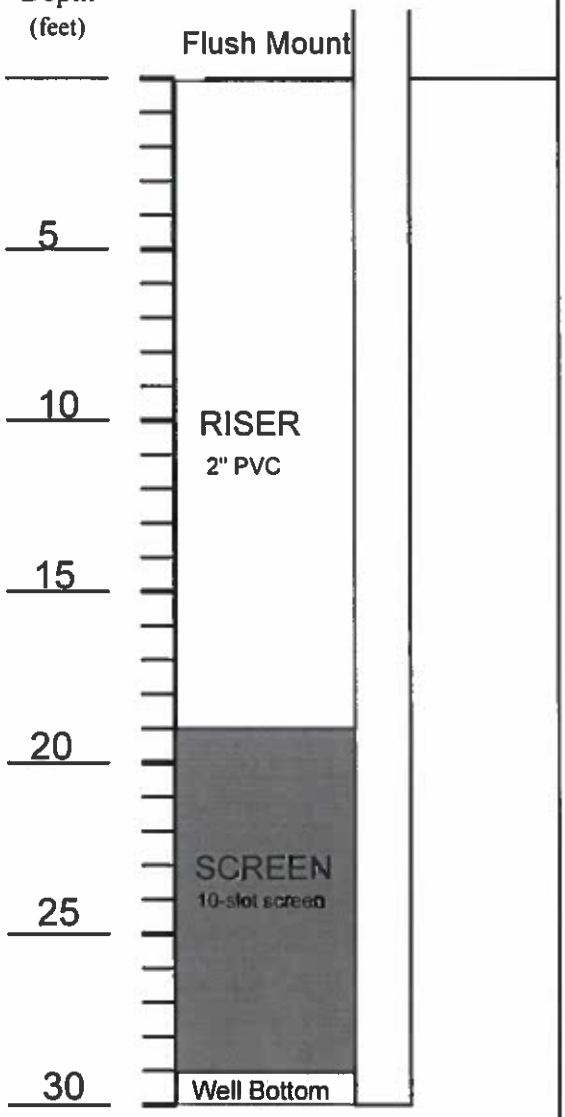
WELL SCHEMATIC*

COMMENTS: Flush mount removed
