ADDITIONAL SUBSURFACE INVESTIGATION

UNIFORMS FOR INDUSTRY
129-09 JAMAICA AVENUE
RICHMOND HILL, NEW YORK 11418

DATE ISSUED: MARCH 29, 2006

GCE PROJECT NUMBER: 05-116-00

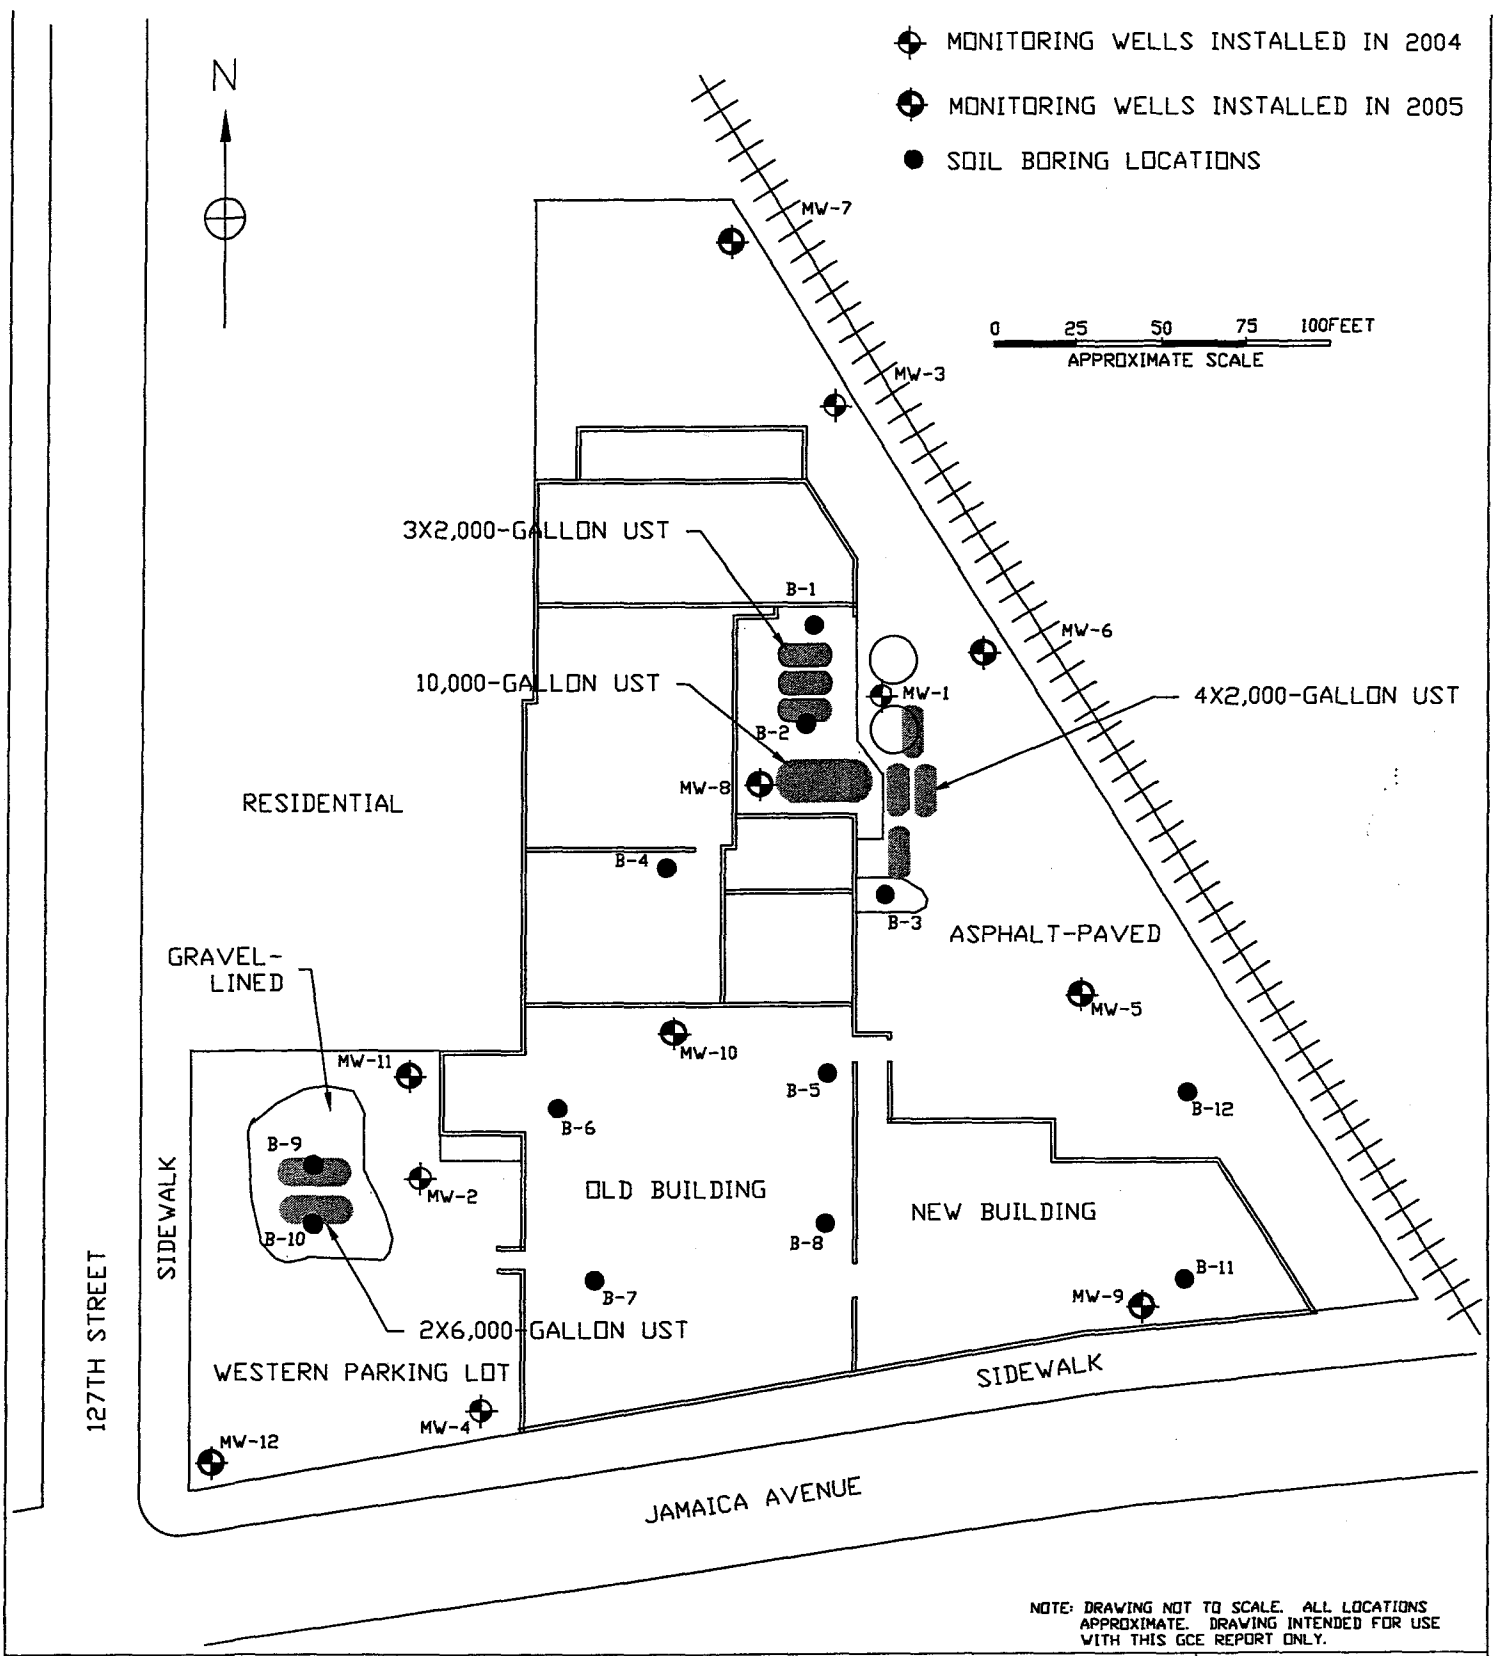
FIGURE 2

The boring locations are presented in Figure 2 - Site Plan. The boring logs are presented in Appendix B.

The monitoring well locations are presented in the Figure 2 – Site Plan. Details of monitoring well construction are presented in the Monitoring Well Logs shown in Appendix B.

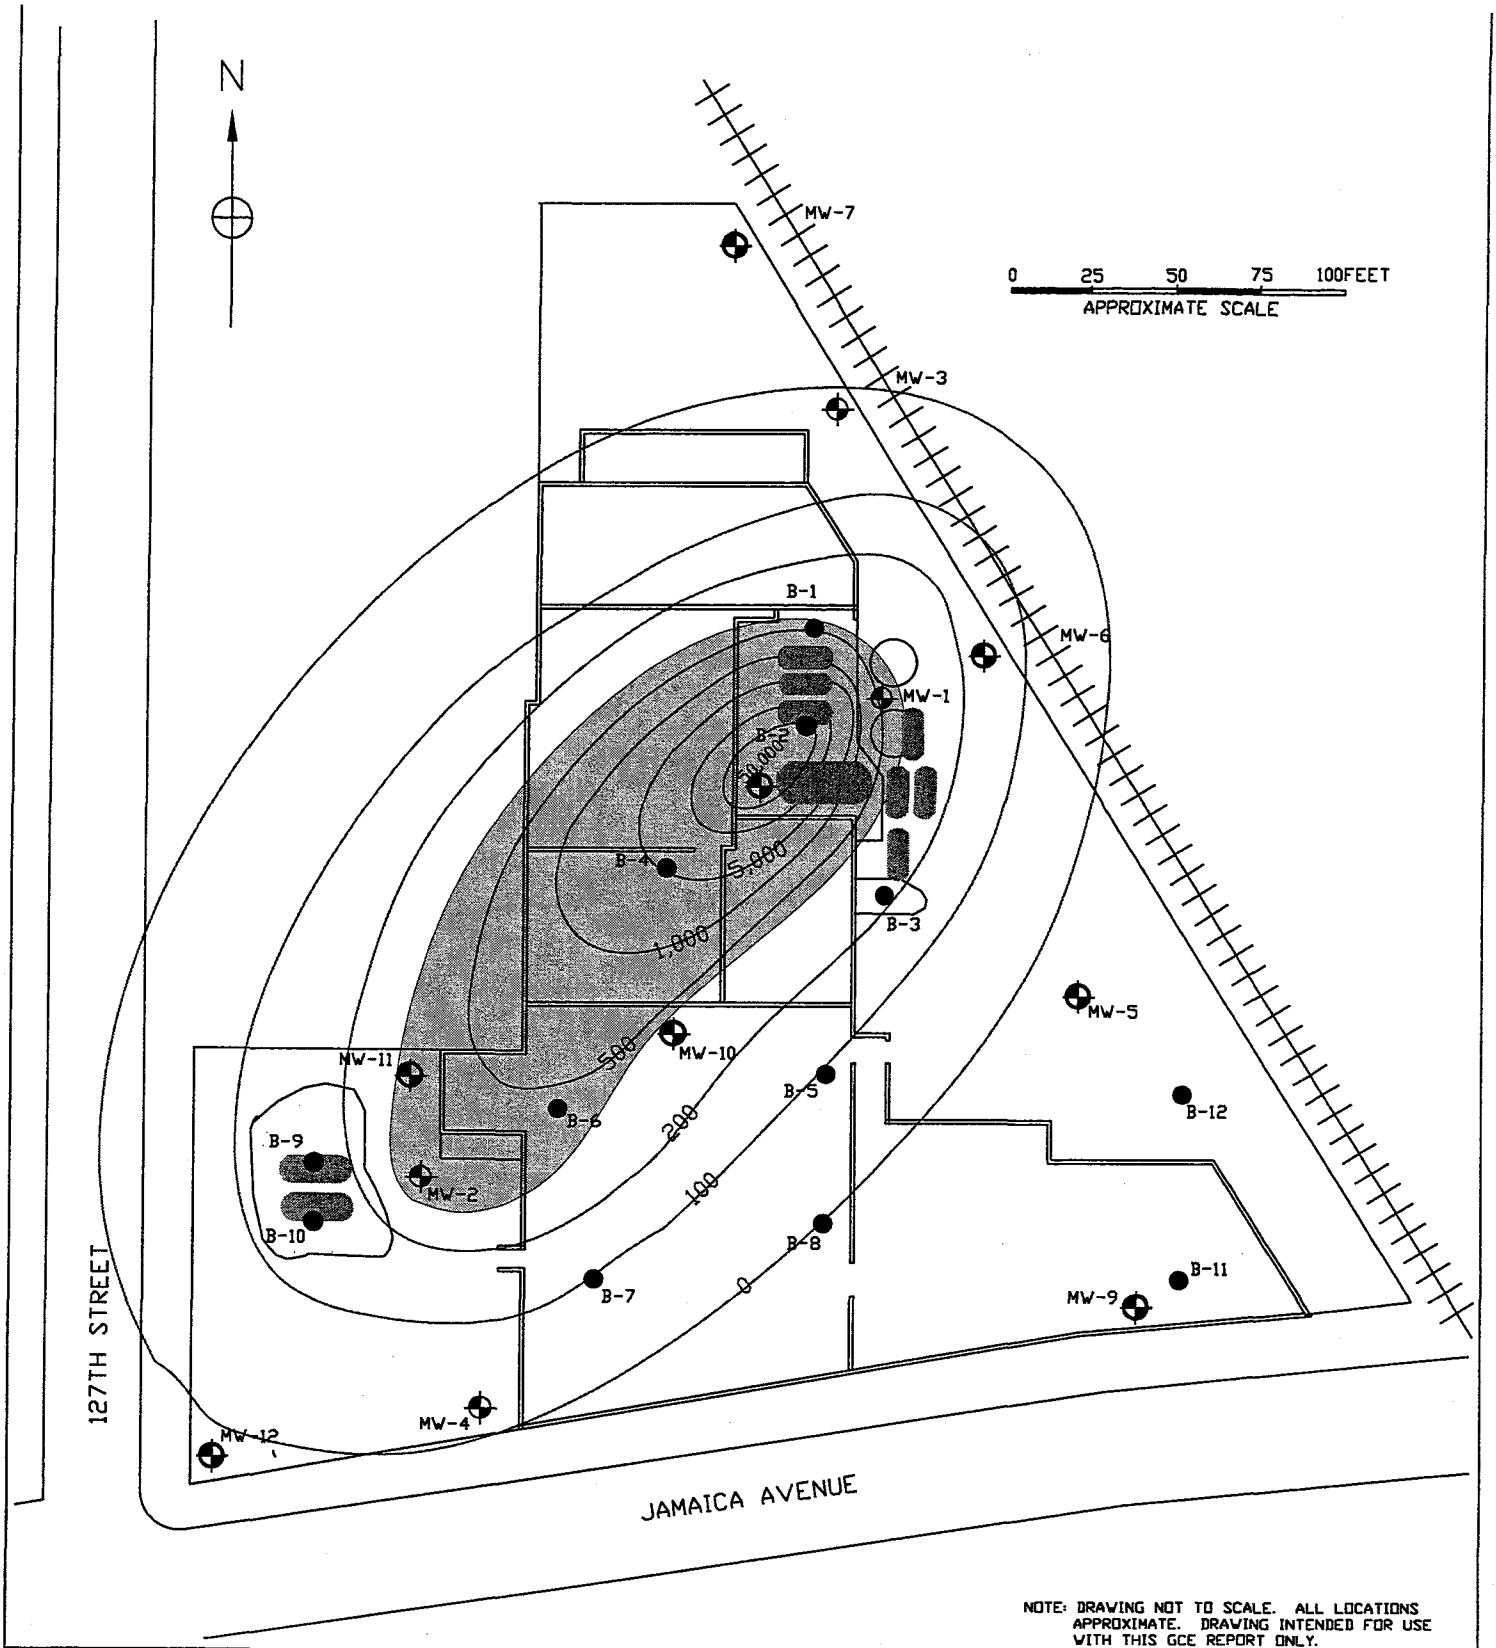
FIGURE 6

Liquid phase hydrocarbons (free product) float on the surface of the water table and cover an area of approximately 12,000 square feet on the central portion of the Site (see Figure 6). Petroleum fingerprint analysis revealed that free product, assumed to be mop oil, consists of a mixture of kerosene and 40W lubricating oil. According to the laboratory results, the density of free product collected in well MW-8 is 0.88 g/cc.

Free product was observed in monitoring well MW-8, where in the central portion of the plume it has apparent (observed) thickness of 6.06 feet. In monitoring wells MW-1, MW-2 and MW-11 free product is wedged out and has a thickness of 0.14, 0.18 and 0.09 feet, respectively. An actual formation free product thickness and consequently the exact volume of the free product cannot be calculated on the basis of just one monitoring well. Furthermore, the actual formation thickness is usually less than the observed thickness in the monitoring well, especially in the fine-grained soil due to capillary effects (see Figure 4).

Aqueous or dissolved phase hydrocarbons, producing petroleum groundwater contamination, are present under the main portion of the Site as well as beneath the residential properties located adjacent to the west (see Figure 6). The groundwater plume was not delineated from the west and could cover more extensive area beneath the residential properties. Due to insufficient data, free product contour and main petroleum compounds - BTEX (benzene, toluene, ethylbenzene and xylenes) isopleths are constructed manually in accordance with groundwater flow directions.

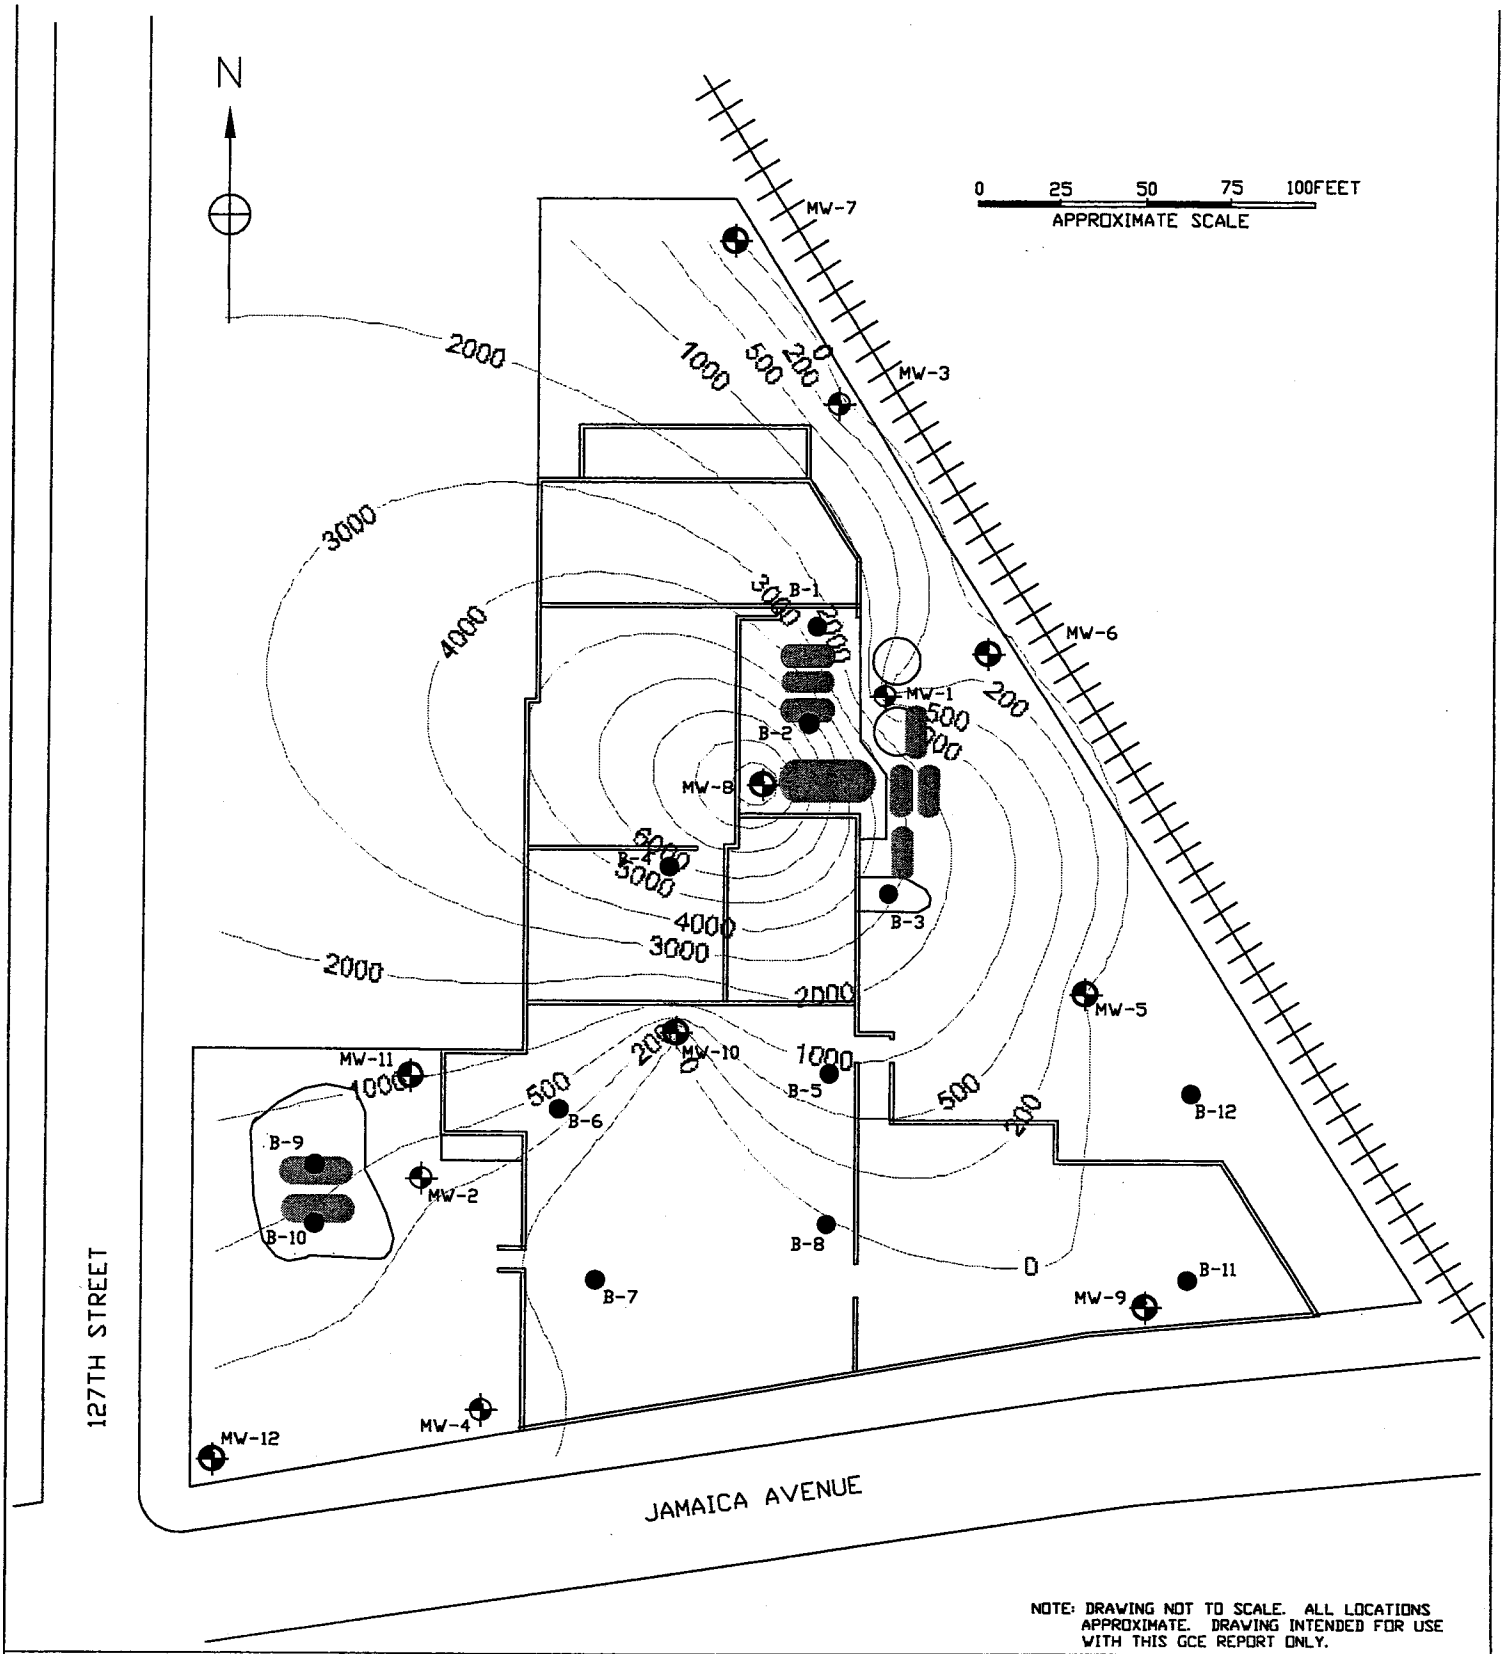
Chlorinated hydrocarbons are present at the Site including tetrachloroethene (PCE), trichloroethene (TCE), dichloroethene (DCE) and vinyl chloride (VC), which are DNAPL (dense nonaqueous phase liquids). Being denser than water, these compounds have a different fate and distribution under the Site and are not detected in all soil borings or detected far below their detection limits (see Table 1). However, groundwater samples results indicated that PCE, TCE and DCE occupied practically the entire area beneath the Site and beyond its boundaries with higher concentrations located along the northern, eastern and southern boundaries of the Site (see Table 2). Minimal concentrations or lack of contamination is observed in the central portion of the Site. The western portion of the site is still not fully investigated (see Figures 7, 8 and 9). The distribution of the VC is slightly different and higher concentrations were present in the central

and western portions of the Site where petroleum free product is present (see Figure 10).
