APPENDIX I

Digital Project Photo Log

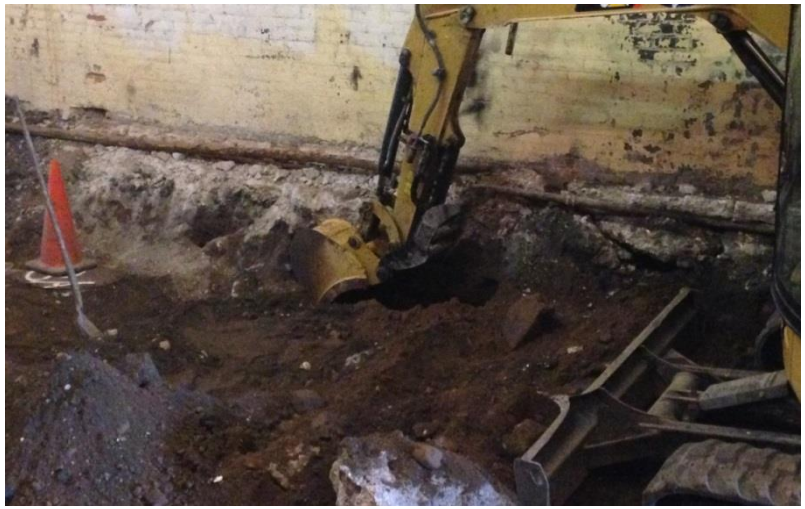
17. Photo taken on Wednesday, October 14, 2015. Looking south inside of the garage; locations of manhole covers for USTs.

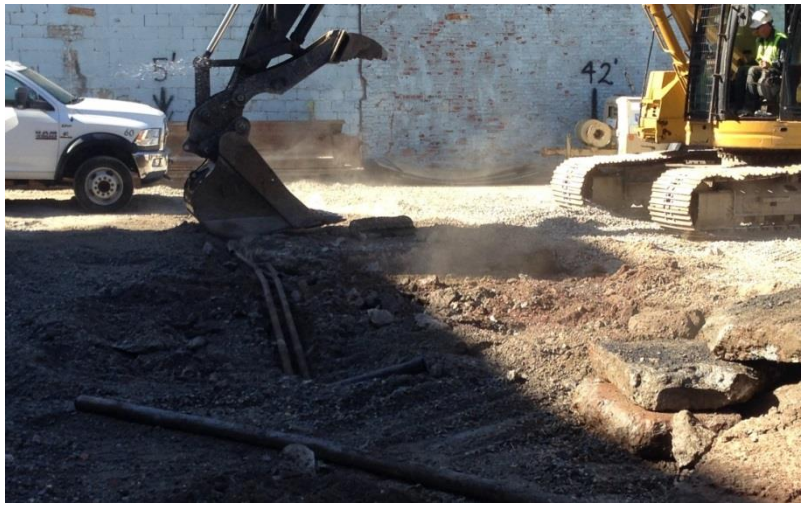
30. Photo taken on Monday, October 19, 2015. In courtyard looking northwest, began removal of concrete in courtyard. Use of dust suppression when moving concrete to reduce generated particulates.

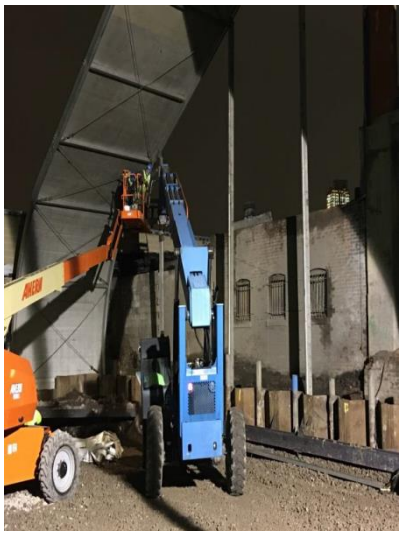
227. Photo taken on Wednesday, December 30, 2015. Looking east inside of tent; removal of dished UST D-4. Staged on poly for future disposal.

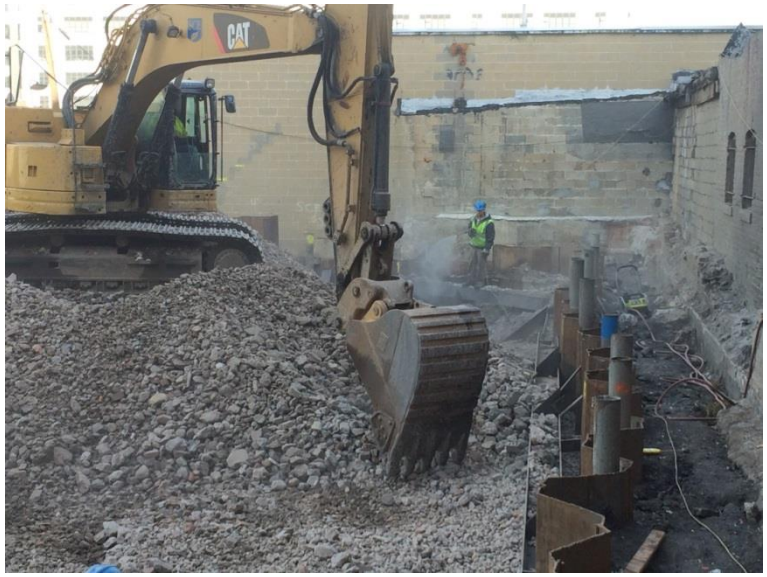
241. Photo taken on Thursday, January 7, 2016. Looking northeast into UST D-5; UST D-5 after cleaning.

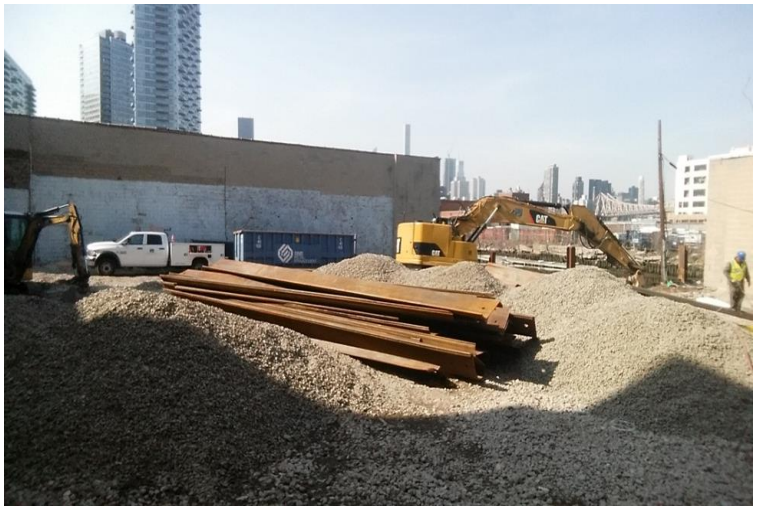
330. Photo taken on Monday, March 7, 2016. Looking northeast across the courtyard; moving decontaminated excavation sheeting from decon area to the middle of courtyard staging area for future offsite demobilization.

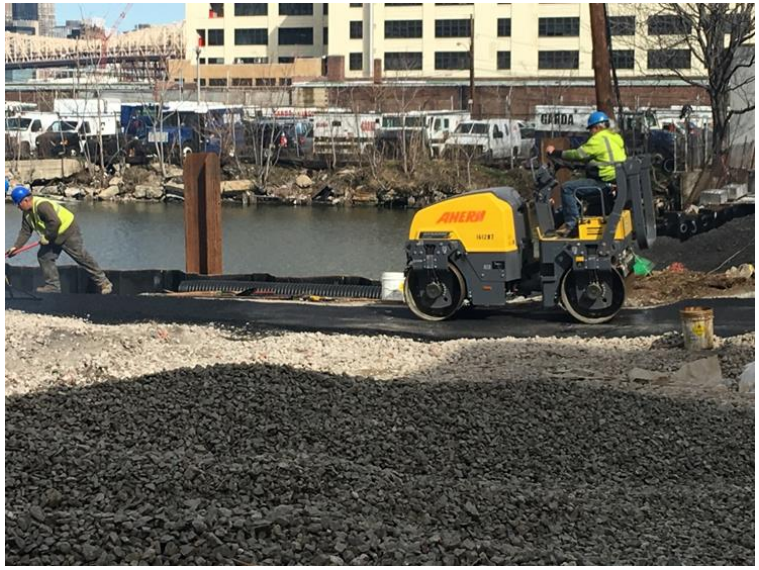
337. Photo taken on Thursday, March 10, 2016. Looking southwest down driveway; use of asphalt spreader to pave driveway.
