Periodic Review Report

Former Paragon Paint and Varnish Site
Long Island City, New York

May 13, 2022

Roux Environmental Engineering and Geology, D.P.C.
209 Shafter Street
Islandia, New York 11749

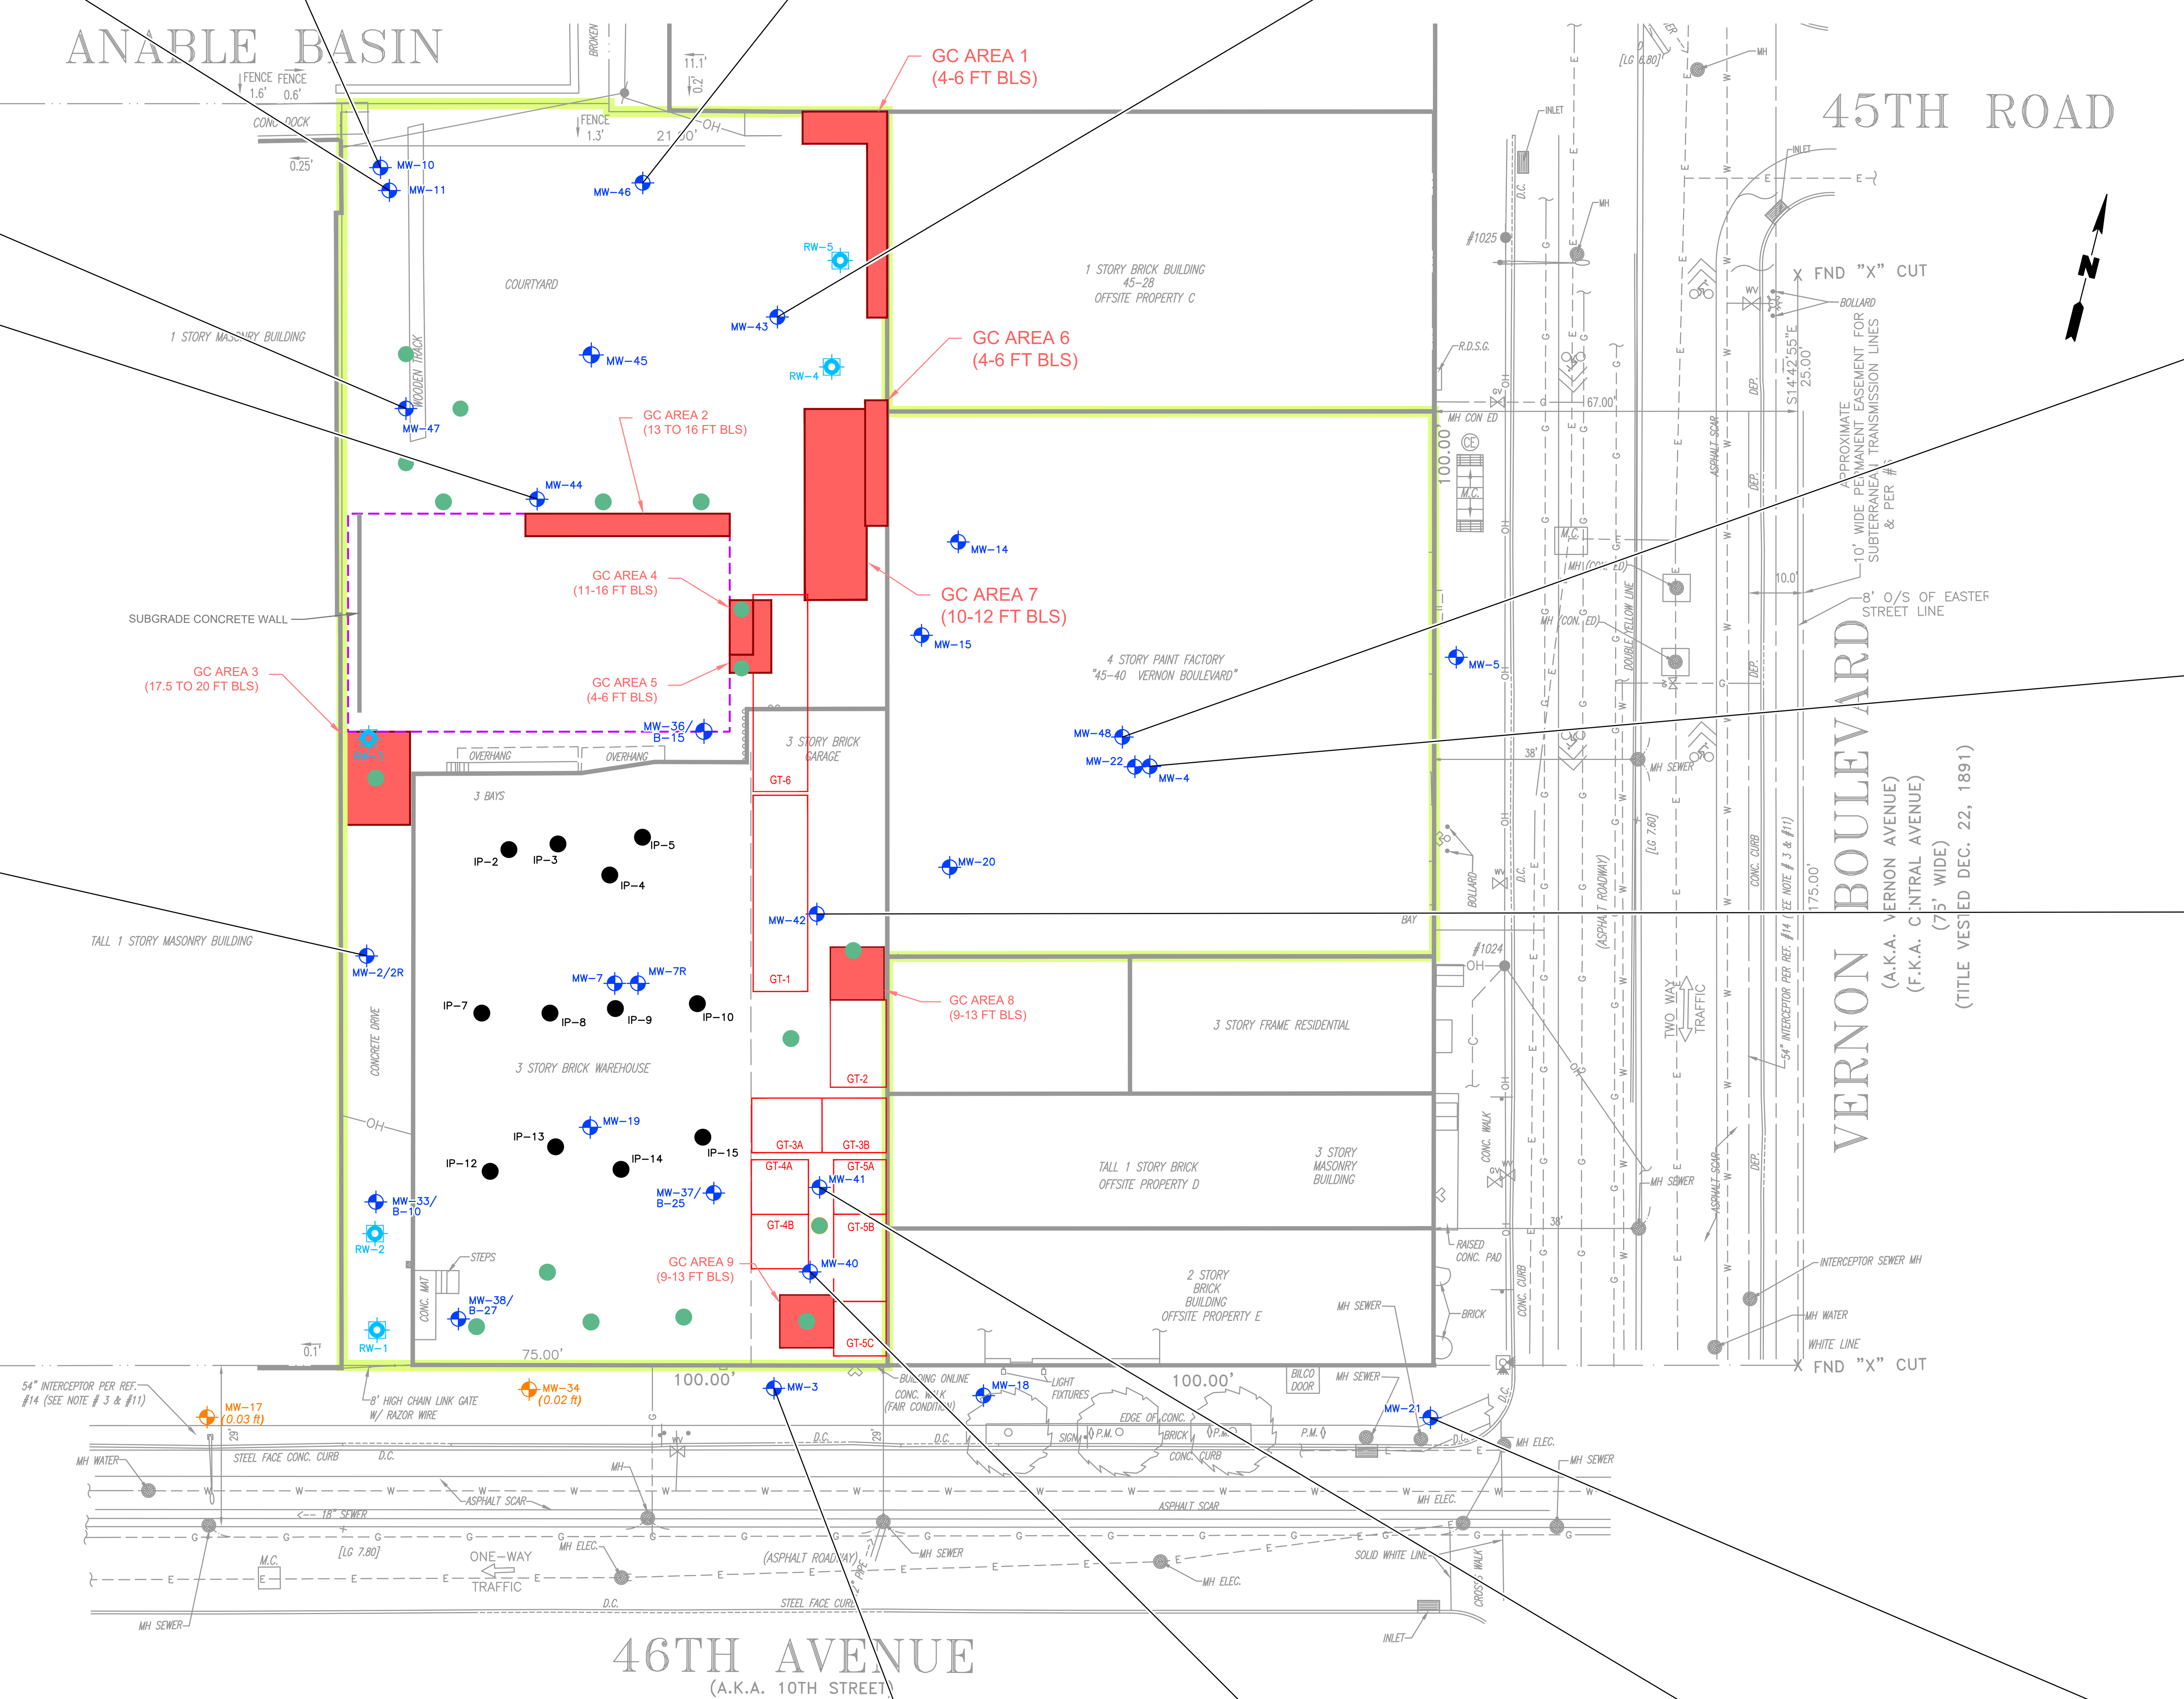
MW-2R	08/27/2020	08/12/2021
COCs		
Benzene	NS	**5.2 J+**
Ethylbenzene	NS	**26 J+**
Isopropylbenzene (Cumene)	NS	**61 J+**
m,p-Xylene	NS	10 U
O-Xylene (1,2-Dimethylbenzene)	NS	10 U
Xylenes	NS	10 U

- The specific COC exceedances of AWQSGVs are noted below:
    - Benzene results exceeded their respective AWQSGV of 1 µg/L at two (2) monitoring well locations (5.2 µg/L at MW-2R and 1.1µg/L at MW-3).
    - Ethylbenzene results exceeded their respective AWQSGV of 5µg/L at one (1) monitoring well location (26 µg/L at MW-2R).
    - Isopropylbenzene results exceeded their respective AWQSGV of 5 µg/L at four (4) monitoring well locations (61 µg/L at MW-2R, 31 µg/L at MW-3, 7.2 µg/L at MW-40, and 9.3 µg/L at MW-43).
    - Xylene results did not exceed their respective AWQSGV of 5 µg/L.

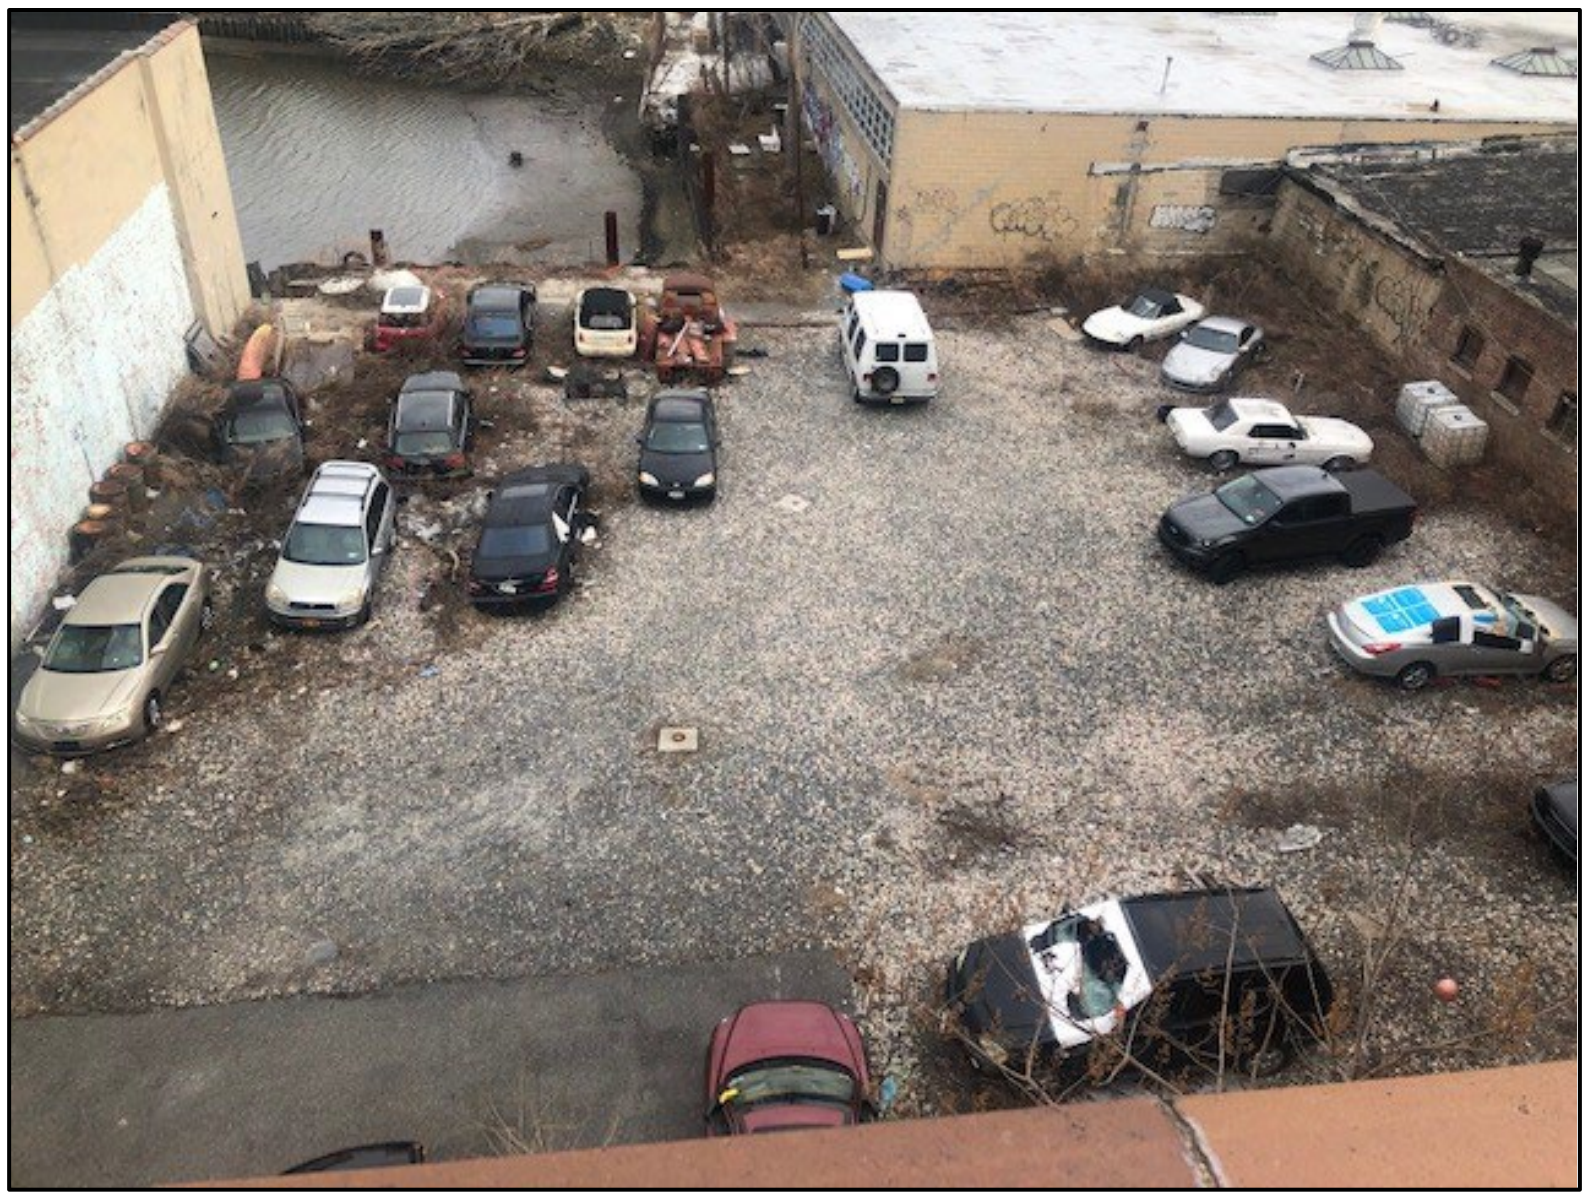
Photograph 5: Condition of courtyard looking north

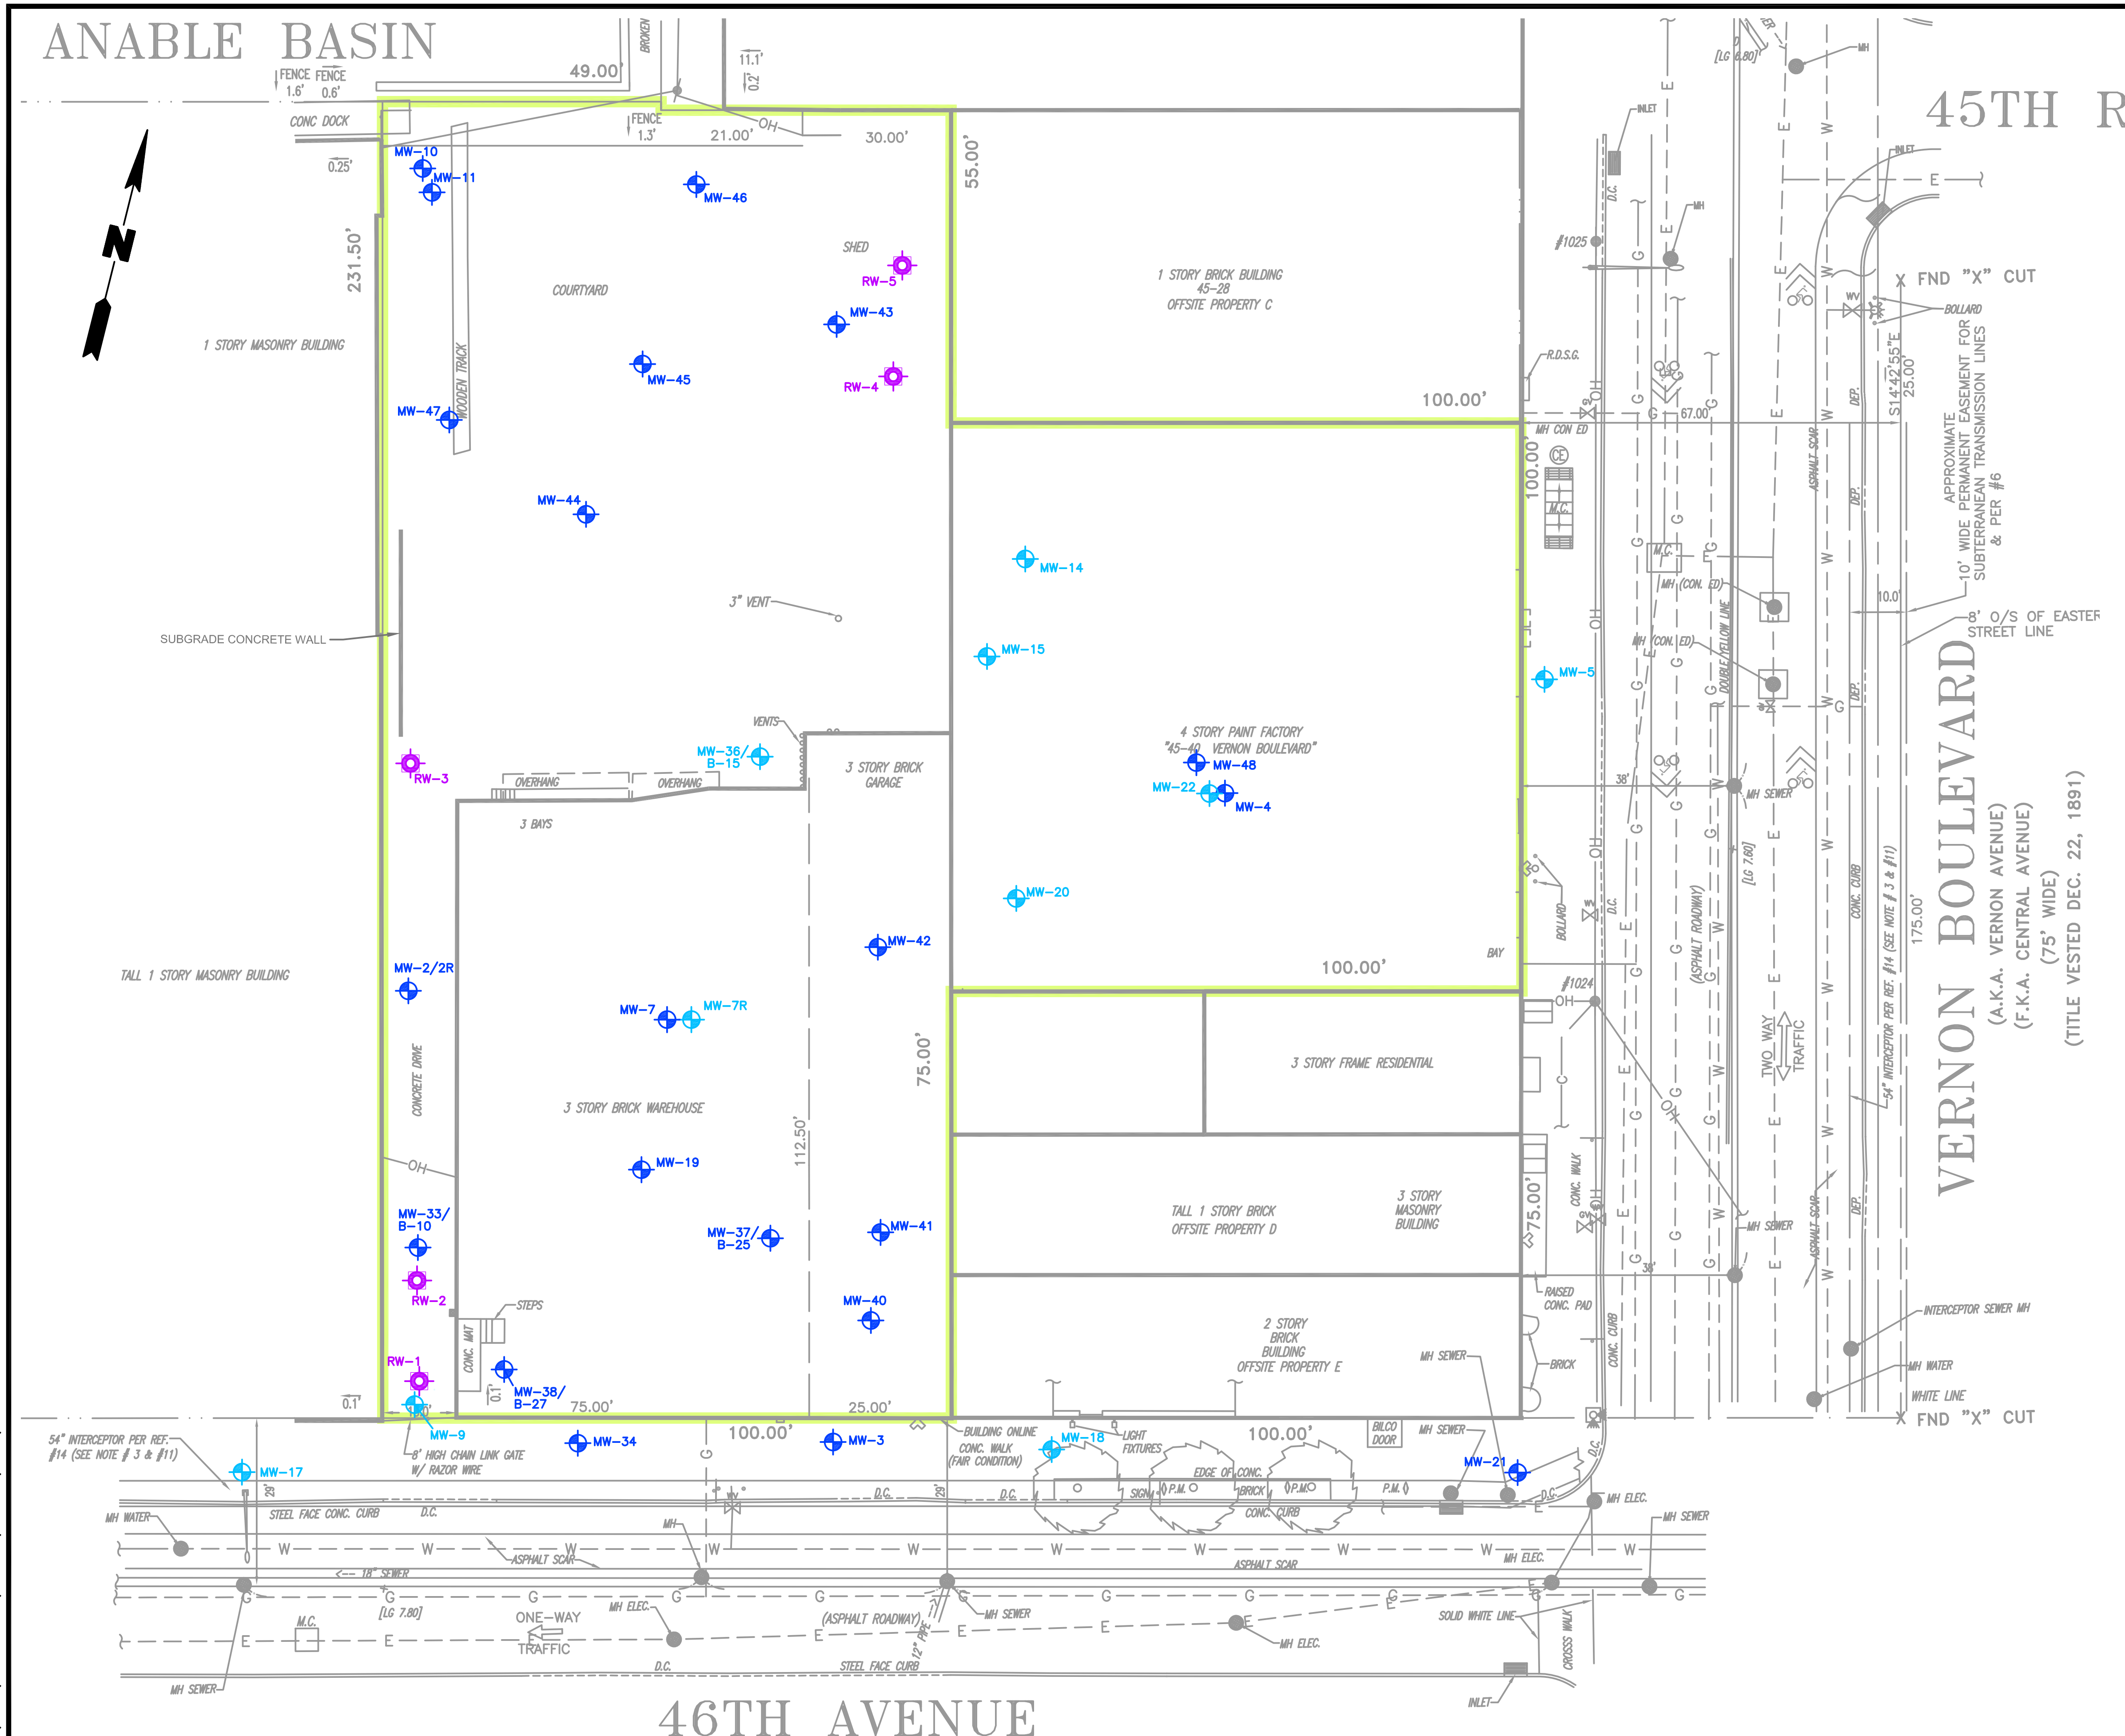
1. SMP Sampling Network

During the gauging event, free-product was present in on-site monitoring wells MW-3 and MW-33. The well locations and LNAPL thicknesses are provided in Figure 1. Absorbent socks were installed in MW-3, MW-17, MW-33, and MW-34 with approximately 1 gallon of free-product absorbed in total based on the saturation of the sock absorbency. The recovered product and saturated absorbent socks are temporarily stored on-Site in a 55-gallon drum until it is required to be disposed. These monitoring wells will continue to be gauged and monitored, with manual bailing and absorbent sock replacement implemented as necessary.

During the gauging event, free-product was present in on-site monitoring wells MW-2R and MW-33. The well locations and LNAPL thicknesses are provided in Figure 1. Absorbent socks were installed in MW-2R and MW-33. The recovered product and saturated absorbent socks are temporarily stored on-Site in a 55-gallon drum until it is required to be disposed. These monitoring wells will continue to be gauged and monitored, with manual bailing and absorbent sock replacement implemented as necessary.

During the gauging event, free-product was present in on-site monitoring wells MW-3 and MW-33. The well locations and LNAPL thicknesses are provided in Figure 1. Absorbent socks were installed in MW-3 and MW-33. The recovered product and saturated absorbent socks are temporarily stored on-Site in a 55-gallon drum until it is required to be disposed. These monitoring wells will continue to be gauged and monitored, with manual bailing and absorbent sock replacement implemented as necessary.
