PHASE I ENVIRONMENTAL SITE ASSESSMENT

27-21 44th DRIVE, 44-18 PURVES STREET
Long Island City, New York

Langan Engineering, Environmental, Surveying and Landscape Architecture, D.P.C.
21 Penn Plaza
360 West 31st Street, 8th Floor
New York, New York 10001

January 13, 2014
Langan Project No. 170281401

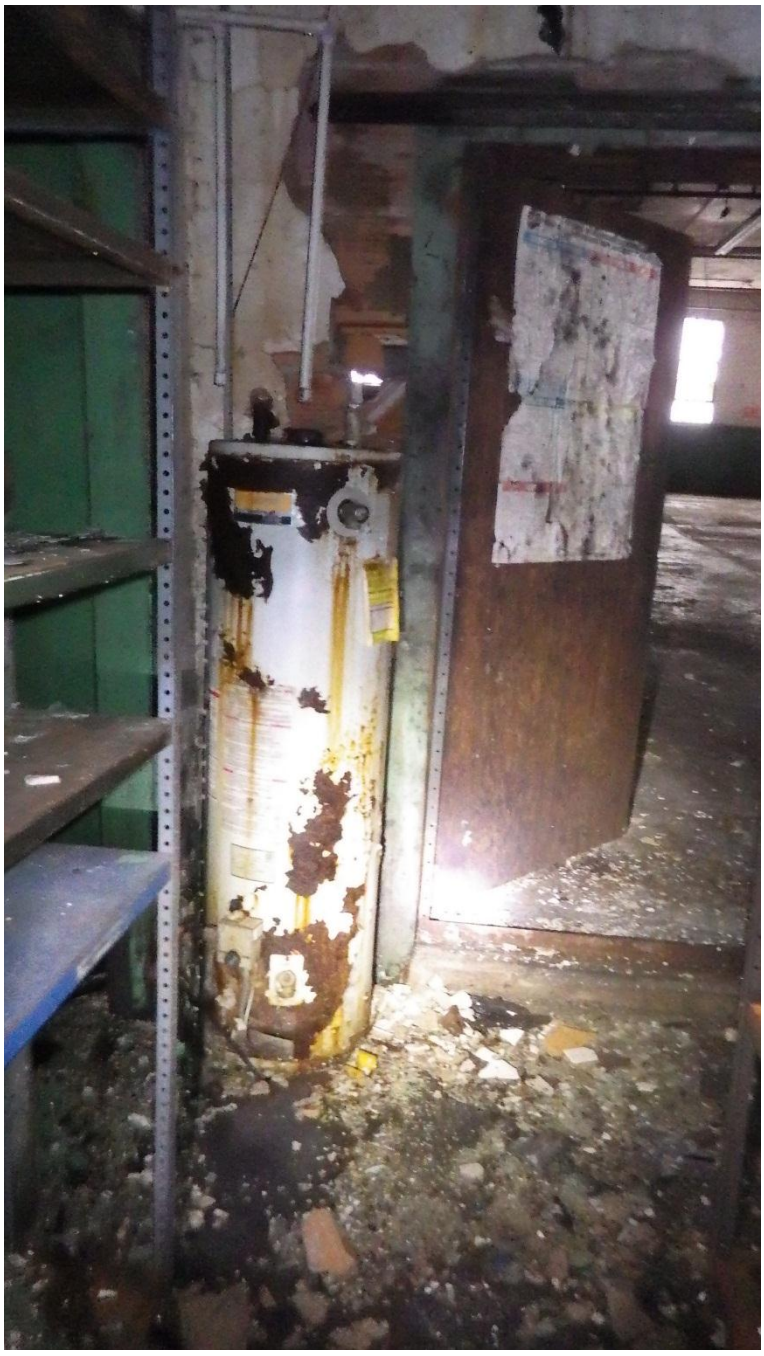
Photo 7: View of water heater in garage/warehouse building.

Photo 8: View of stained walls and flooring in the garage/warehouse section of the building.
