PHASE I ENVIRONMENTAL SITE ASSESSMENT

28-90 REVIEW AVENUE
LONG ISLAND CITY, NEW YORK 11101

ATC PROJECT NO. 301TAA0060

June 8, 2017

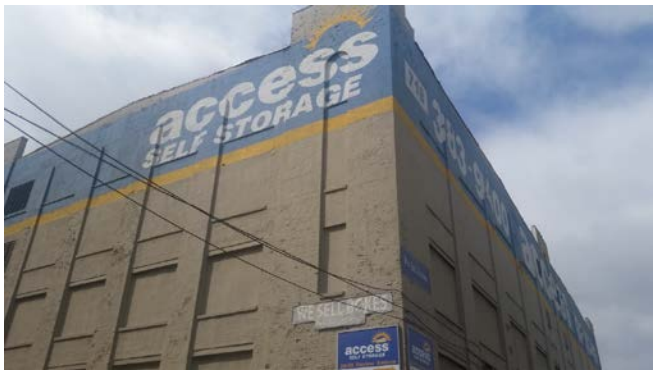
Photo 18: Adjoining site to the east

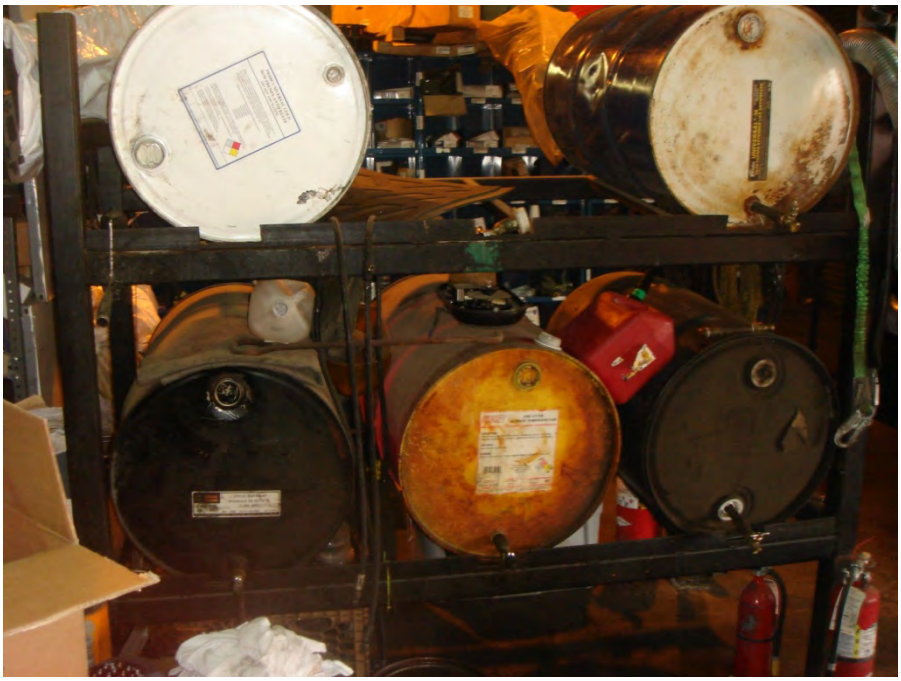
Photo 11: View of a waste oil AST with a capacity of 150 gallons located in the repair shop

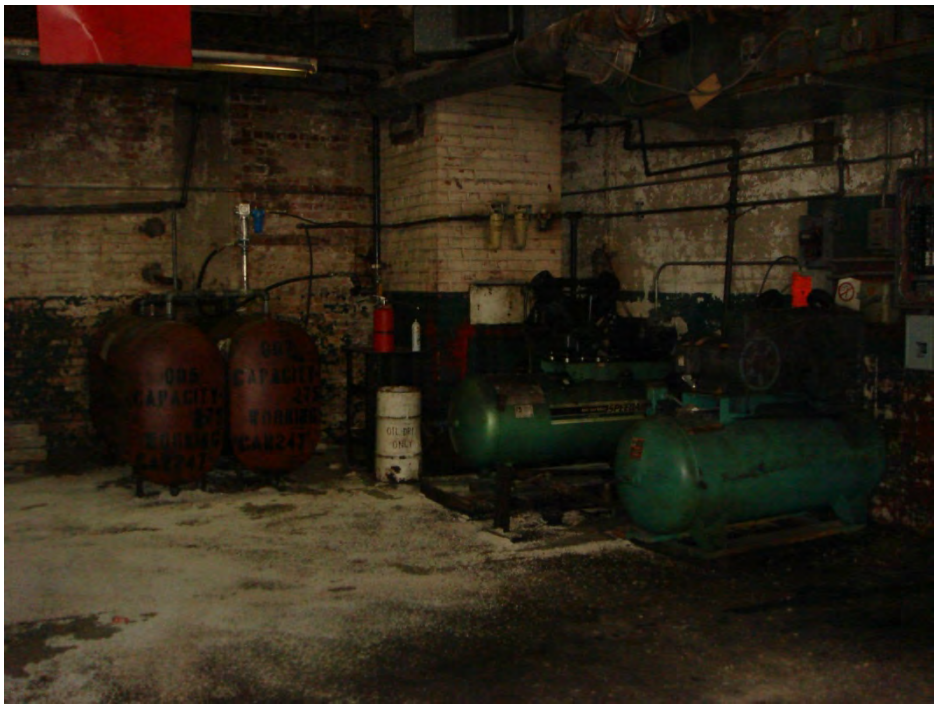
Photo 11: View of two (2) 275 gallon bulk motor oil ASTs and two (2) air compressors located in the two story masonry building to the south of the repair shop

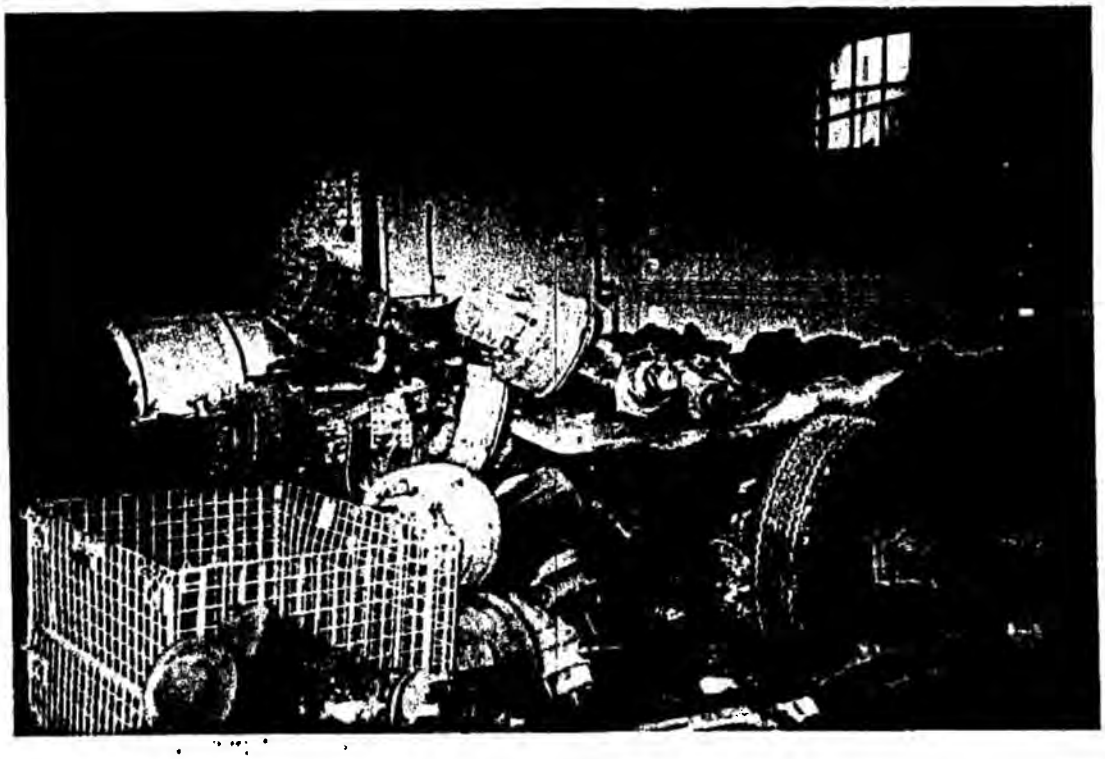
Photo 3: ***(Top): Typical view of truck washing area outside of building A.***

Photo 4: ***(Bottom): Typical view of interior of building B.***

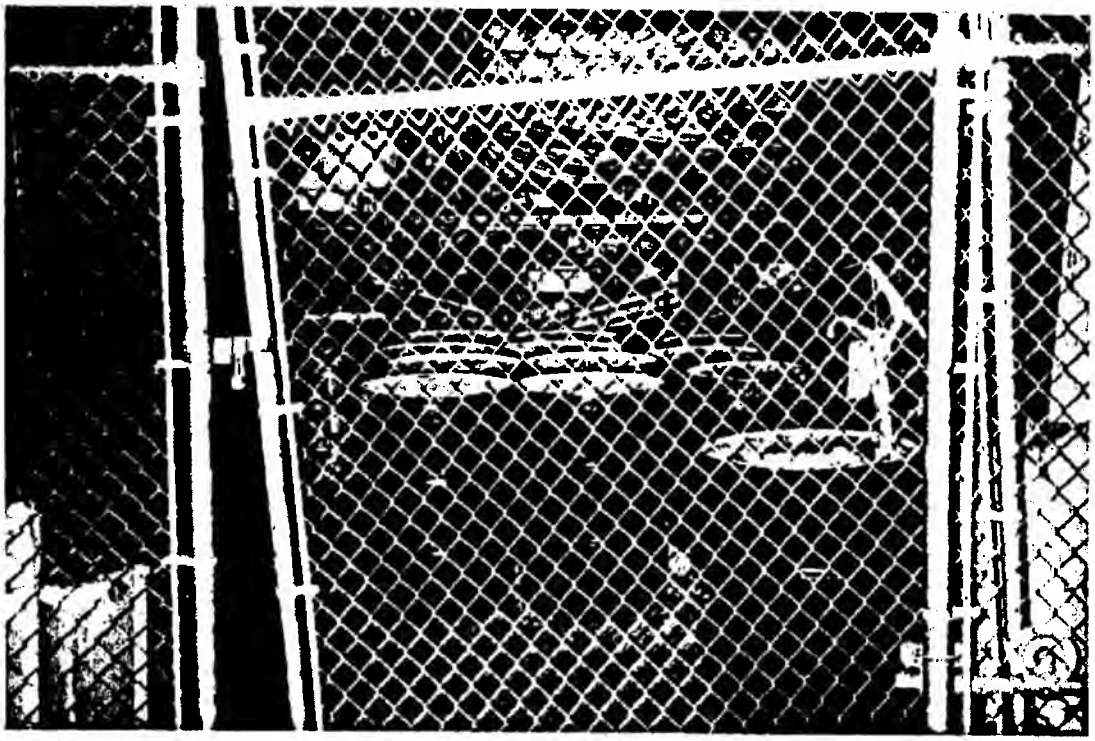
Photo 9: *(Top): View of drum storage in building C.*

Photo 10: *(Bottom): View of ASTs in building D.*

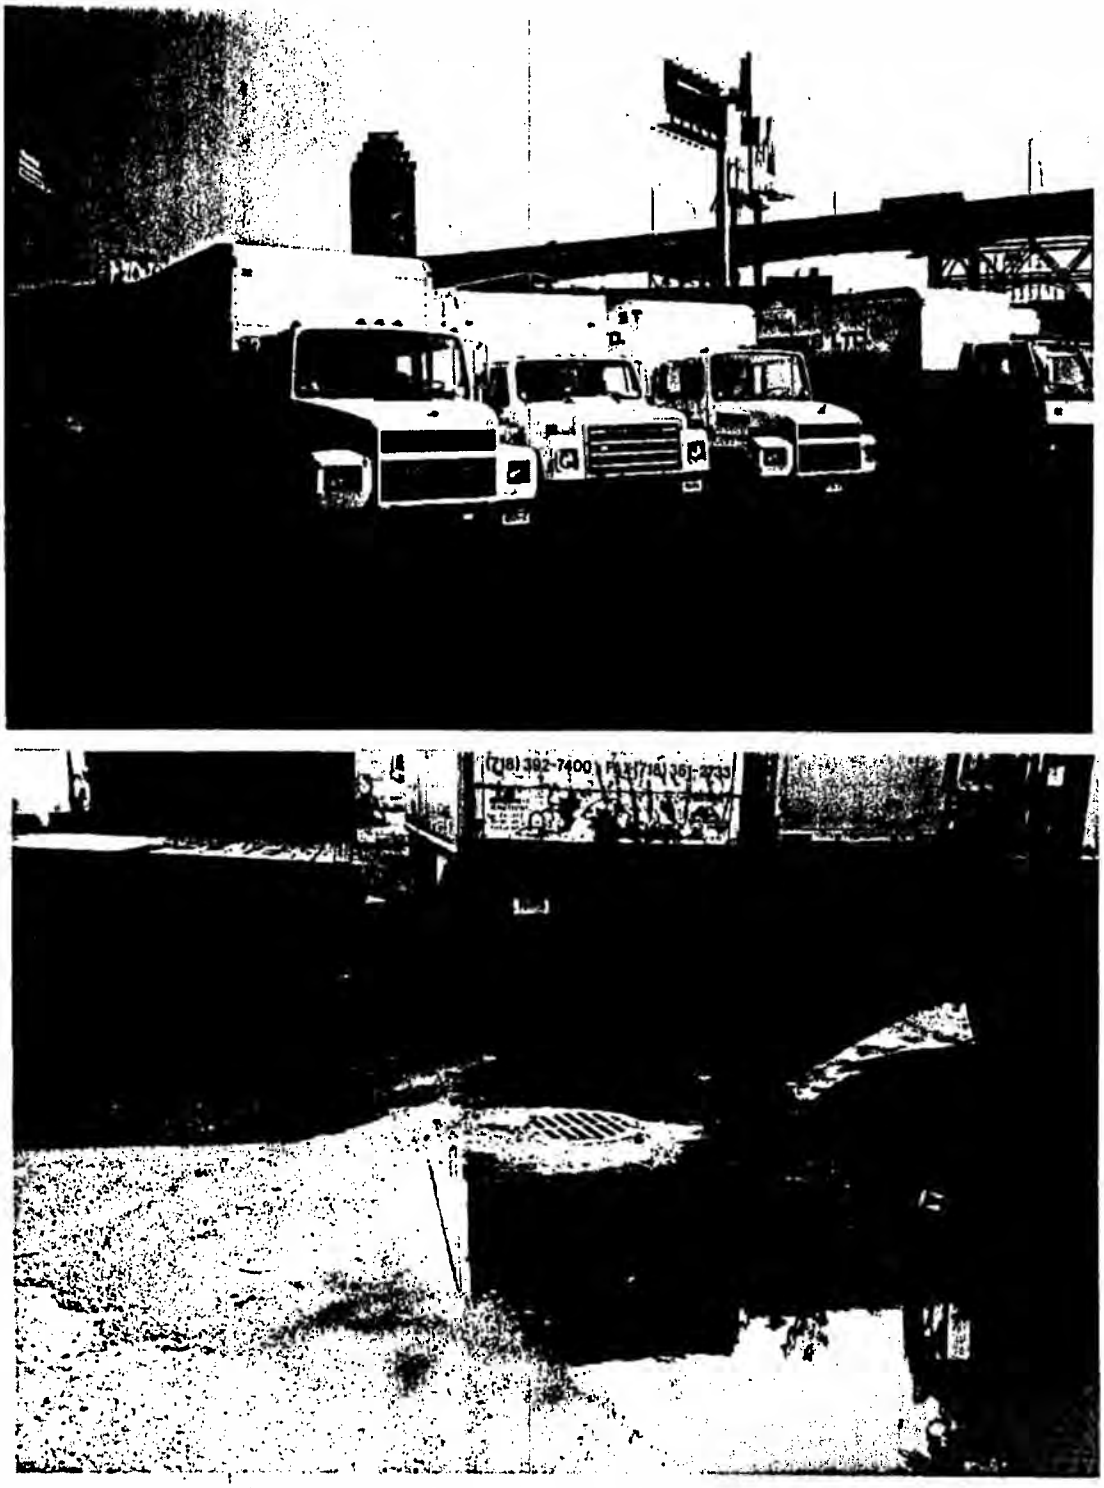
Photo 11: *(Top): Typical exterior view.*

Photo 12: *(Bottom): View of typical exterior UIW.*

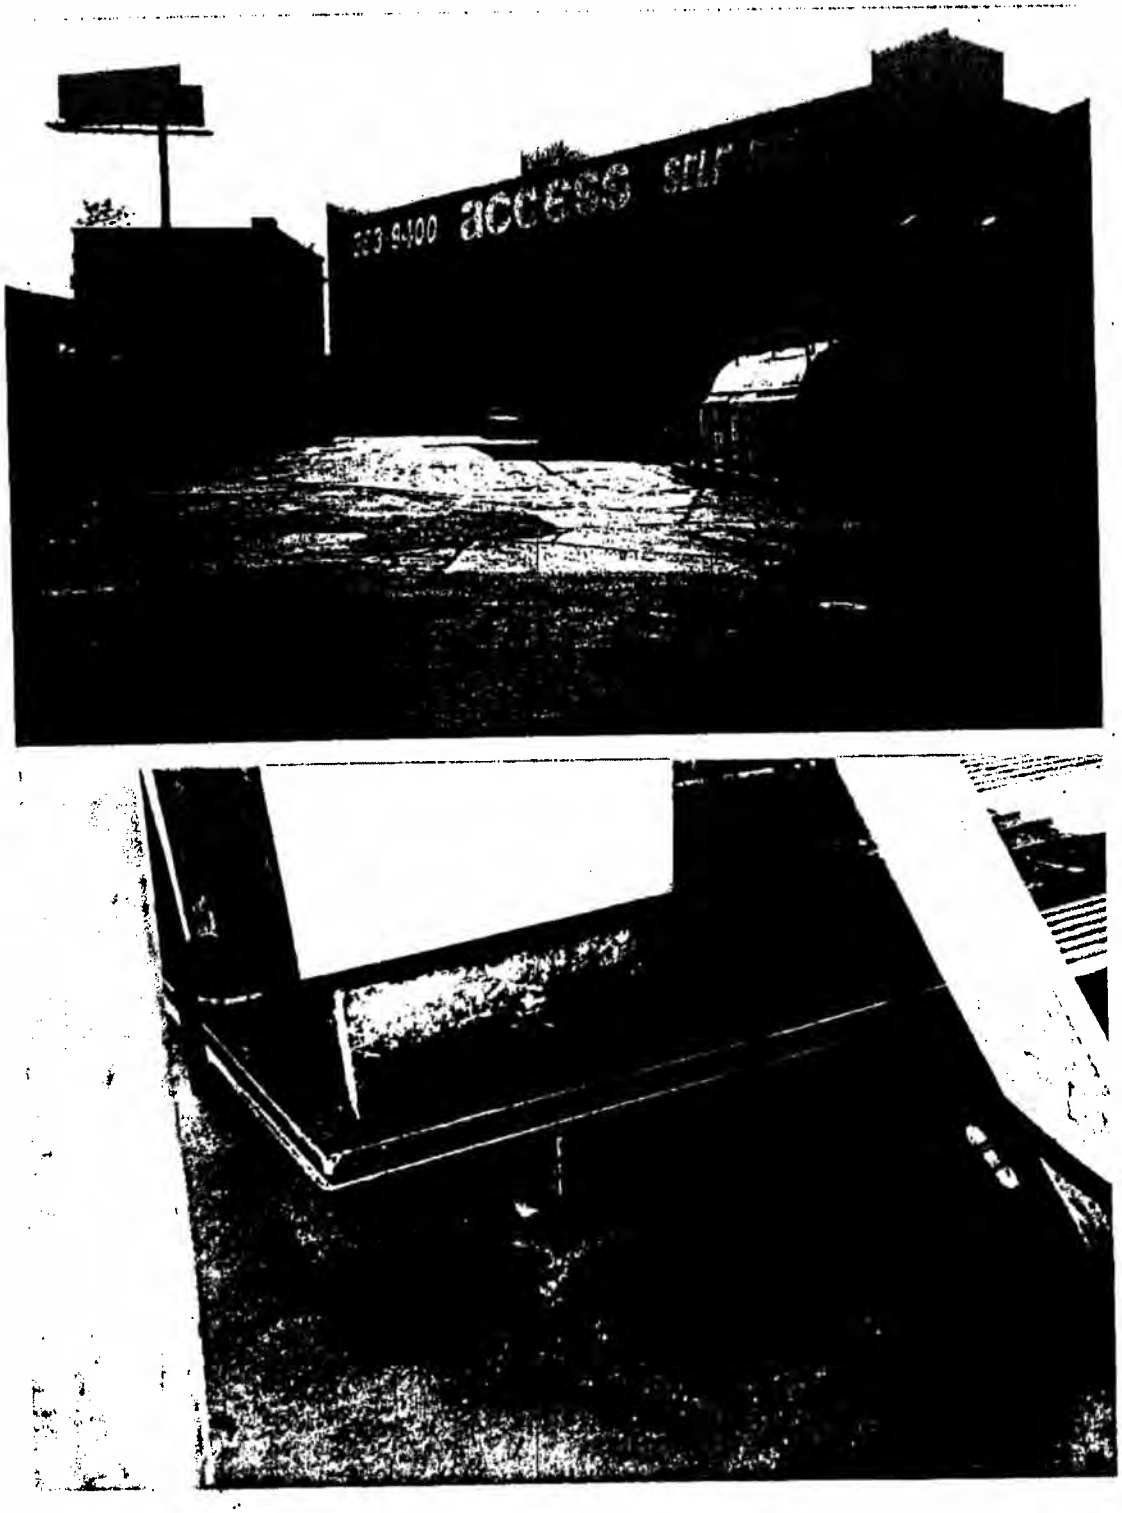
Photo 13: *(Top): View of former loading area and diesel AST.*

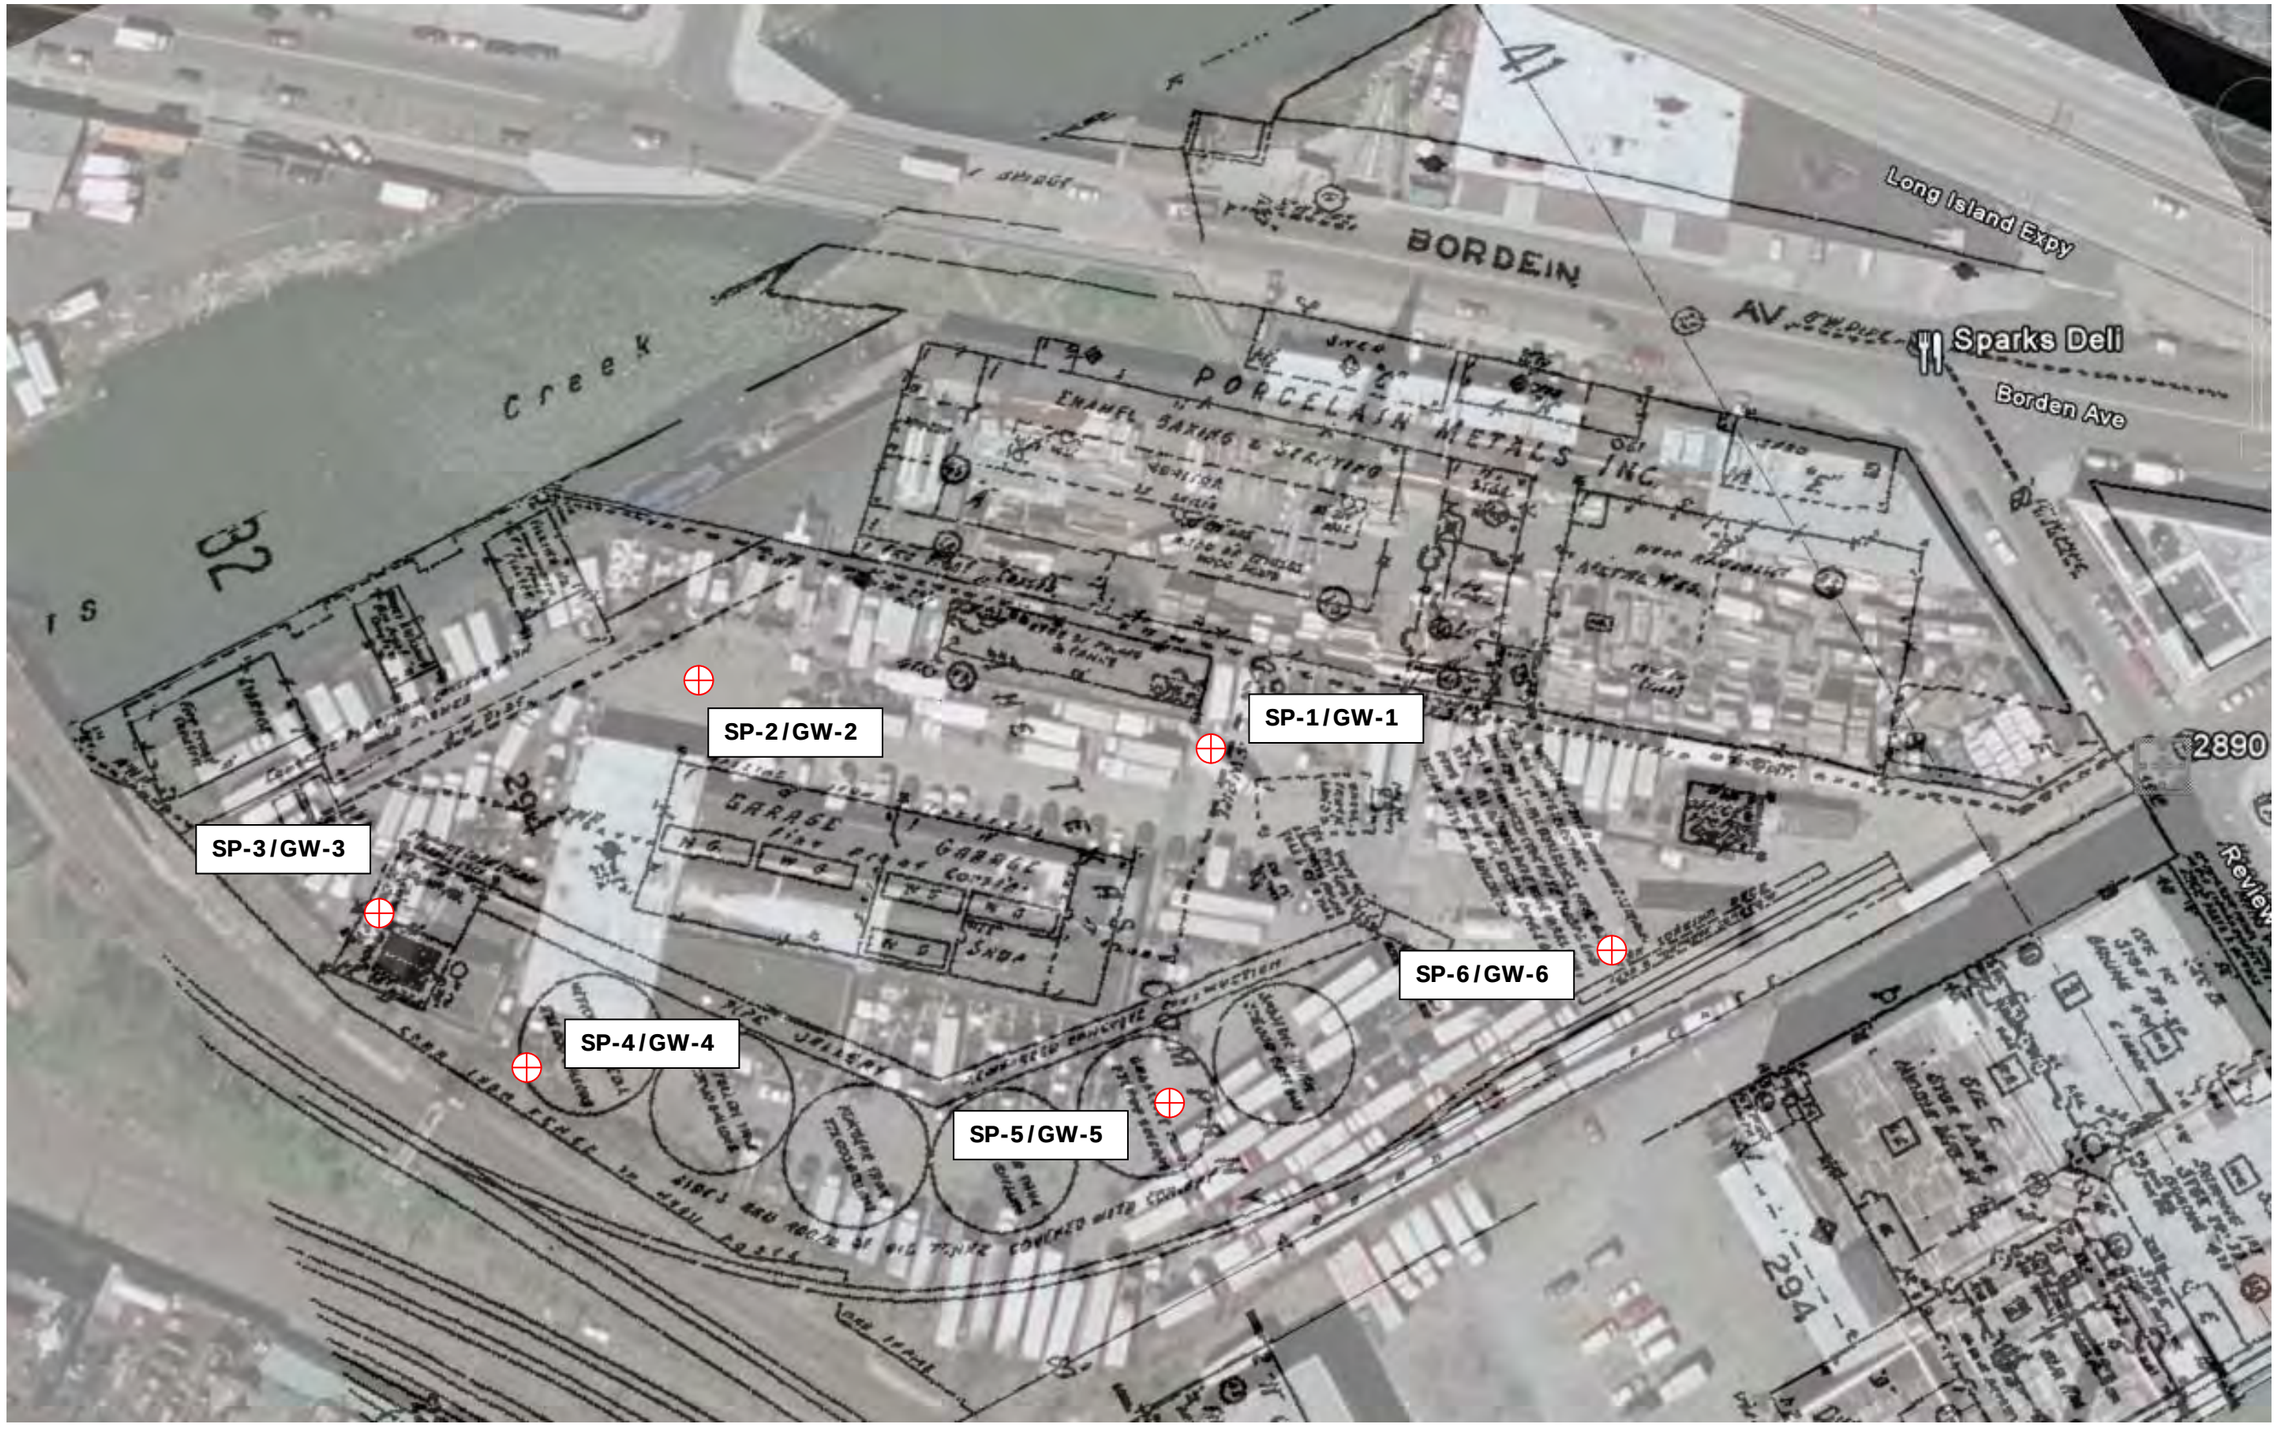
BORDEIN
AV
Long Island Expy
Sparks Deli
Borden Ave
Creek
PORCELAIN METALS INC.
ENAMEL BAKING & SERVICE
GARAGE
SHED
32
29
294
2890
SP-1/GW-1
SP-2/GW-2
SP-3/GW-3
SP-4/GW-4
SP-5/GW-5
SP-6/GW-6

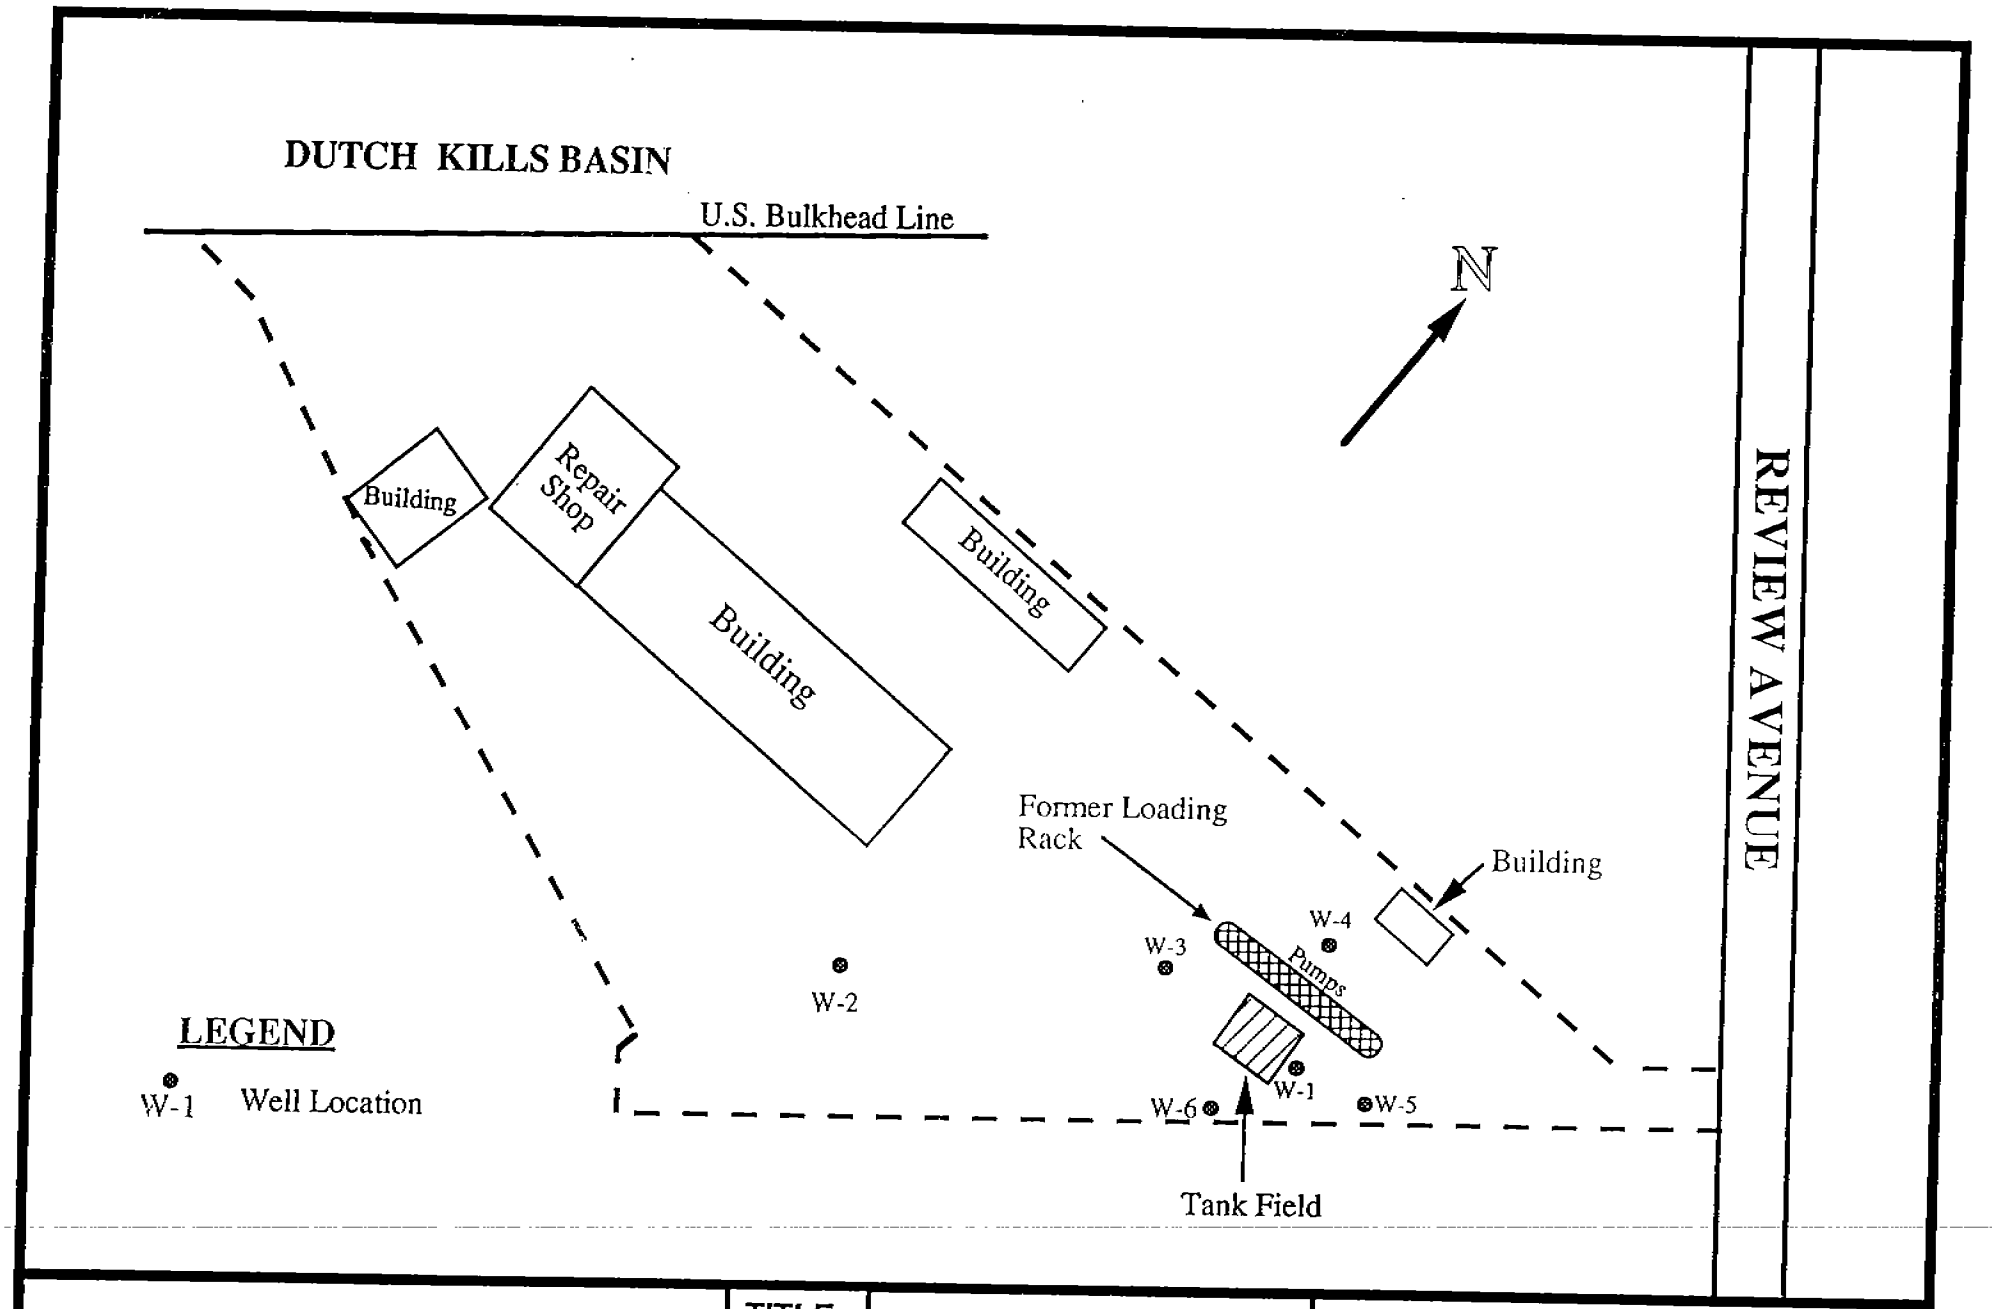
DRAWN BY:	Michael Gremillion	***TITLE***	**Tyree Brothers Environmental Services, Inc.**
SCALE:	1" = 100'	**AA TRUCK RENTAL** 28-90 Review Avenue Long Island City, New York	208 Route 109 Farmingdale, New York 11735
DATE:	6-90		
ID:

presence of floating petroleum product. Two of the six wells were found to contain a measurable amount of floating product. Since that time one well shows thickness of floating product in the three to six inch range. The second well initially showed less than one inch of product, it now shows zero to a trace.

The presence of floating product is limited solely to the small immediate area of the existing underground storage tanks. The probable causes of the identified release are as follows:

OBSERVED PETROLEUM PRODUCT THICKNESS (INCHES)

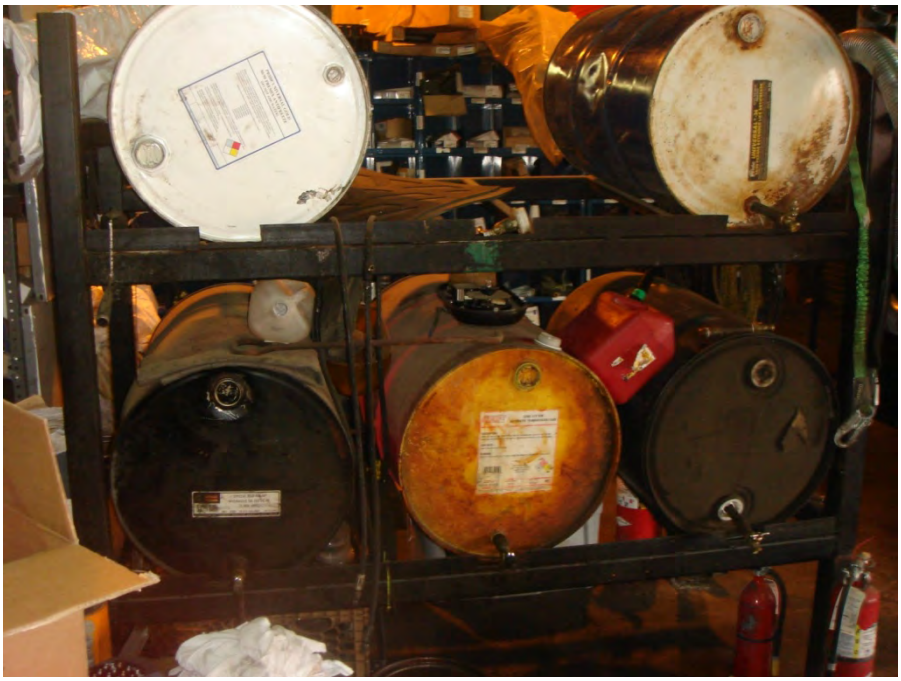
Photo 12: View of portable storage containers with automotive fluids located within the repair shop

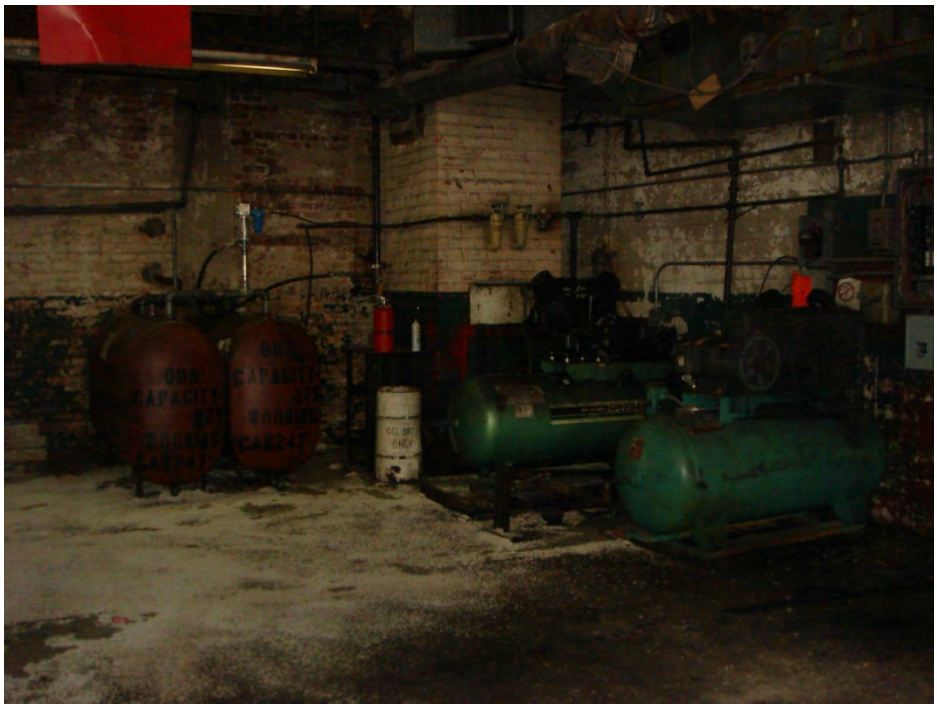
Photo 11: View of two (2) 275 gallon bulk motor oil ASTs and two (2) air compressors located in the two story masonry building to the south of the repair shop
