PHASE I ENVIRONMENTAL SITE ASSESSMENT

126-12 Northern Boulevard
Queens, New York

Langan Engineering, Environmental, Surveying,
Landscape Architecture and Geology, D.P.C.
360 West 31st Street, 8th Floor
New York, New York 10001

Report Date: **8 February 2023**
180-Day Viability Date: **26 June 2024**
170197608

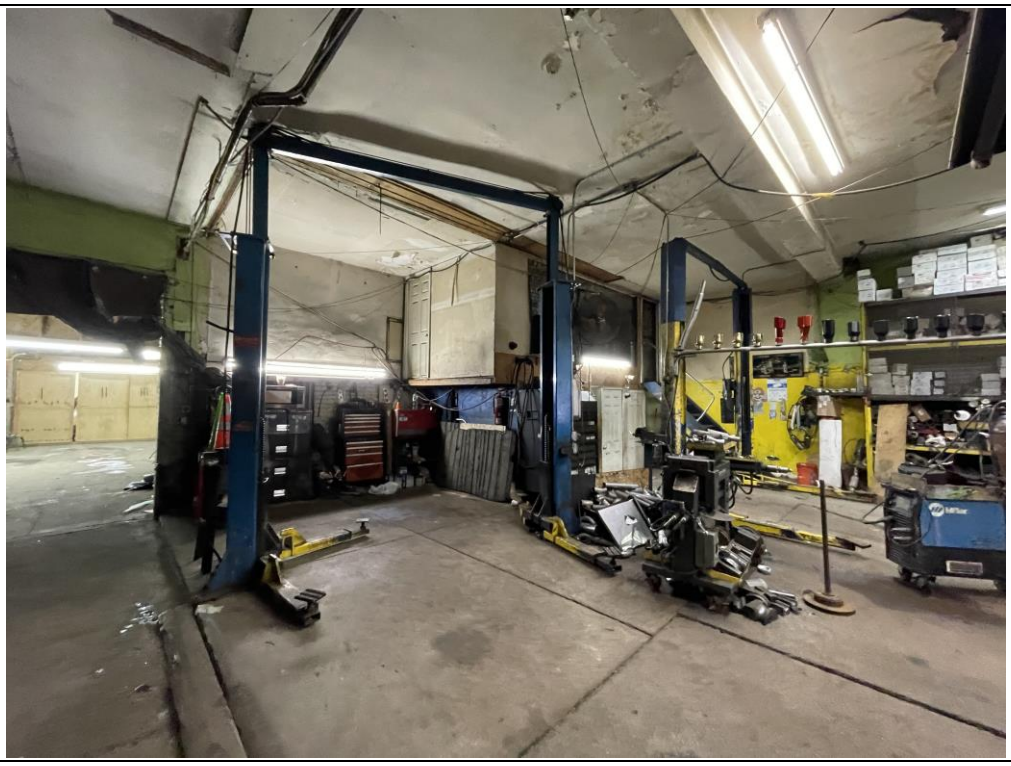
Four hydraulic lifts were visible within the northern part of the building. Langan observed an approximately 1-foot by 3-foot-stained area on the concrete slab on the northern part of the building. Langan also observed an approximately 1-foot by 1-foot pool of oil on the ground floor of the subject property near an open, unmarked oil container. Both stained areas appear to be related to on-site automobile repair activities. Langan did not observe obvious cracks or pathways to the subsurface in the stained areas. Based on the current and historical use of the subject property, the staining is a REC.

View of ground floor and hydraulic lifts utilized in the northern part of the subject property building.

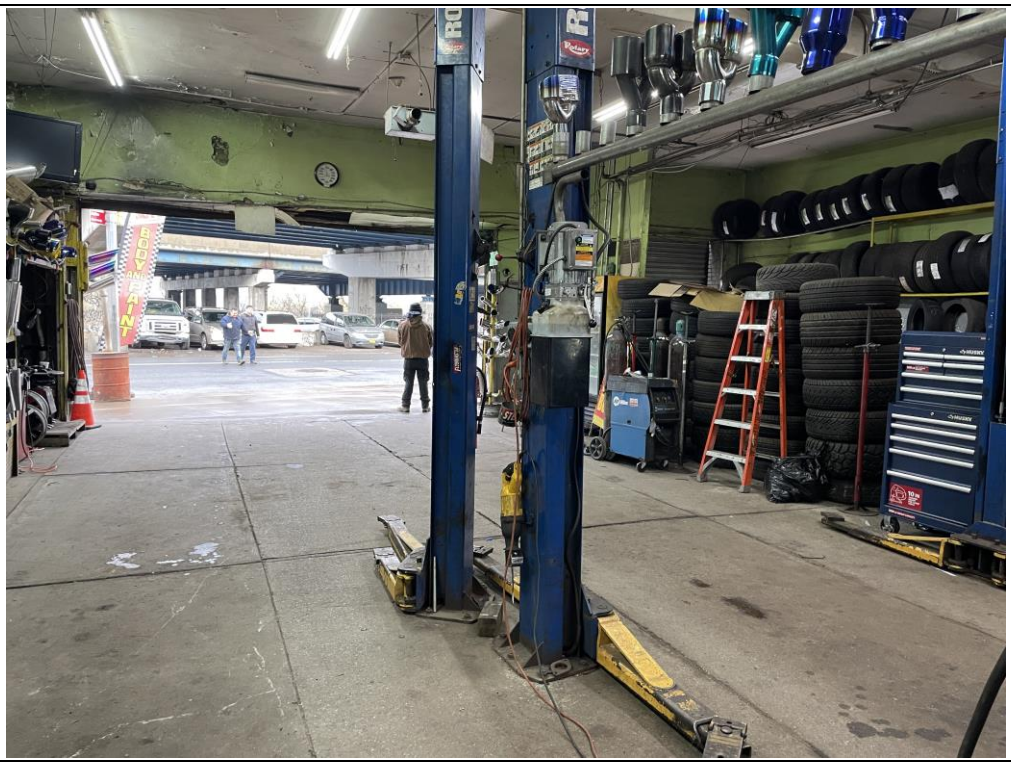
View of the northern part of the ground floor of the subject property building.

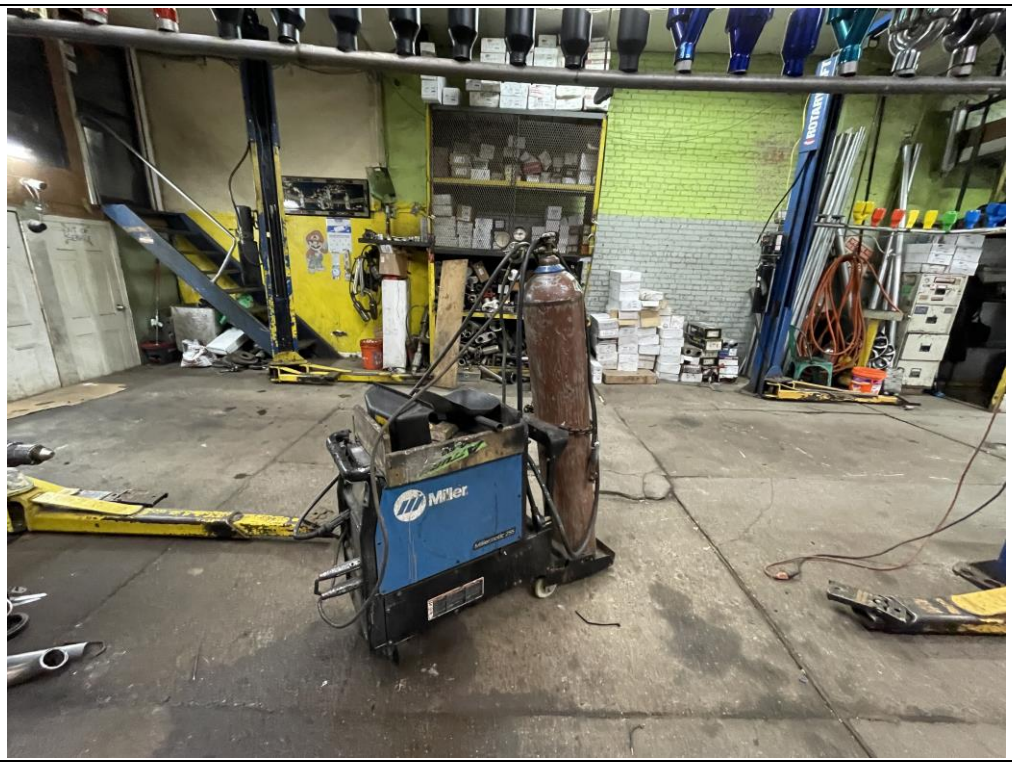
View of equipment and storage in the northern part of the subject property building.

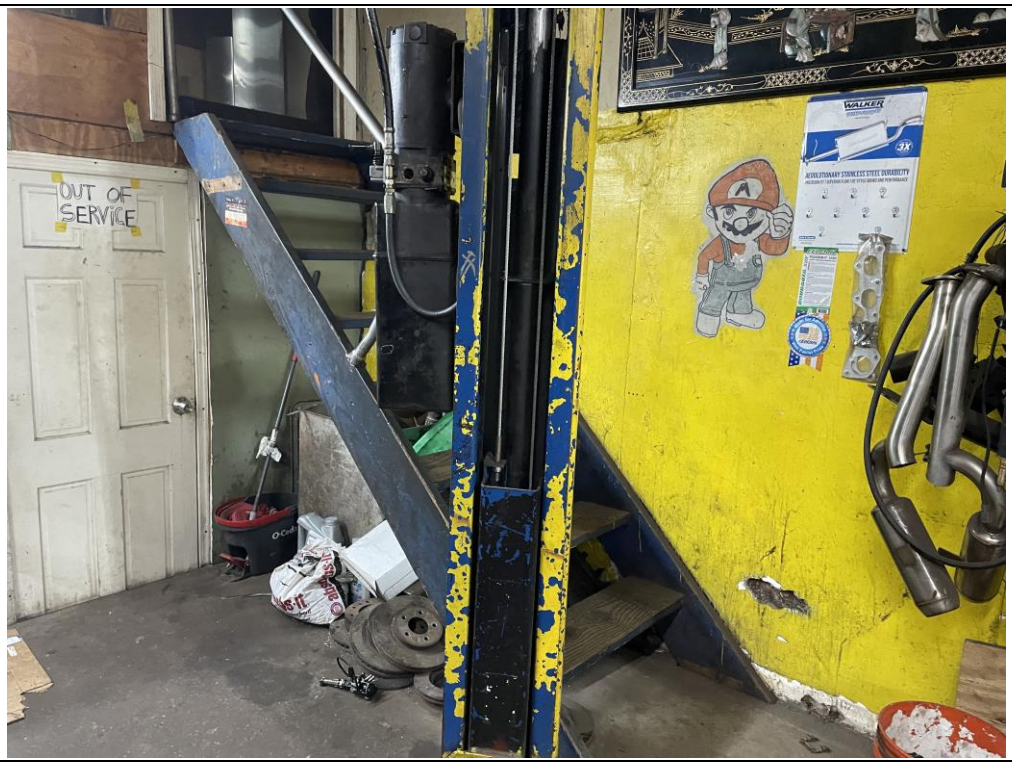
View of the western part of the subject property building.

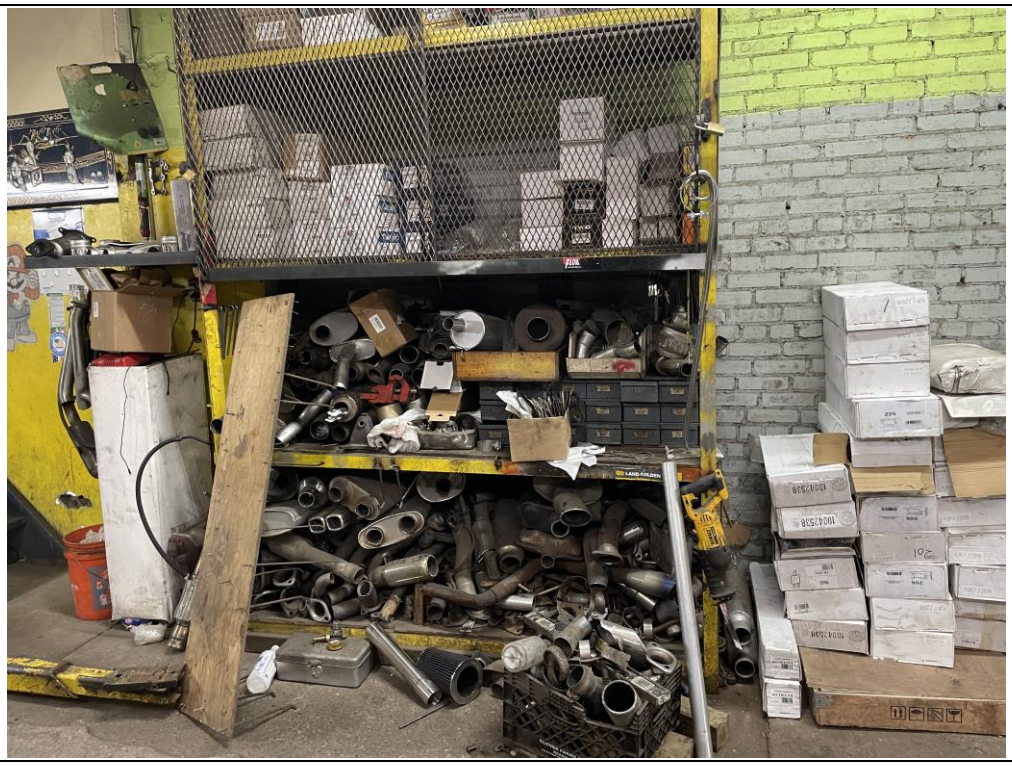
View of muffler storage in the western part of the subject property building.

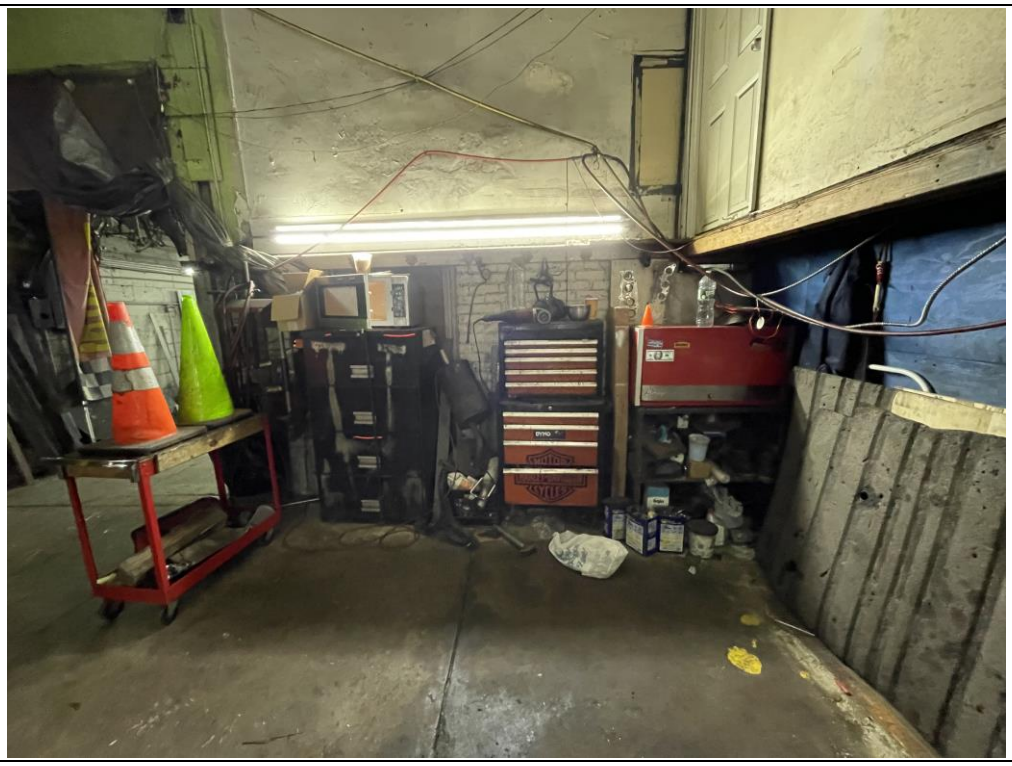
View of tool storage in the central part of the subject property. An approximately 1-foot by 3-foot-stained area is visible in the foreground.

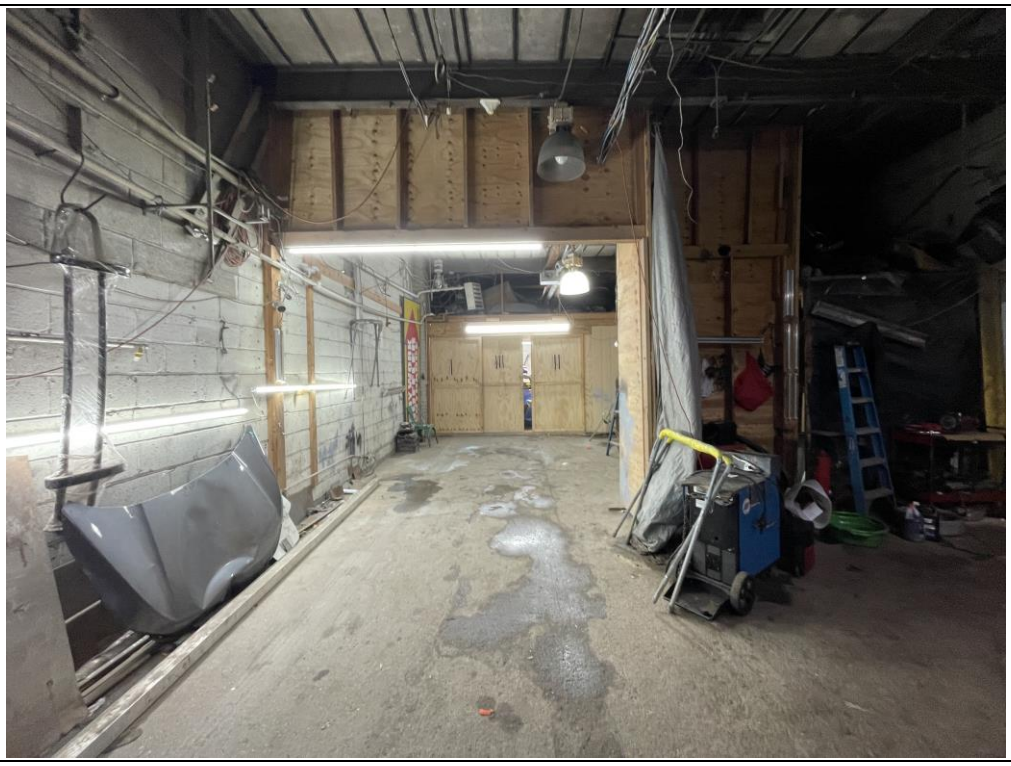
View of the southern part of the subject property building.

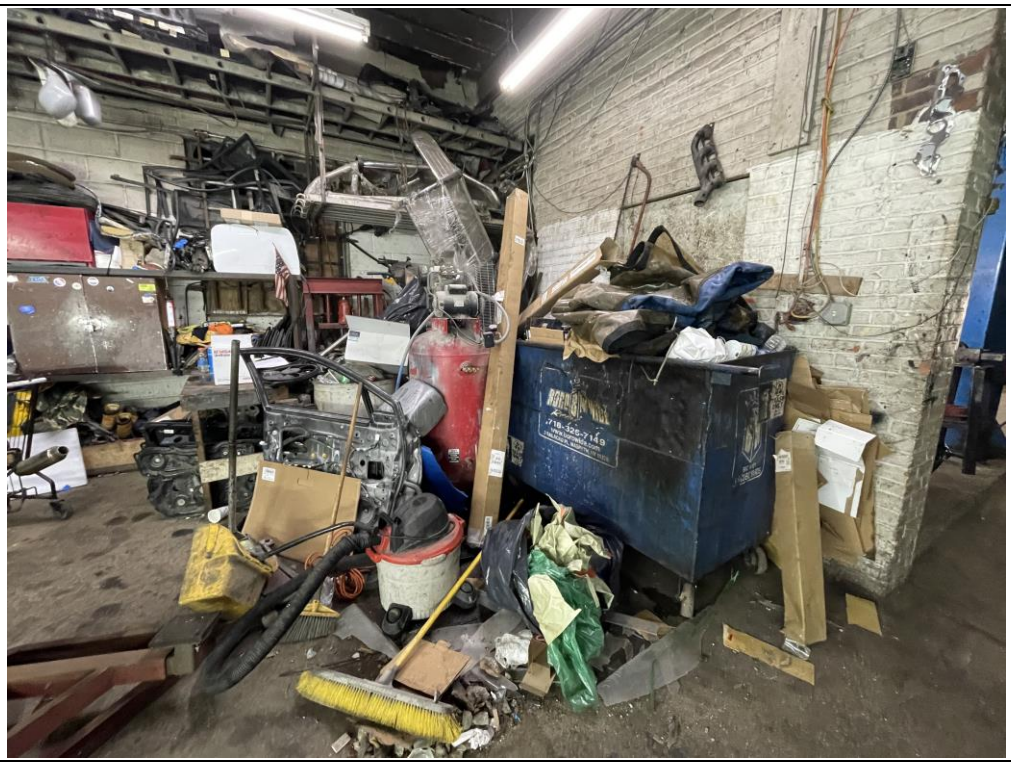
A 1.5-CY dumpster containing cardboard and municipal solid waste was observed in the southern part of the building. According to a February 2023 interview, the key site manager indicated that the container is emptied and refuse is disposed of by the New York City Department of Sanitation.

View of a 1.5-cubic-yard (CY) dumpster containing cardboard and municipal solid waste in the southern part of the subject property building.

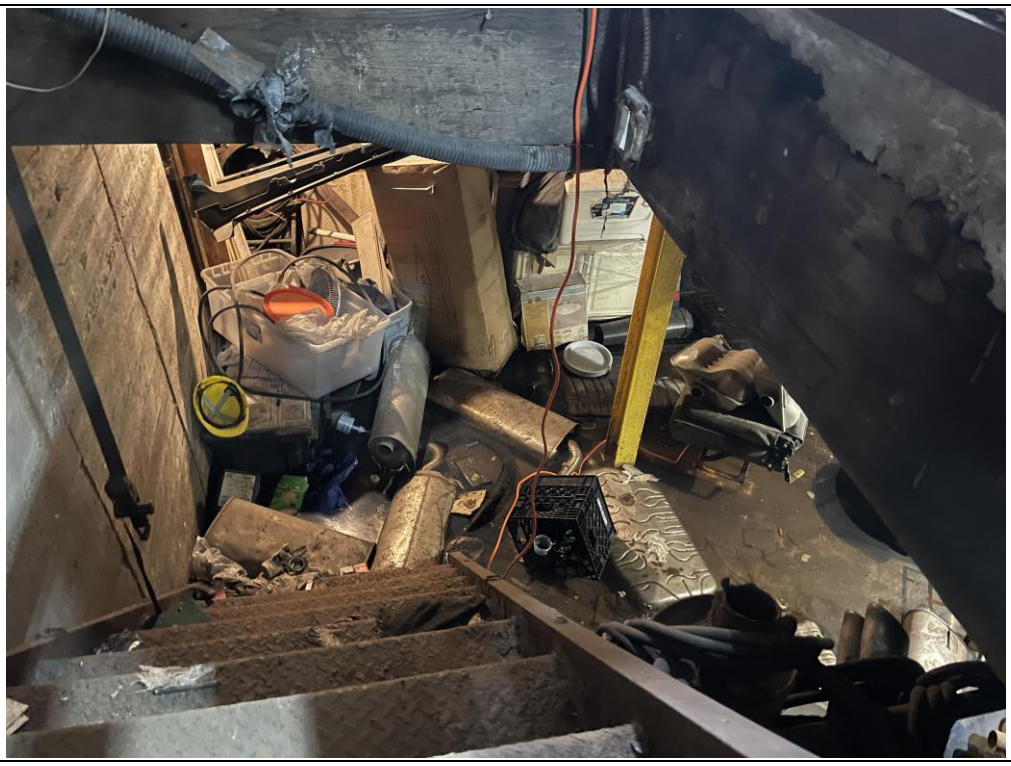
Date	Photo No.
12/29/2023	14

At the time of the site reconnaissance, the basement was flooded with water and was inaccessible. The lack of access to the subject property basement during the site reconnaissance is a significant data gap. Langan walked the periphery of the subject property, observed the subject property from adjoining public thoroughfares, and walked the accessible interiors of structures at the subject property. Langan observed the adjoining properties and the surrounding area from the periphery of the subject property and from public thoroughfares adjoining to or traveled on to access the subject property. The weather at the time of the site reconnaissance was approximately 51°F and sunny.

View of the subject property basement. The basement was flooded with water at the time of the site reconnaissance.

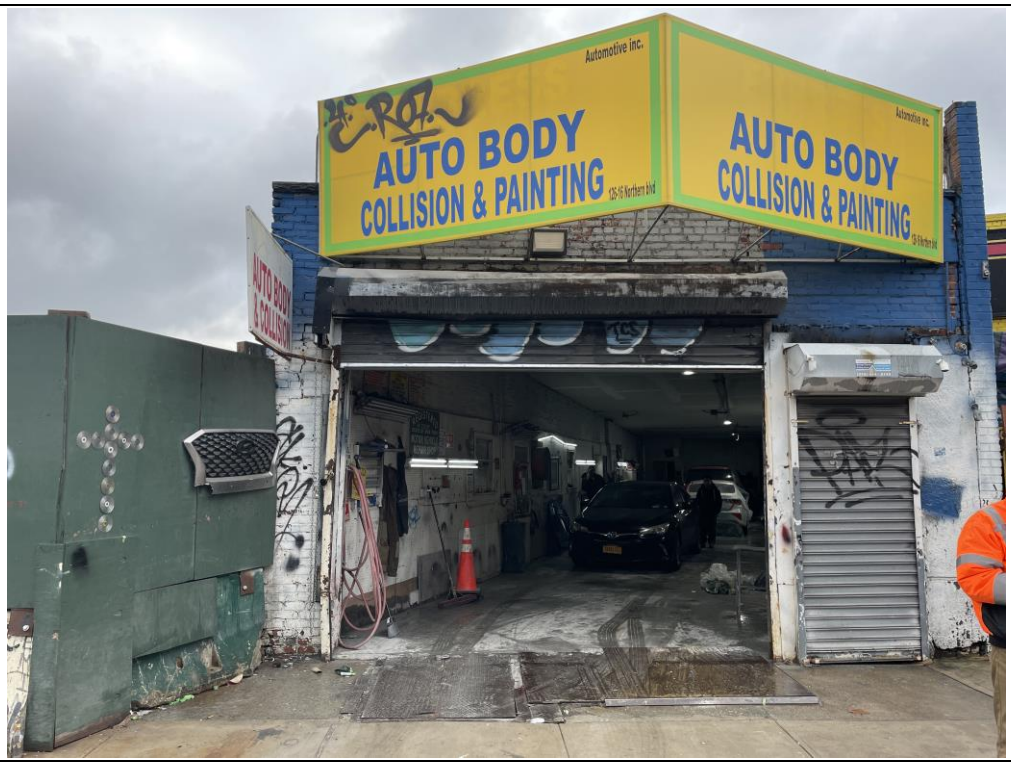
View of the eastern adjoining automobile repair and maintenance shop.
