Phase I Environmental Site Assessment Report

MEI Project Number 23-0454

Property located at 3705-3727 21st Street in Long Island City, New York

July 26, 2023

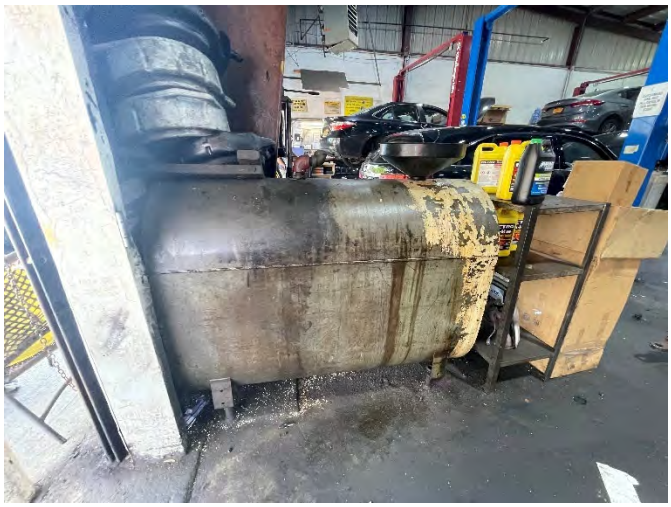
275-gallon AST
