SITE INVESTIGATION REPORT
FOR THE
AKZO NOBEL CHEMICALS INC. PILOT PLANT
ARDSLEY, NEW YORK

November 4, 2009

Sovereign Consulting Inc.
100 Dobbs Lane
Suite 212
Cherry Hill, New Jersey 08034

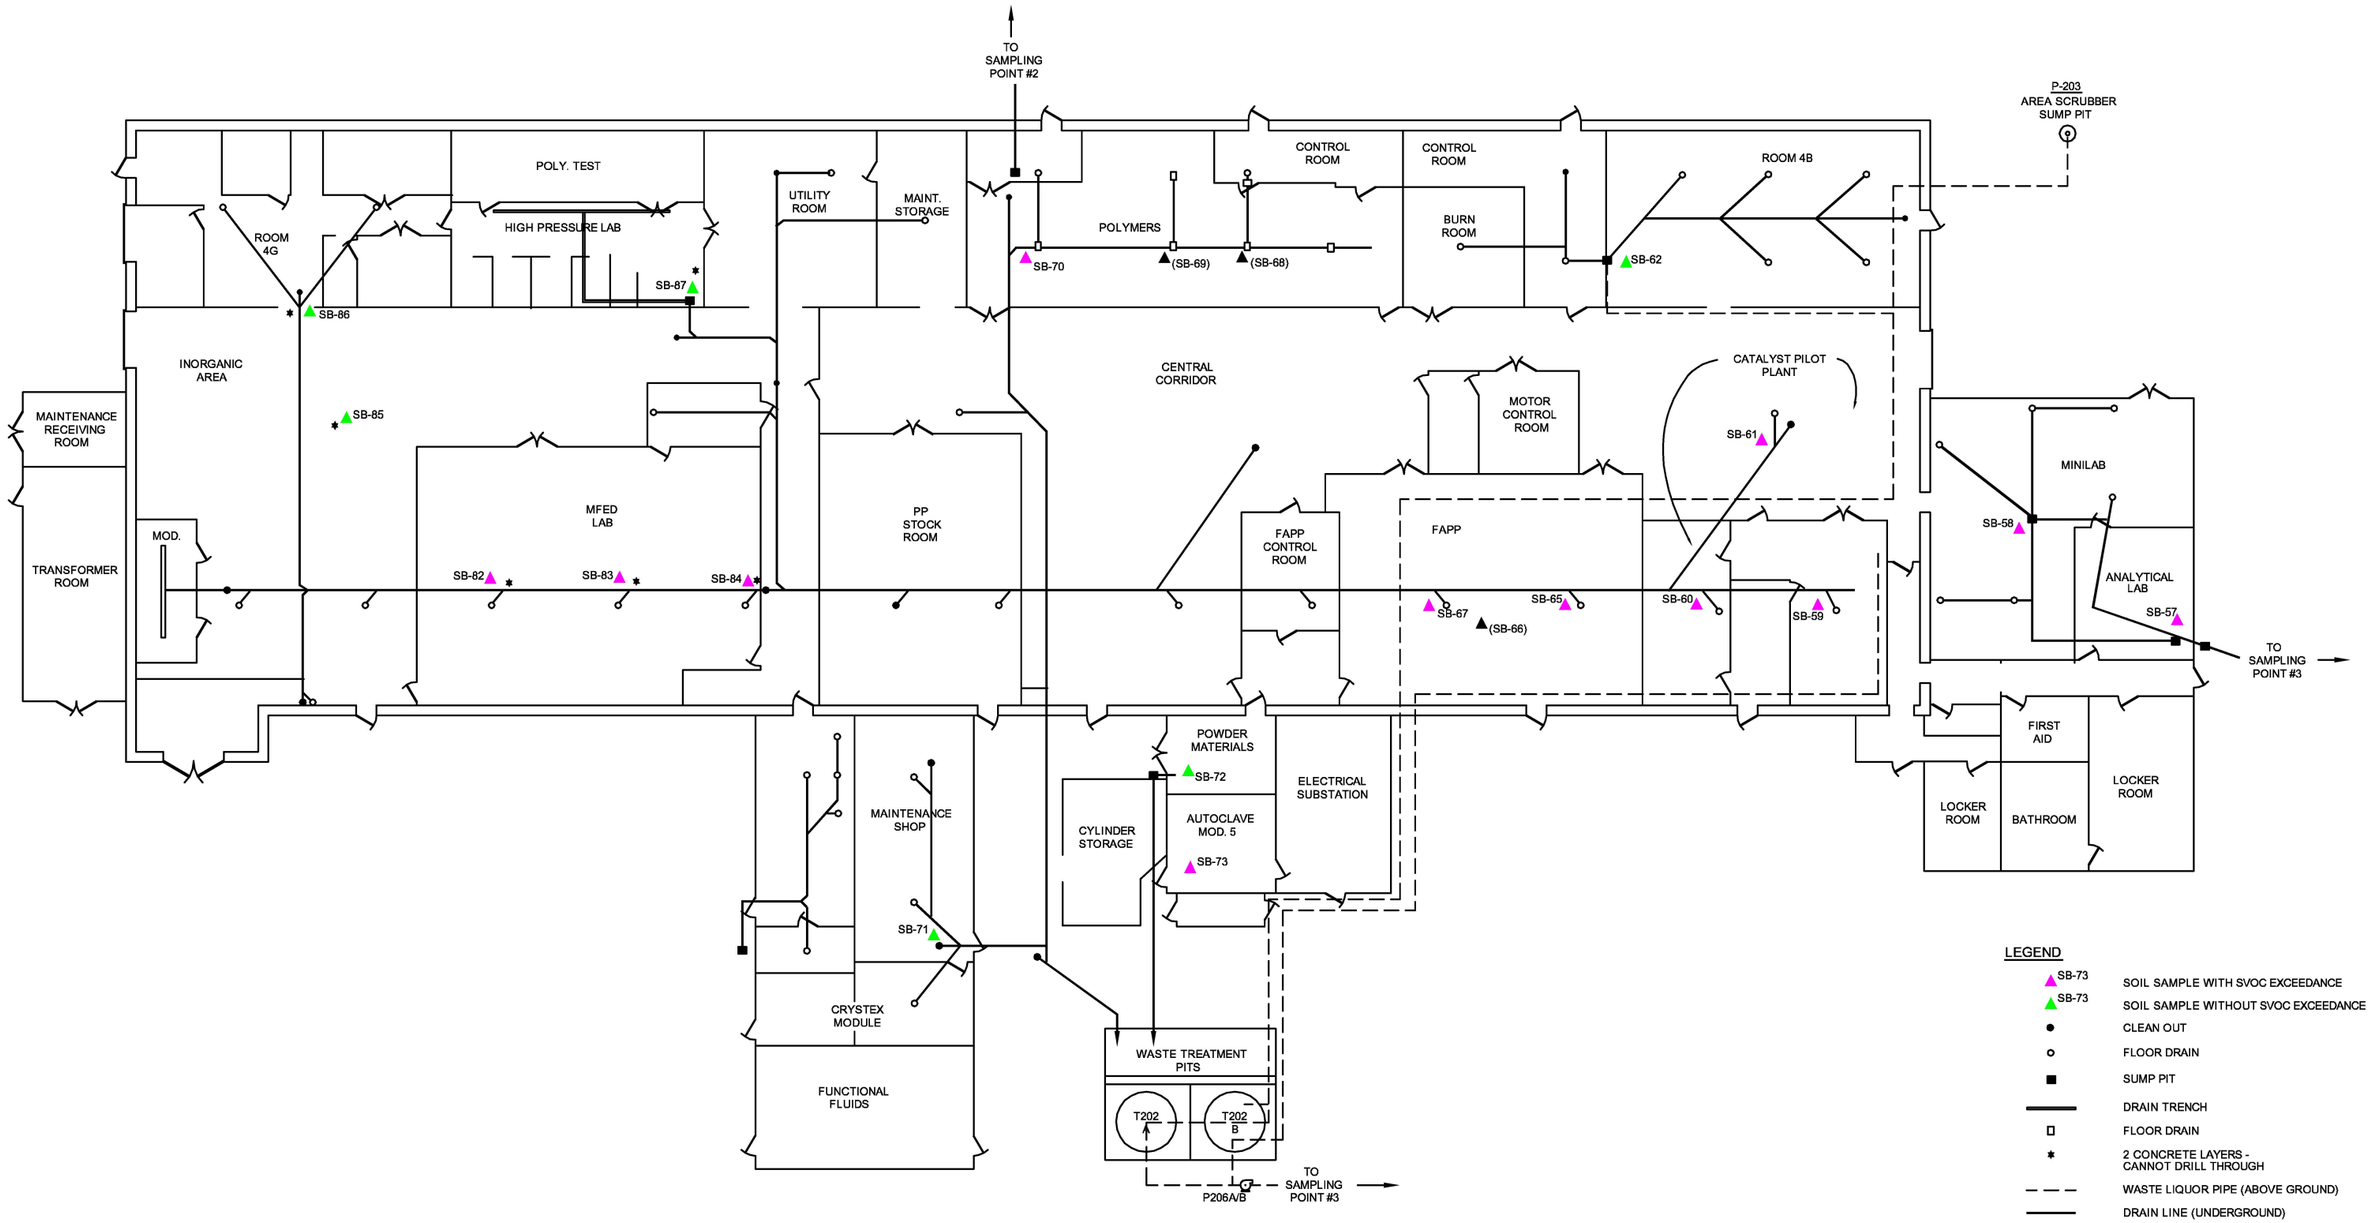
- SB-73 — SOIL SAMPLE WITH SVOC EXCEEDANCE
- SB-73 — SOIL SAMPLE WITHOUT SVOC EXCEEDANCE
- CLEAN OUT
- FLOOR DRAIN
- SUMP PIT
- DRAIN TRENCH
- FLOOR DRAIN
- 2 CONCRETE LAYERS - CANNOT DRILL THROUGH
- WASTE LIQUOR PIPE (ABOVE GROUND)
- DRAIN LINE (UNDERGROUND)

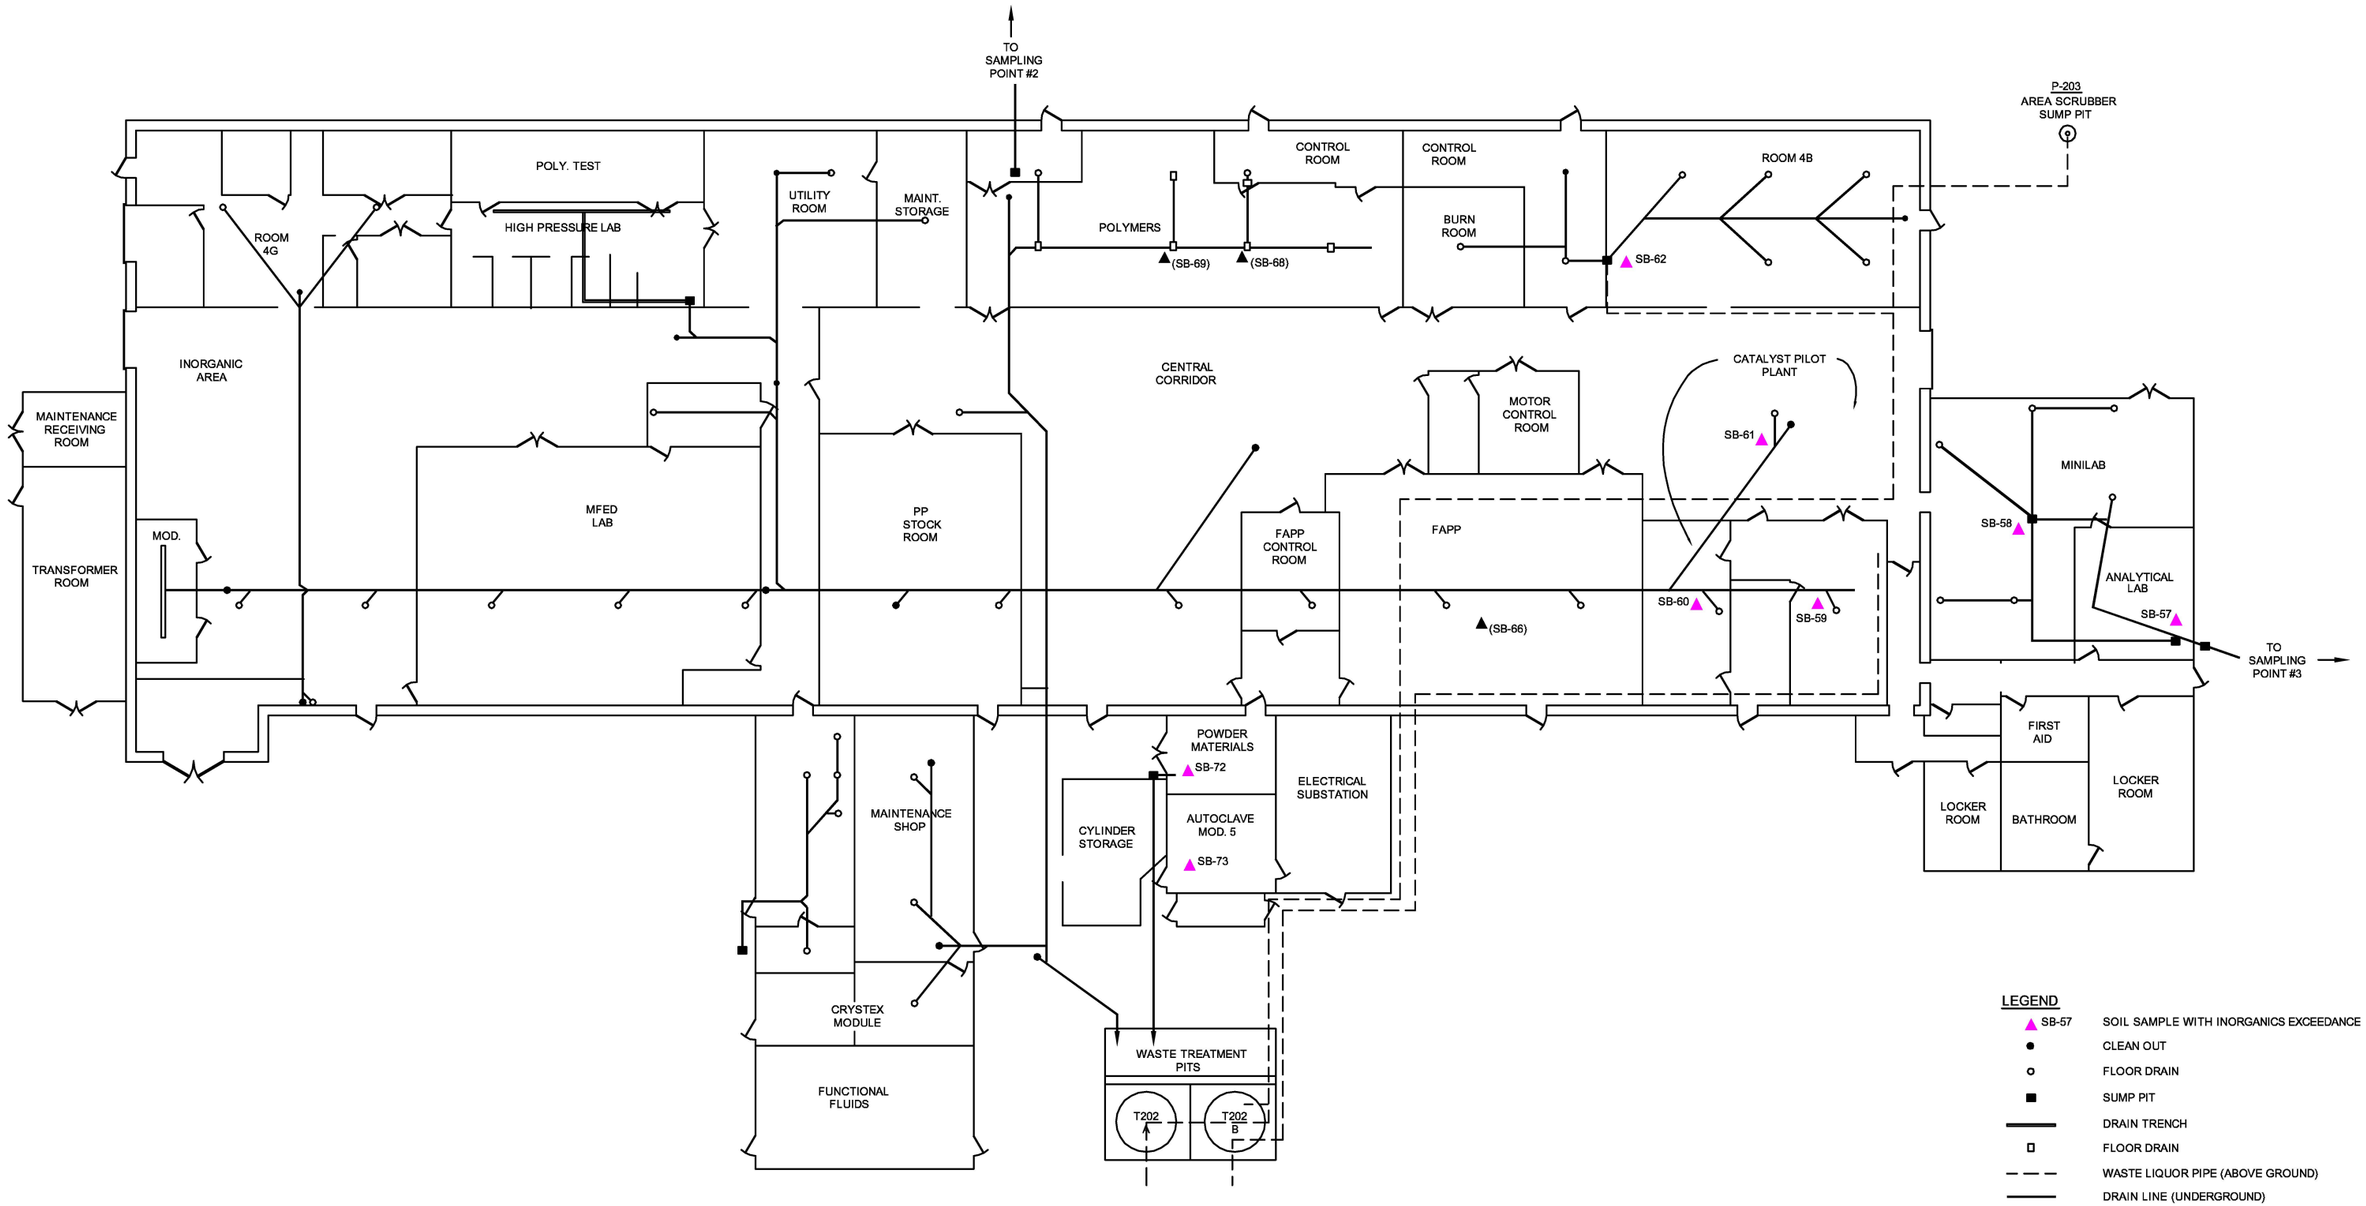
▲ SB-57	SOIL SAMPLE WITH INORGANICS EXCEEDANCE
●	CLEAN OUT
○	FLOOR DRAIN
■	SUMP PIT
———	DRAIN TRENCH
▯	FLOOR DRAIN
– – –	WASTE LIQUOR PIPE (ABOVE GROUND)
———	DRAIN LINE (UNDERGROUND)

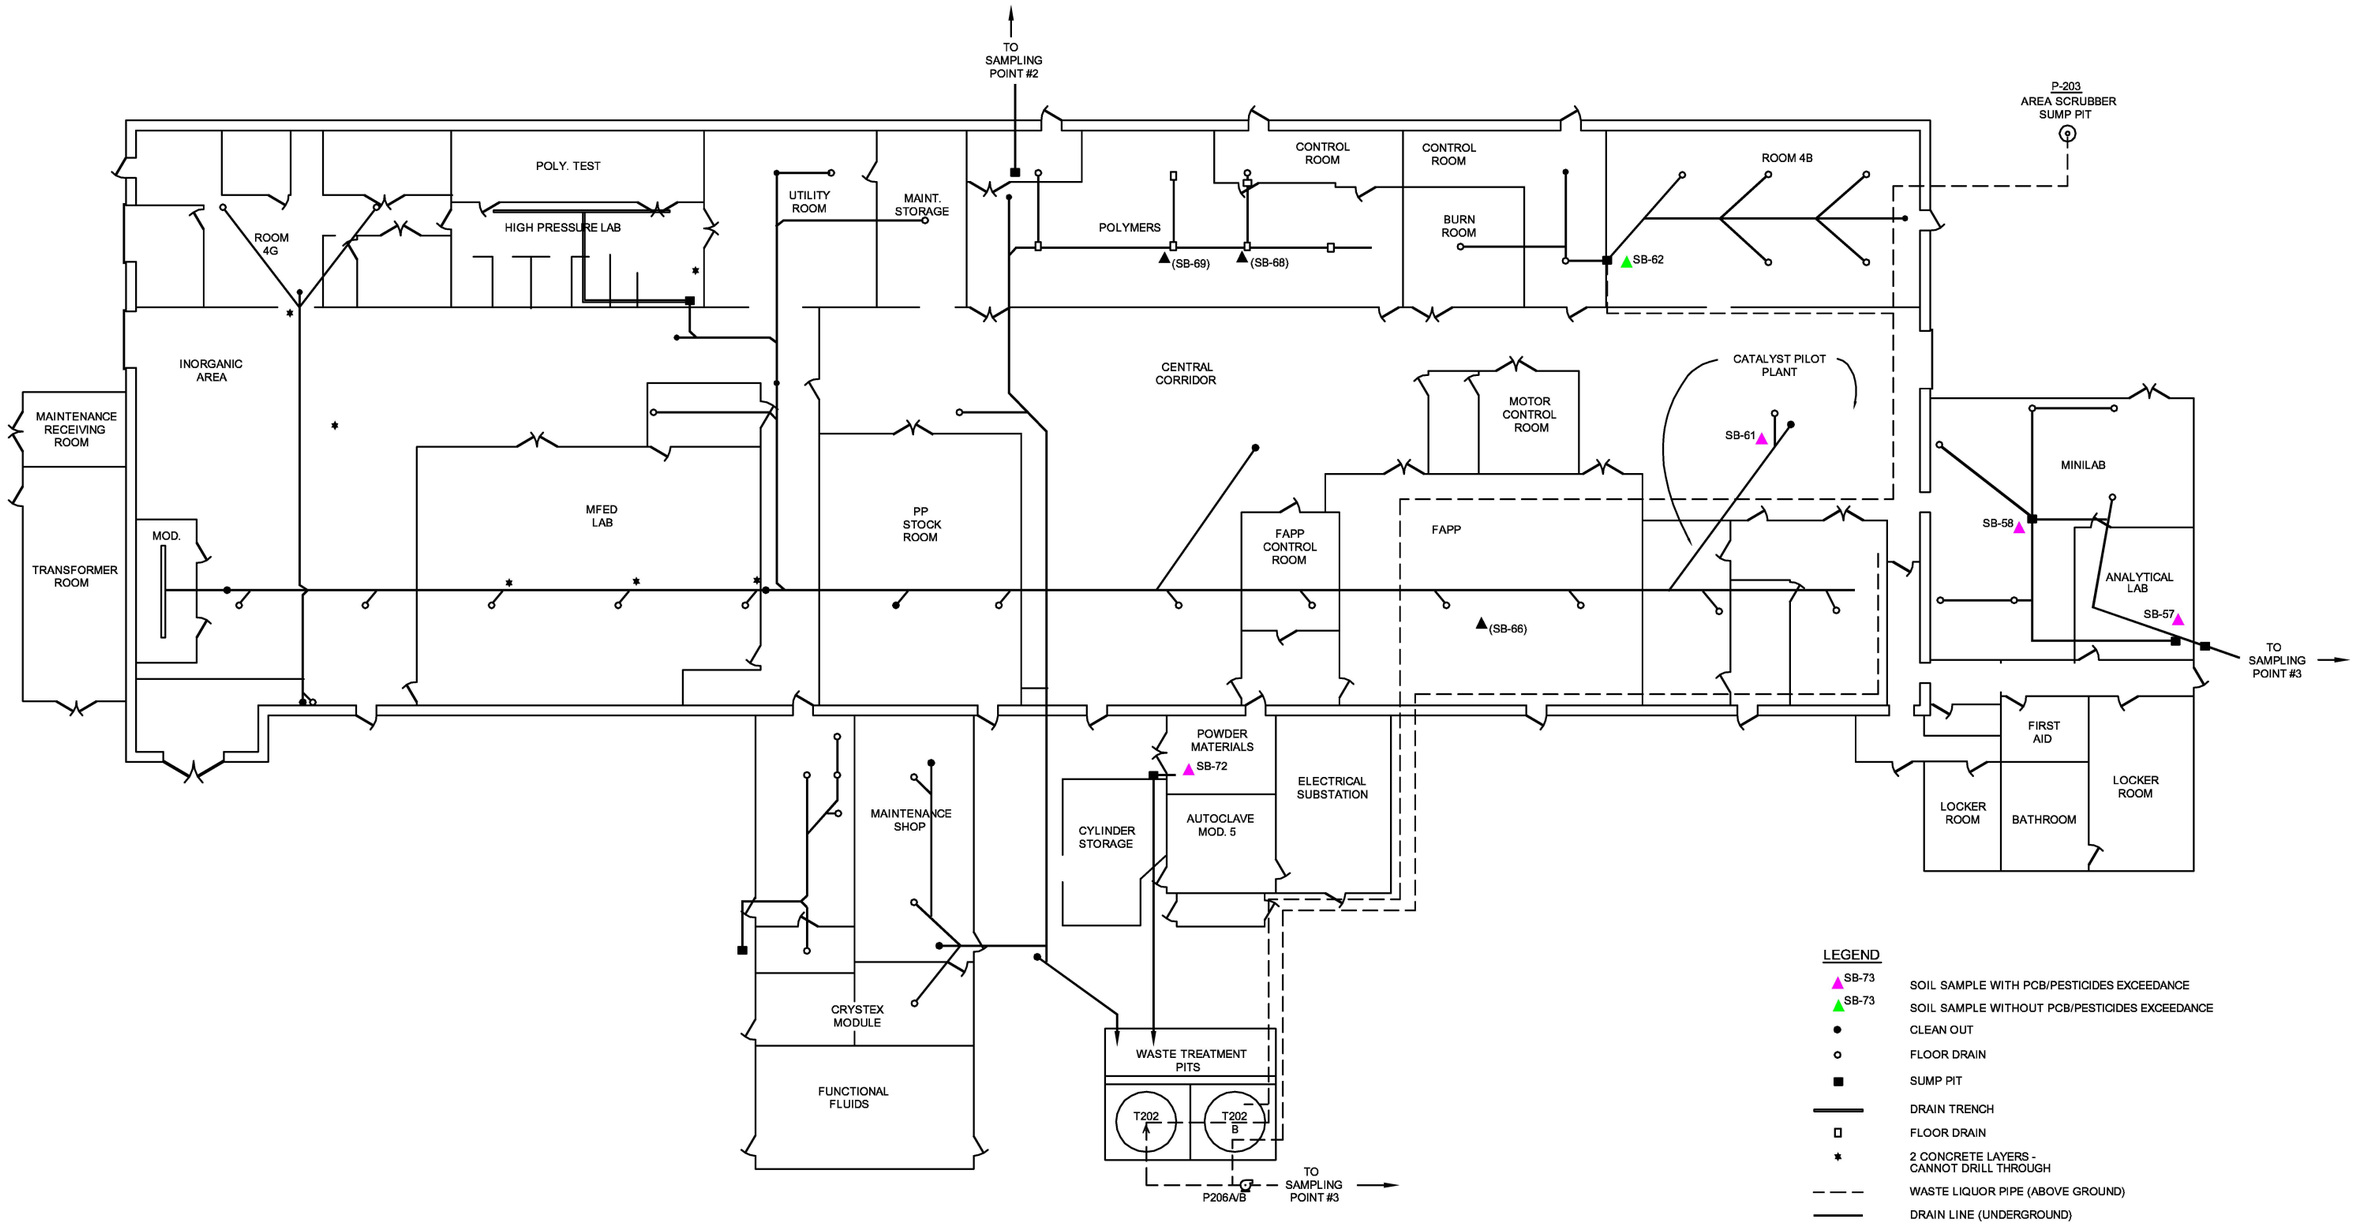
- SB-73 — SOIL SAMPLE WITH PCB/PESTICIDES EXCEEDANCE
- SB-73 — SOIL SAMPLE WITHOUT PCB/PESTICIDES EXCEEDANCE
- CLEAN OUT
- FLOOR DRAIN
- SUMP PIT
- DRAIN TRENCH
- FLOOR DRAIN
- 2 CONCRETE LAYERS - CANNOT DRILL THROUGH
- WASTE LIQUOR PIPE (ABOVE GROUND)
- DRAIN LINE (UNDERGROUND)

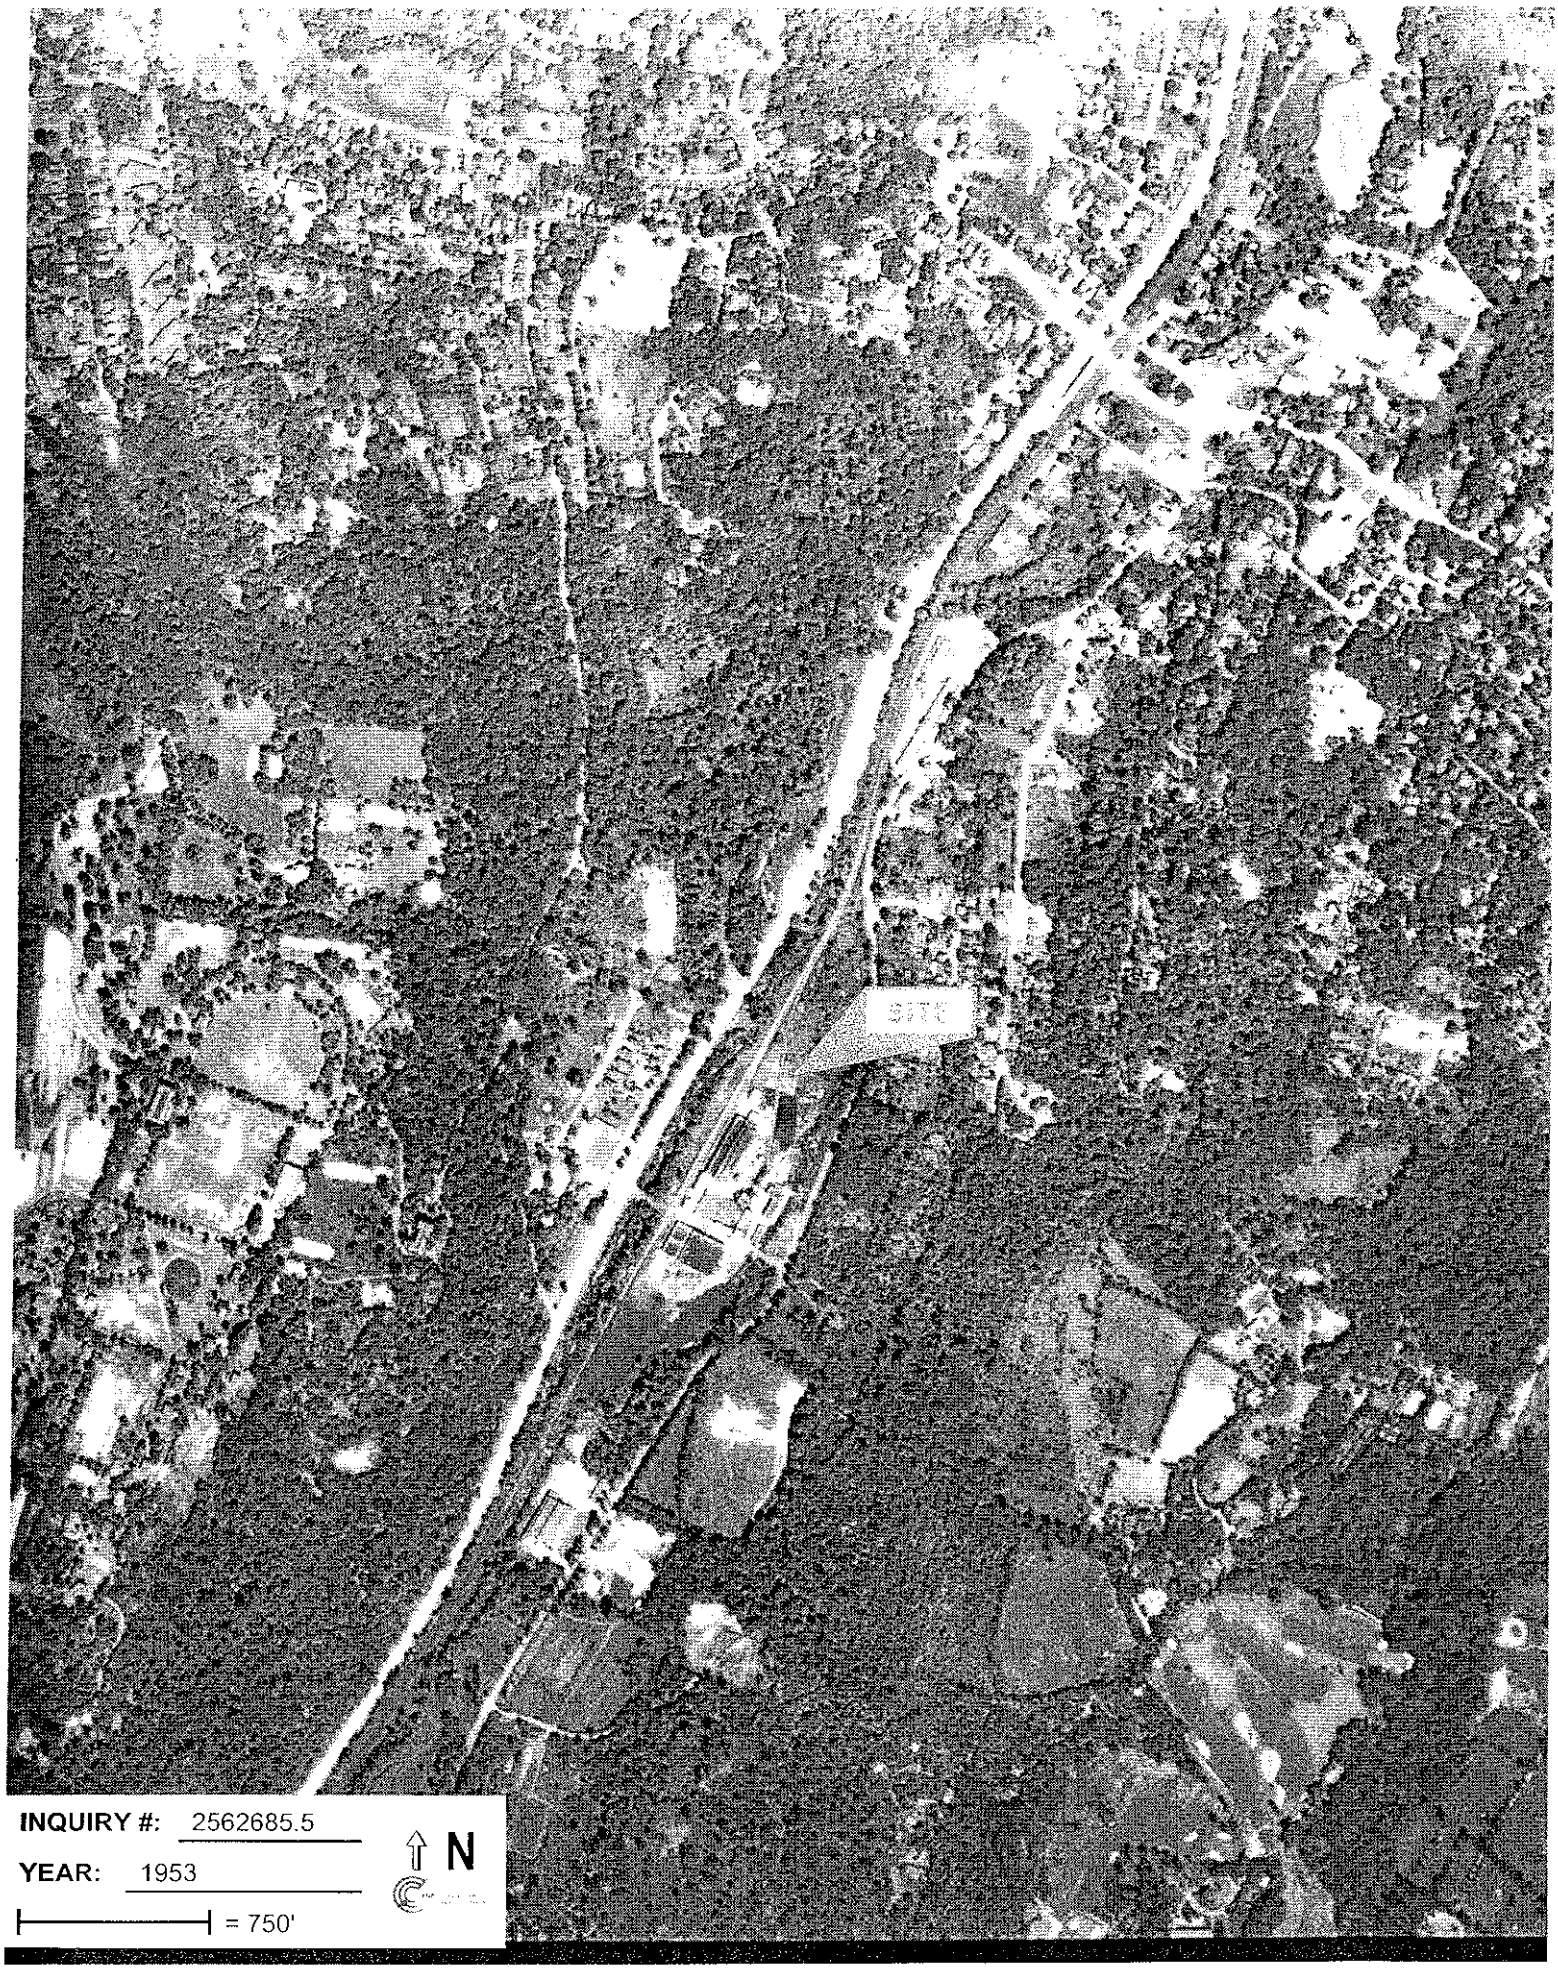
YEAR: 1953

The southern portion of the site is developed with approximately six or seven main structures. Several smaller structures are observed but their use cannot be determined due to the scale of the photograph. A rail spur entered the site from the northwest and

terminated near the center of the developed southern portion of the site. The Saw Mill River is observed in the undeveloped northern portion of the site and along the eastern property boundary.

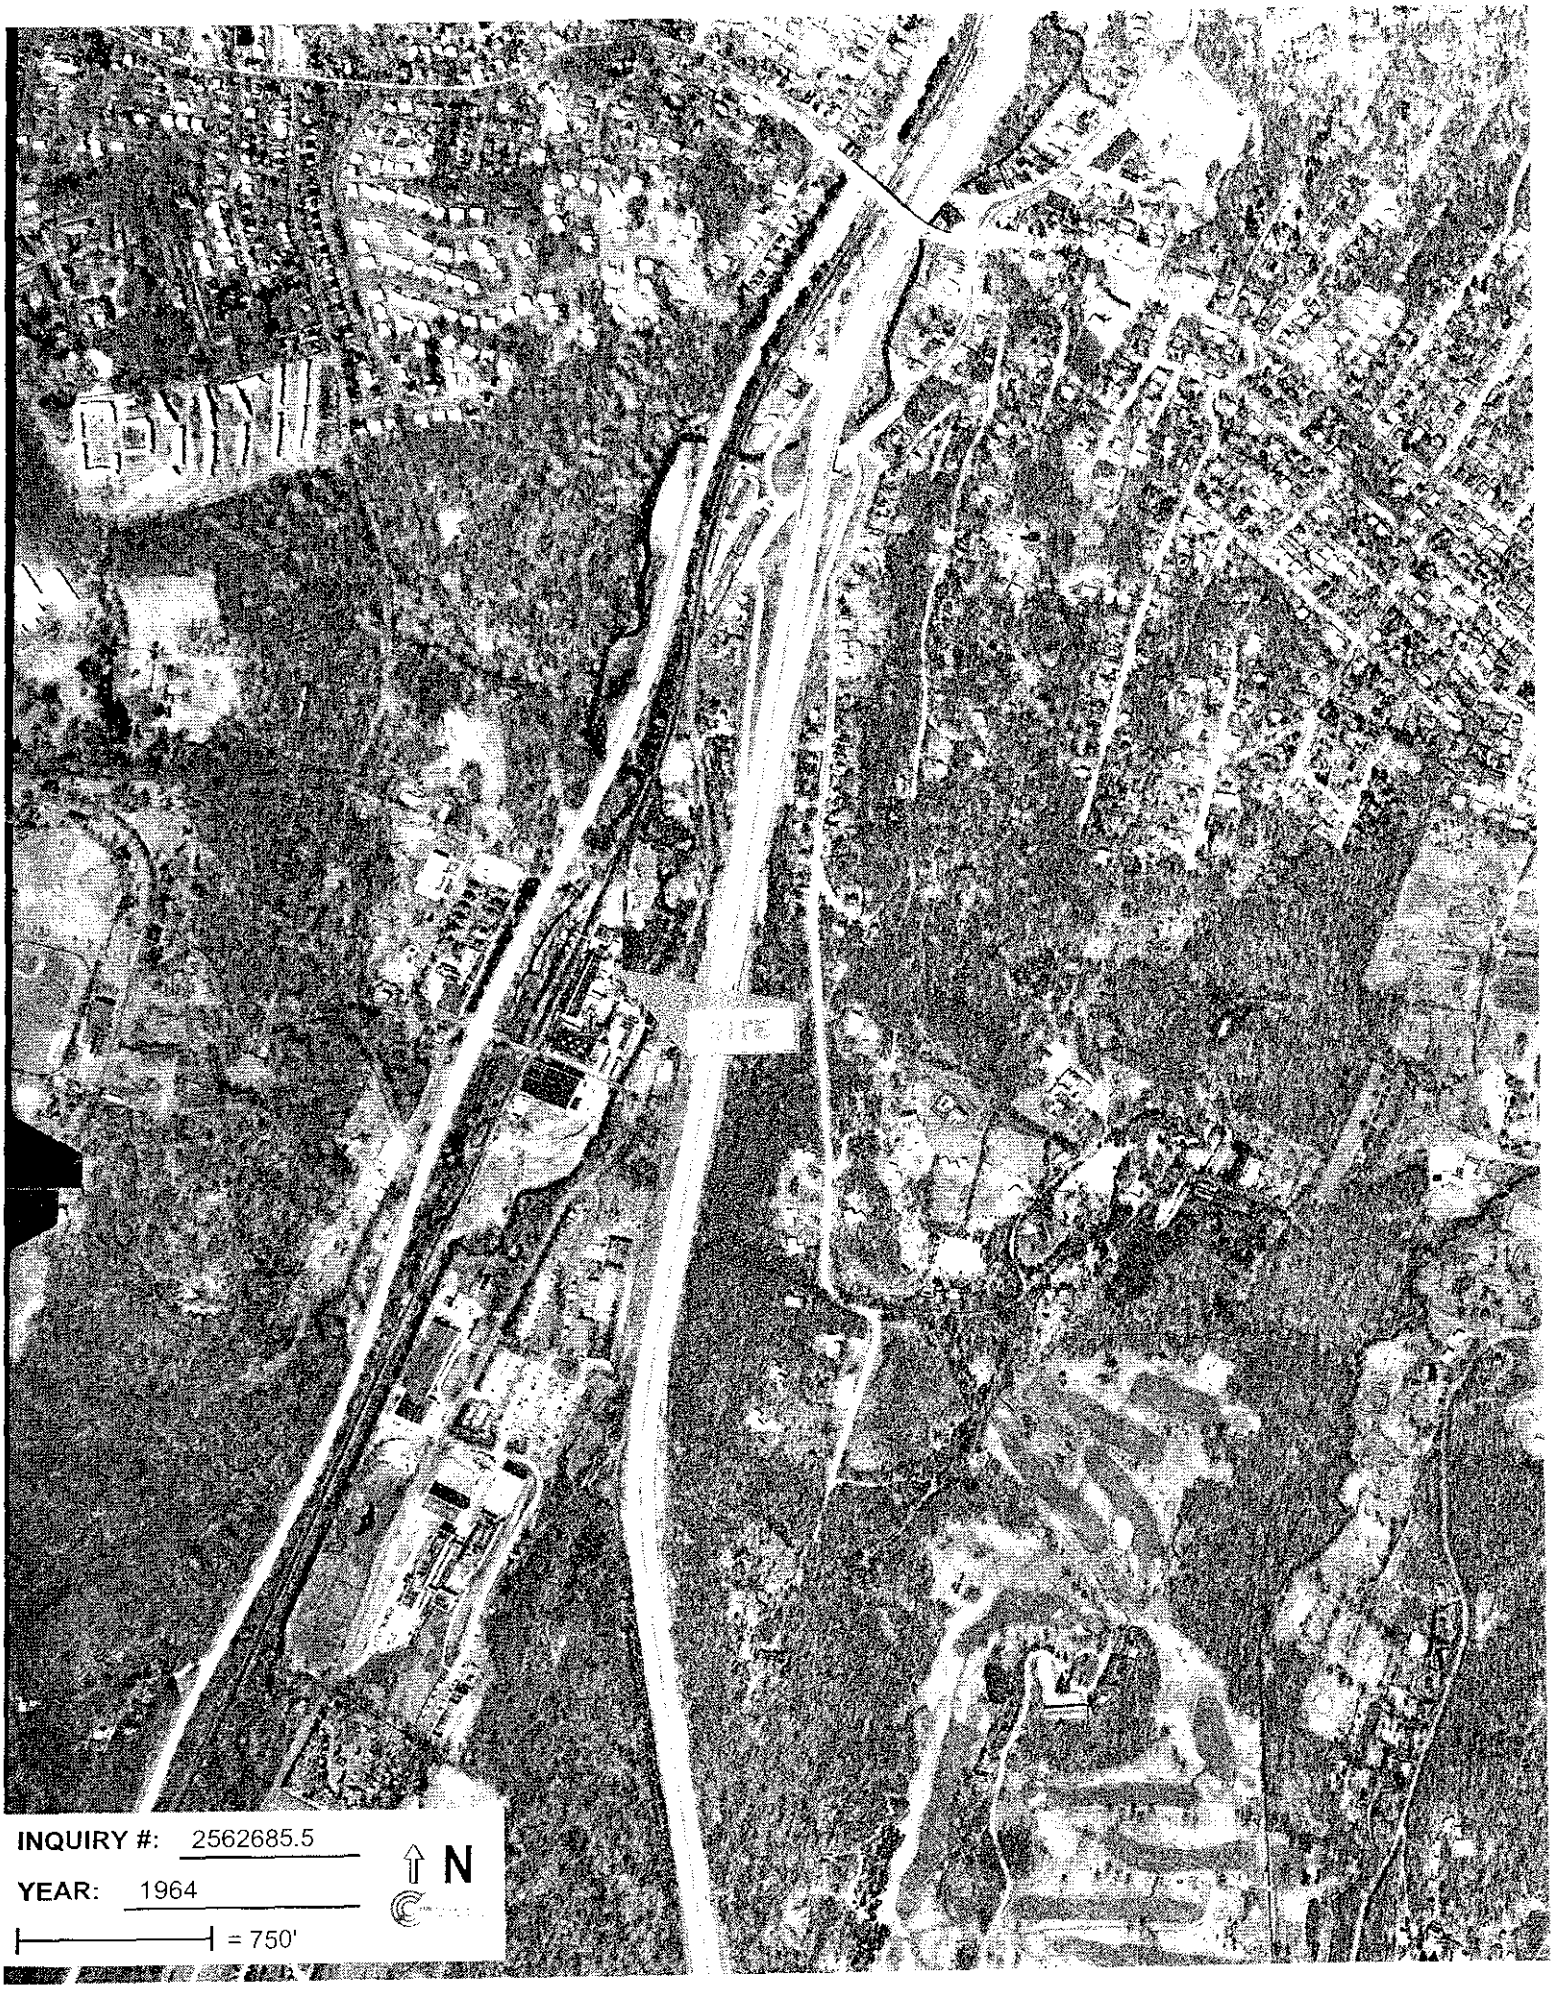
YEAR: 1964

Two or three ASTs may be present in the center portion of the developed plant area. Two additional structures are observed to the north and northeast of the main Pilot Plant in comparison to the 1953 aerial photograph; one near the location of the former office building and the other near the location of a former solvent shed. Several objects are observed in a cleared area in the southeast corner of the site to the east of the Saw Mill River; however, neither these objects nor the activities in that portion of the site can be identified. Additional clearing is observed in the northernmost area of the site on the north and east side of the Saw Mill River; however, the purpose of the clearing is unknown.

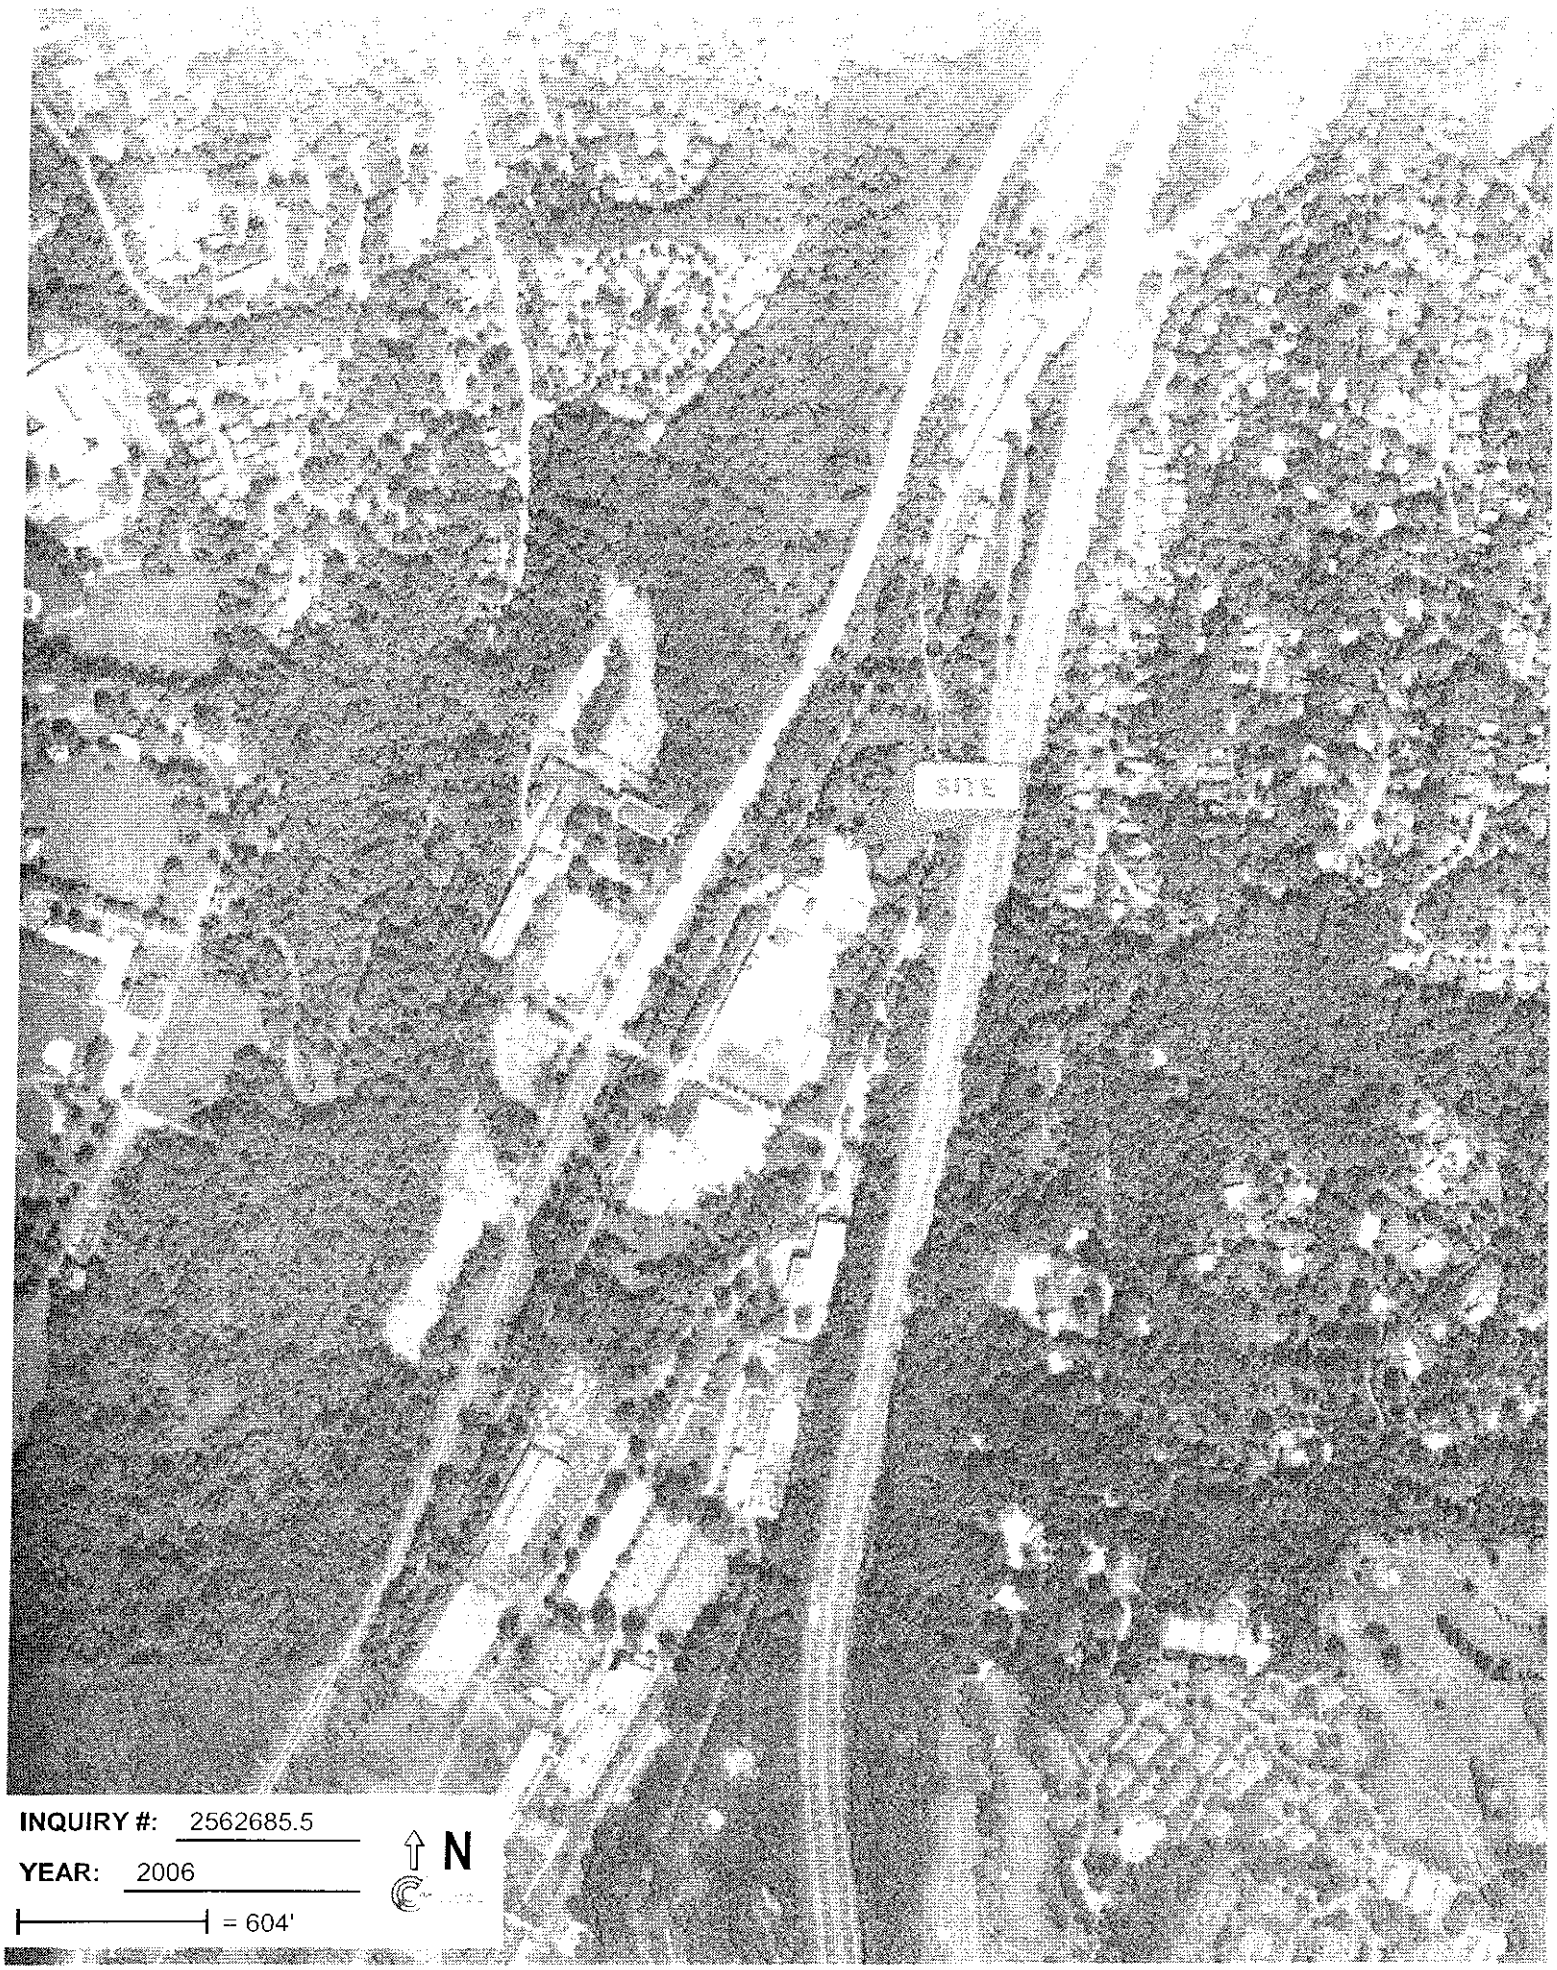
YEAR: 2006

The structure (Potash Plant) immediately north of Lawrence Street has been removed in the 2006 aerial photograph. This structure has been replaced with a landscaped area. The remainder of the site appears similar to pre-demolition conditions. No other changes are observed to the Site or surrounding properties in comparison to the 1994 aerial photograph.
