Phase I Environmental Site Assessment Report

Proposed 119 Oregon Road Multifamily Development Site

Block 1, Lot 12
Town of Cortlandt
Westchester County, New York

January 14, 2021
FPA No. 16875.001

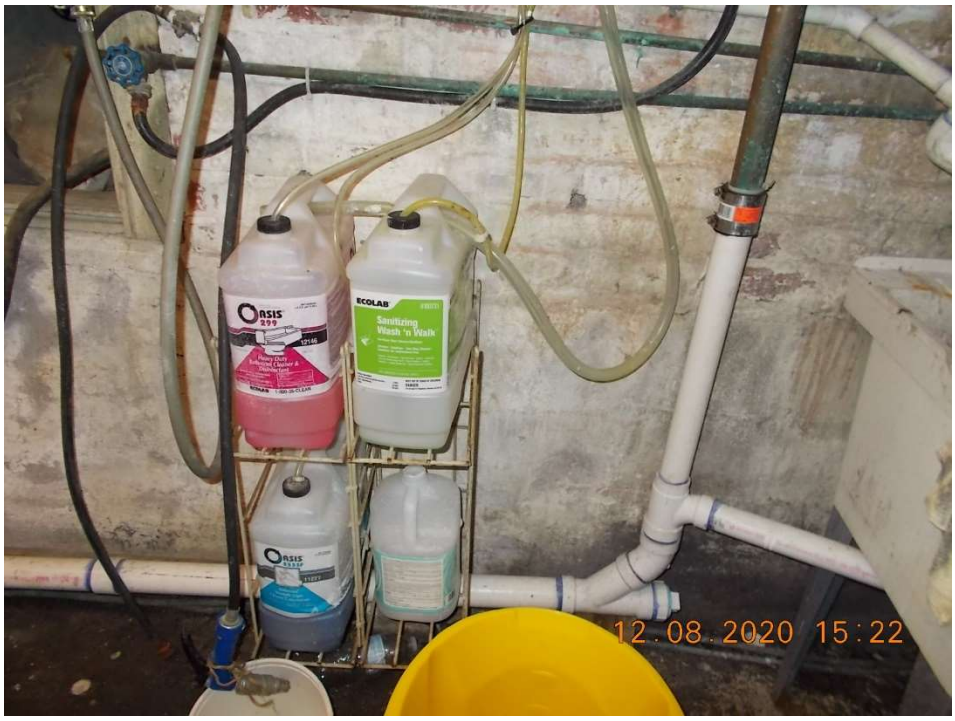
SCALE:	DATE:	JOB No.	PHOTO No.
N.T.S.	December 2020	16875.001	17 and 18

Multiple pint, quart, and gallon cans, containers of paints, vanishes, mineral spirits, aerosol cans of paint, tubes of caulk, and plastic containers of spackle are stored on wooden shelves in the basement. The area is clean and well maintained and no evidence discharges was noted. Various small electric motors and other equipment associated with the entertainment ballrooms are stored in the basement.

Containers of Liquid Cleaners in Basement Connected to First Floor Kitchen Area

Containers of Paints, Vanishes, Mineral Spirits, Spackle, and Caulk in Basement Storage Area

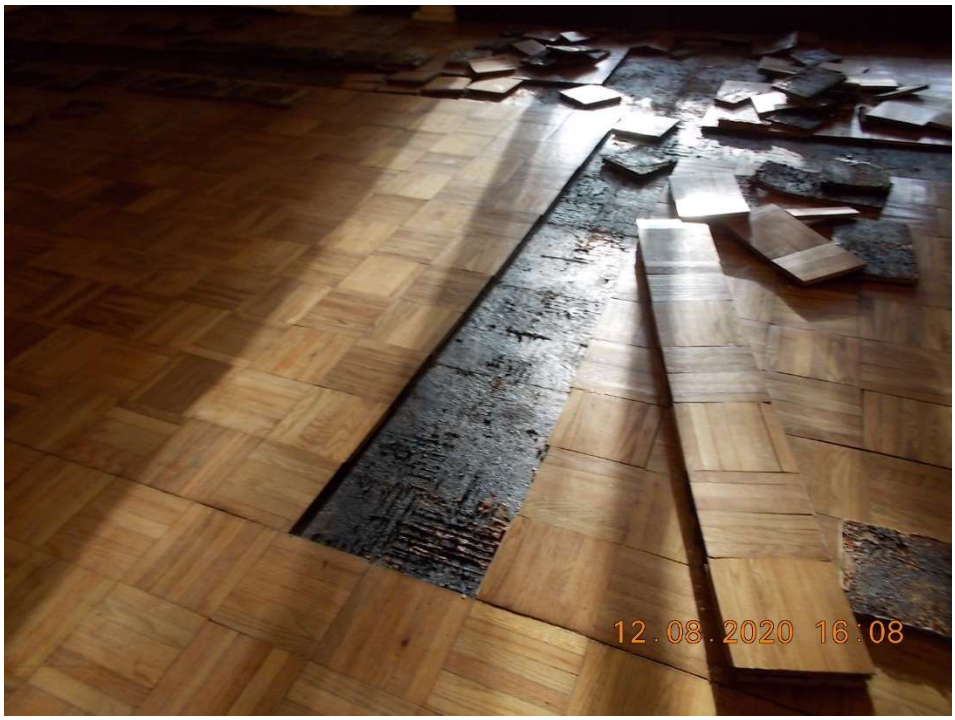
SCALE:	DATE:	JOB No.	PHOTO No.
N.T.S.	December 2020	16875.001	25 and 26

Black Mastic Beneath Wood Parquet Floor in Lounge

First Floor Ballroom
