**Phase I Environmental Site Assessment**

BROOKFIELD COMMONS PHASE 3
159 S. LEXINGTON AVENUE
WHITE PLAINS, NEW YORK
Remedial Action Work Plan
NYSDEC BCP Number: C360246
AKRF Project Number: 210122

**Re: Phase I Environmental Site Assessment**
***Brookfield Commons Phase 3 – White Plains, New York***
***AKRF Project Number: 210122***

# Phase I Environmental Site Assessment

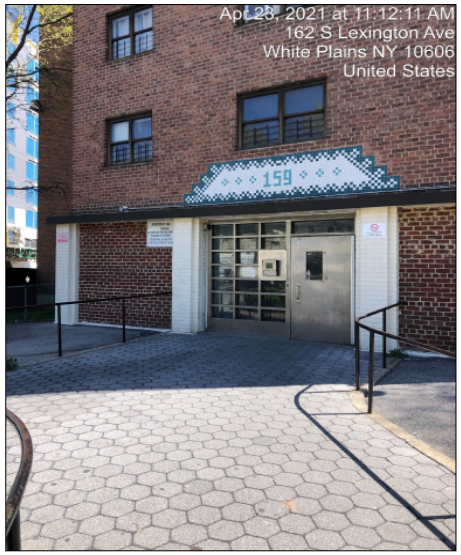
**Photograph 3.** View of the entrance to the Property from South Lexington Avenue.

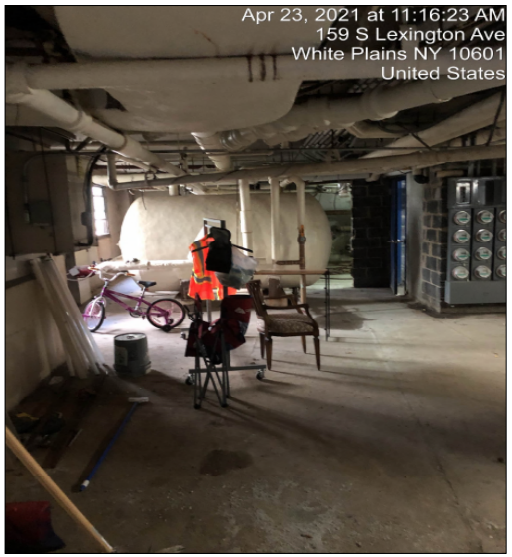
**Photograph 4.** View of the basement meter room and storage area.
