DAILY OBSERVATION REPORT

11-4-2025

Site: 227 Westchester Ave, Port Chester, NY 10573
Phase: Well Sampling
Site No.: C360253

Project Engineers: Haley & Aldrich of New York Engineering and Geology

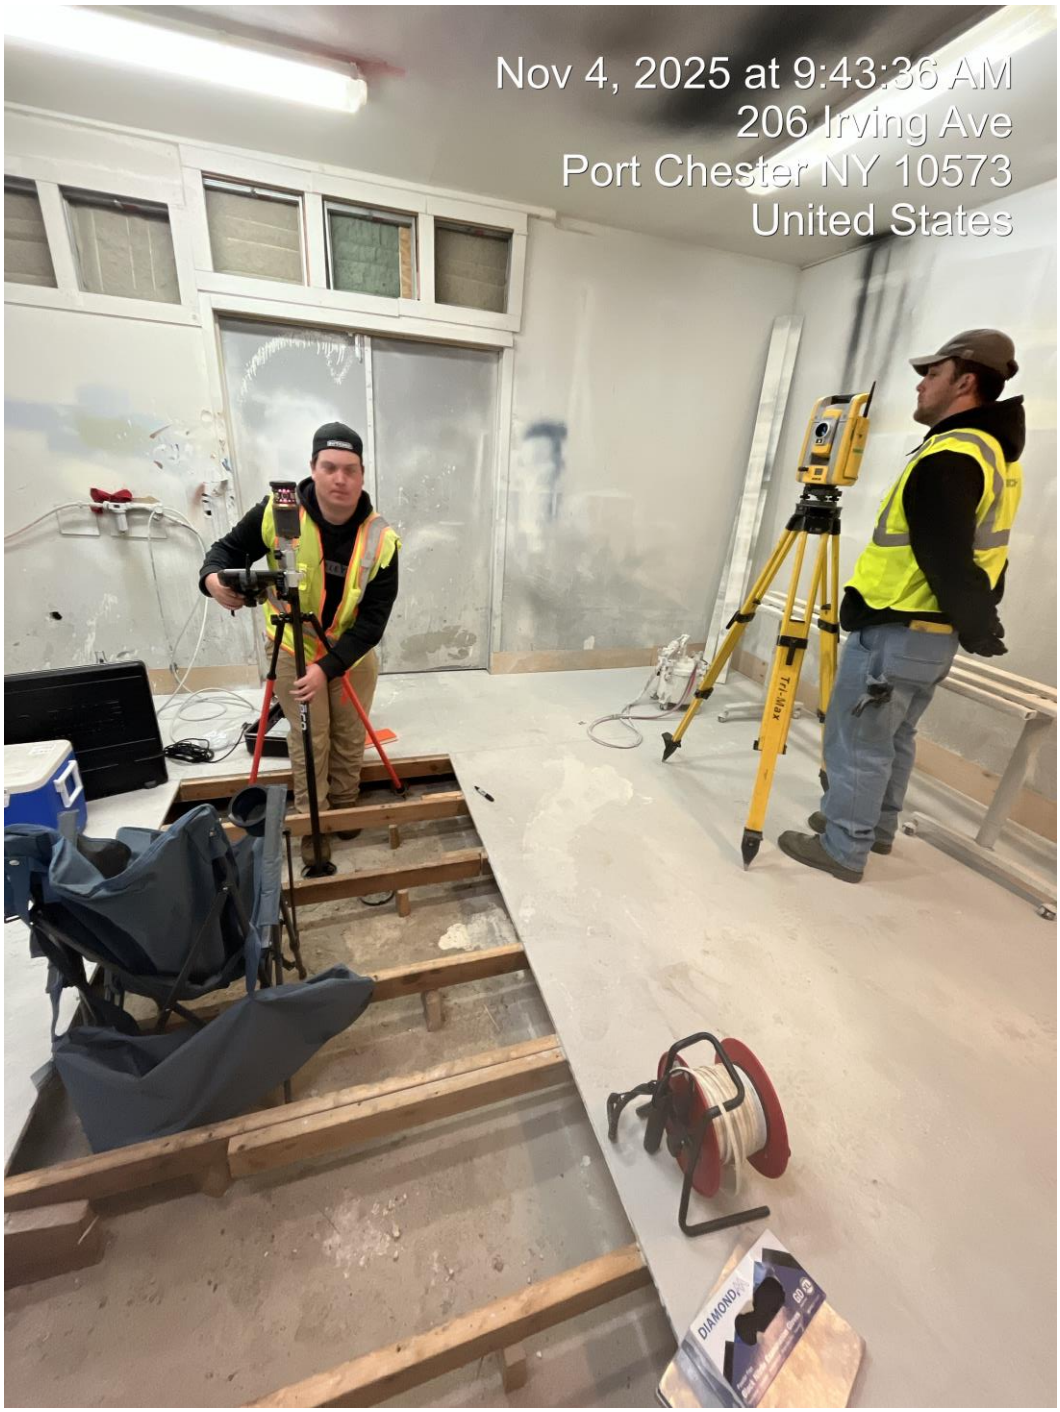
- **There was strong petroleum odors associated with the AST located North of MW02.**
- **MW04 was found to be 15.04ft deep and ground water was 8.95ft below the top of the well.**

Depths being determined with the interface meter of MW04. The image is facing West.

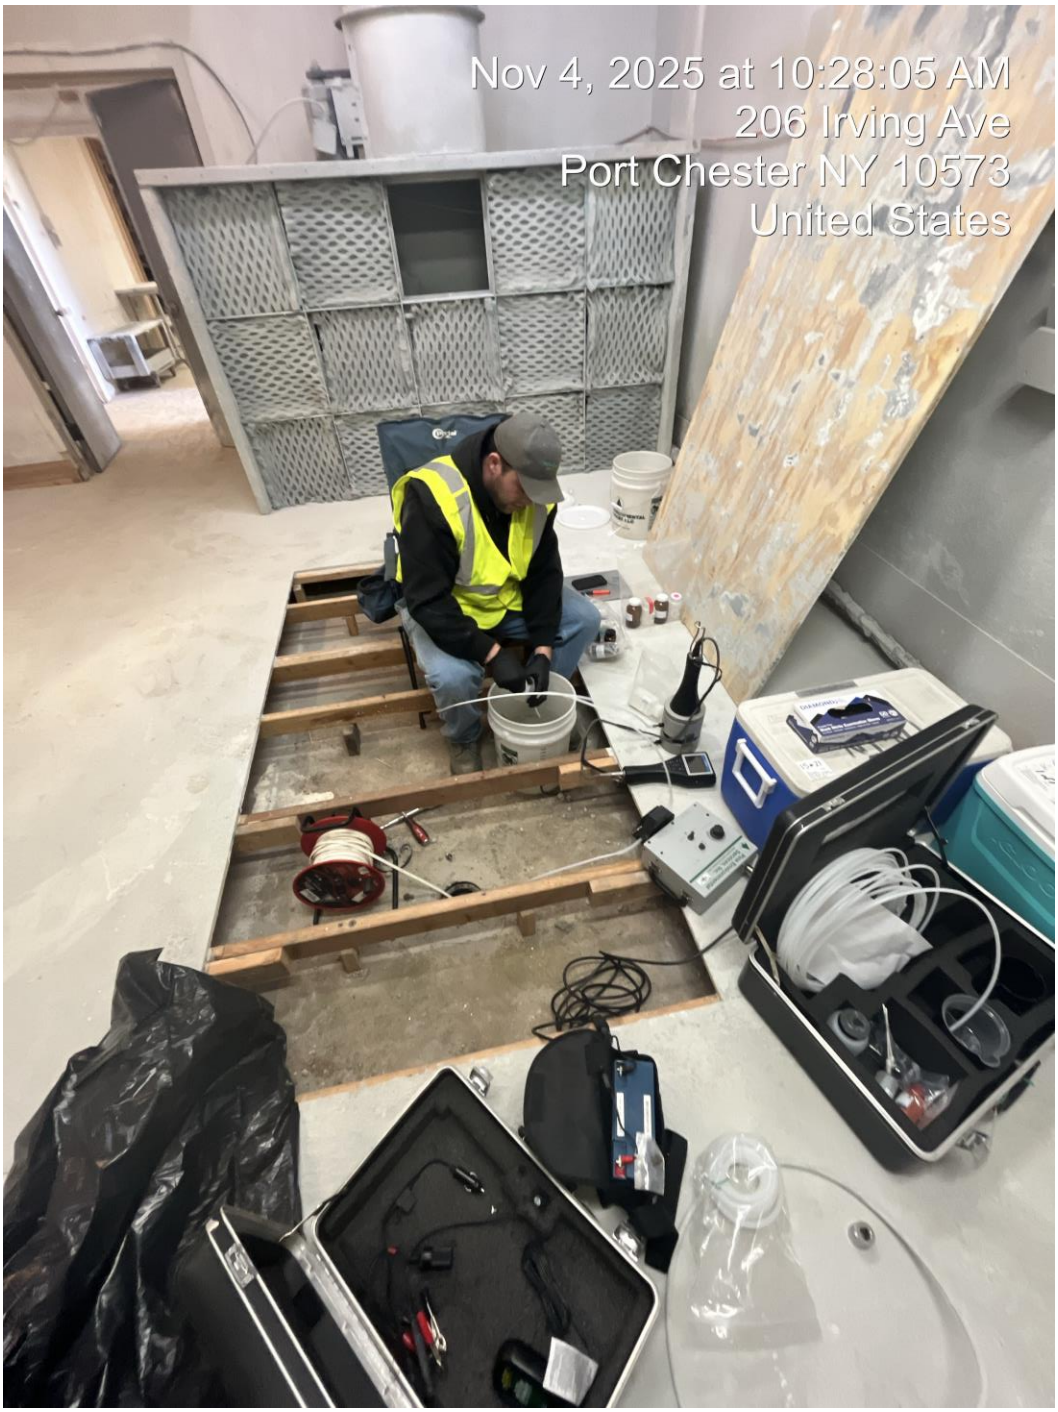
Surverying of MW01. The image is facing North.

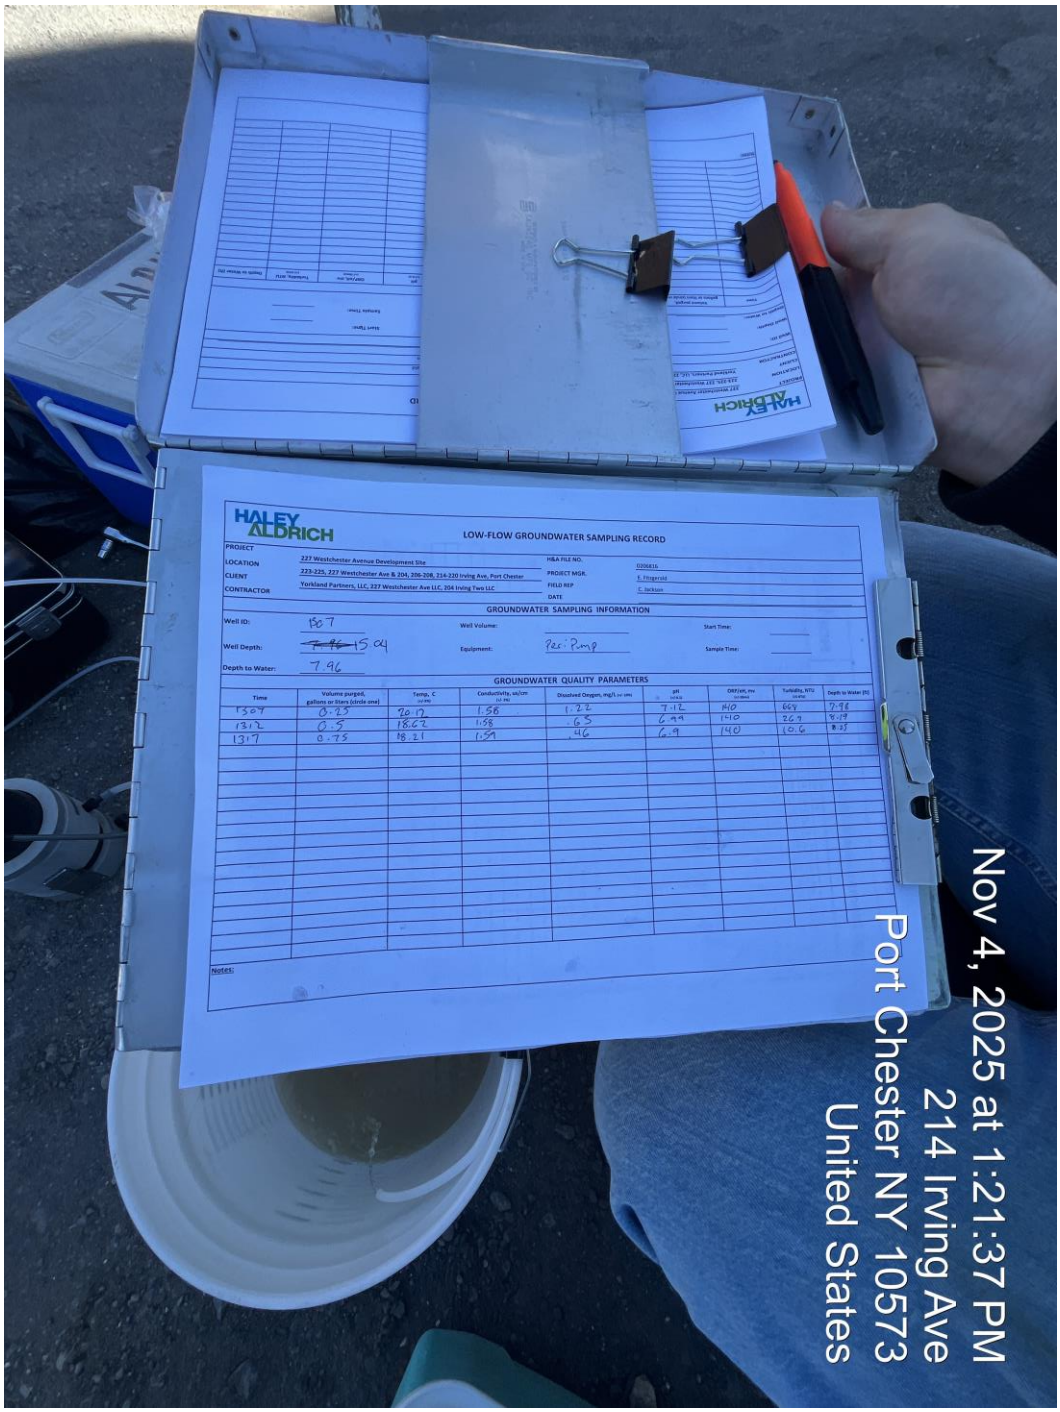
- **When investigating MW02 for water elevation and well depth, product was detected with the interface meter from 7ft to 11ft below the top of the well. Haley Aldrich then ordered a bailer to investigate the situation. Depth was determined in MW02 to be 14.89ft. When the bailer was delivered and used, the resulting sample was several feet of black NAPL. Odors were associated with MW02.**

Product can be seen on the interface meter.
