PHASE I ENVIRONMENTAL SITE ASSESSMENT
OF

MACY'S WHITE PLAINS GALLERIA
100 MAIN STREET
WHITE PLAINS, NEW YORK 10601

ATC PROJECT NO. Z214DCWP01

APRIL 12, 2019

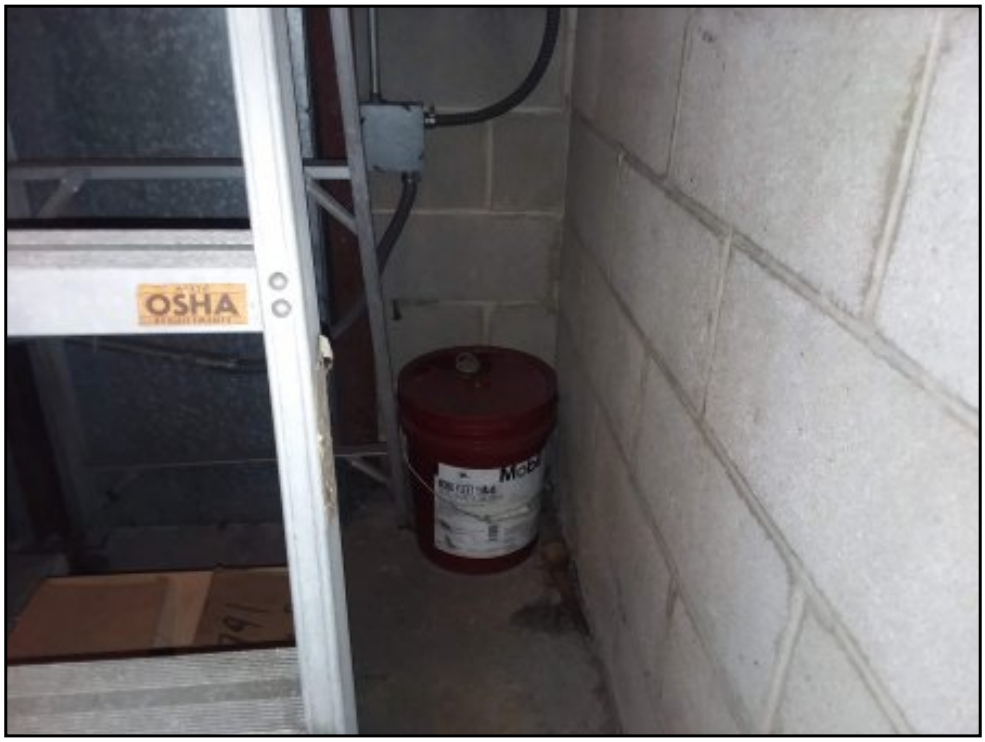
Note 3: ATC observed one 1,000-gallon diesel fuel aboveground storage tank (AST) within the east portion of the loading dock area that was reportedly installed in 1997. The 1,000-gallon diesel AST transfers fuel to a 100-gallon day tank AST and emergency generator located within the penthouse generator room of the property building. ATC observed oil staining on the concrete pad below the emergency generator engine. No unusually strong odors or signs of corrosion were noted.Based on its location, minor quantity and lack of pathway to the subsurface, this minor staining is considered to be a *de minimis condition.*

Photograph 5: "Dry Type" electric transformers located at the property.

Photograph 6: DeMinimis oil staining beneath the property's emergency generator.

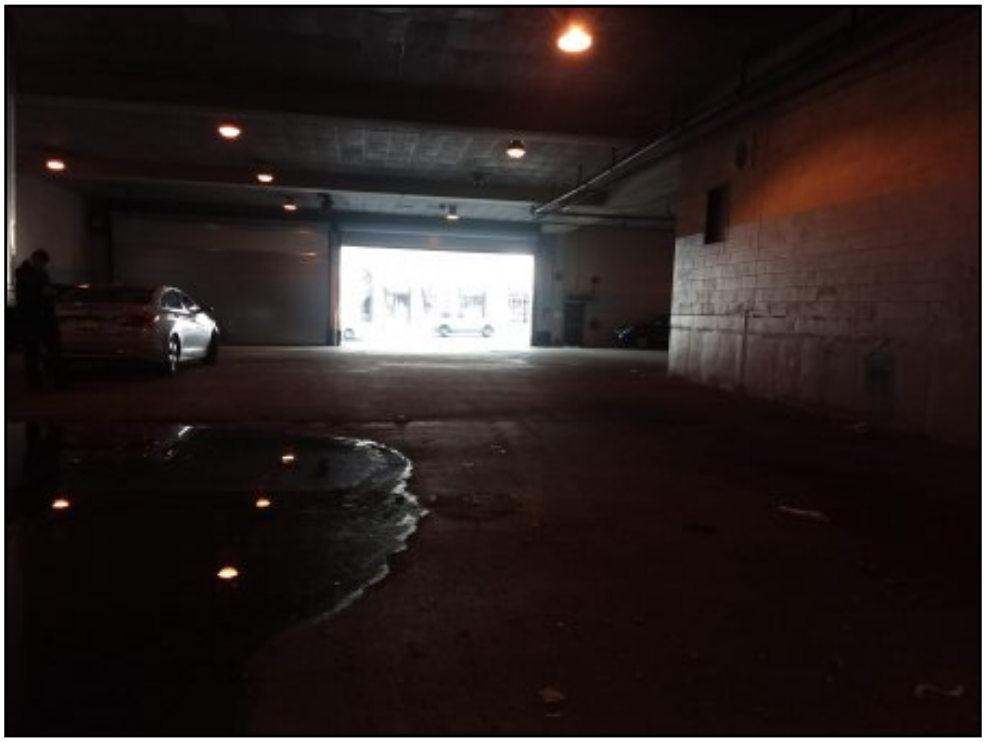
Photograph 21: Hydraulic trash compactor on the first floor of the property building.

Photograph 22: Representative view of the loading docks within the property building.

Photograph 23: Standing water with slight petroleum sheen observed within the loading dock area of the property building.
