Phase I Environmental Site Assessment/

White Plains – Five Parcels

26-28, 34, 42 and 60 East Post Road, 223-225 Dr. Martin Luther King Jr. Boulevard

June 2021

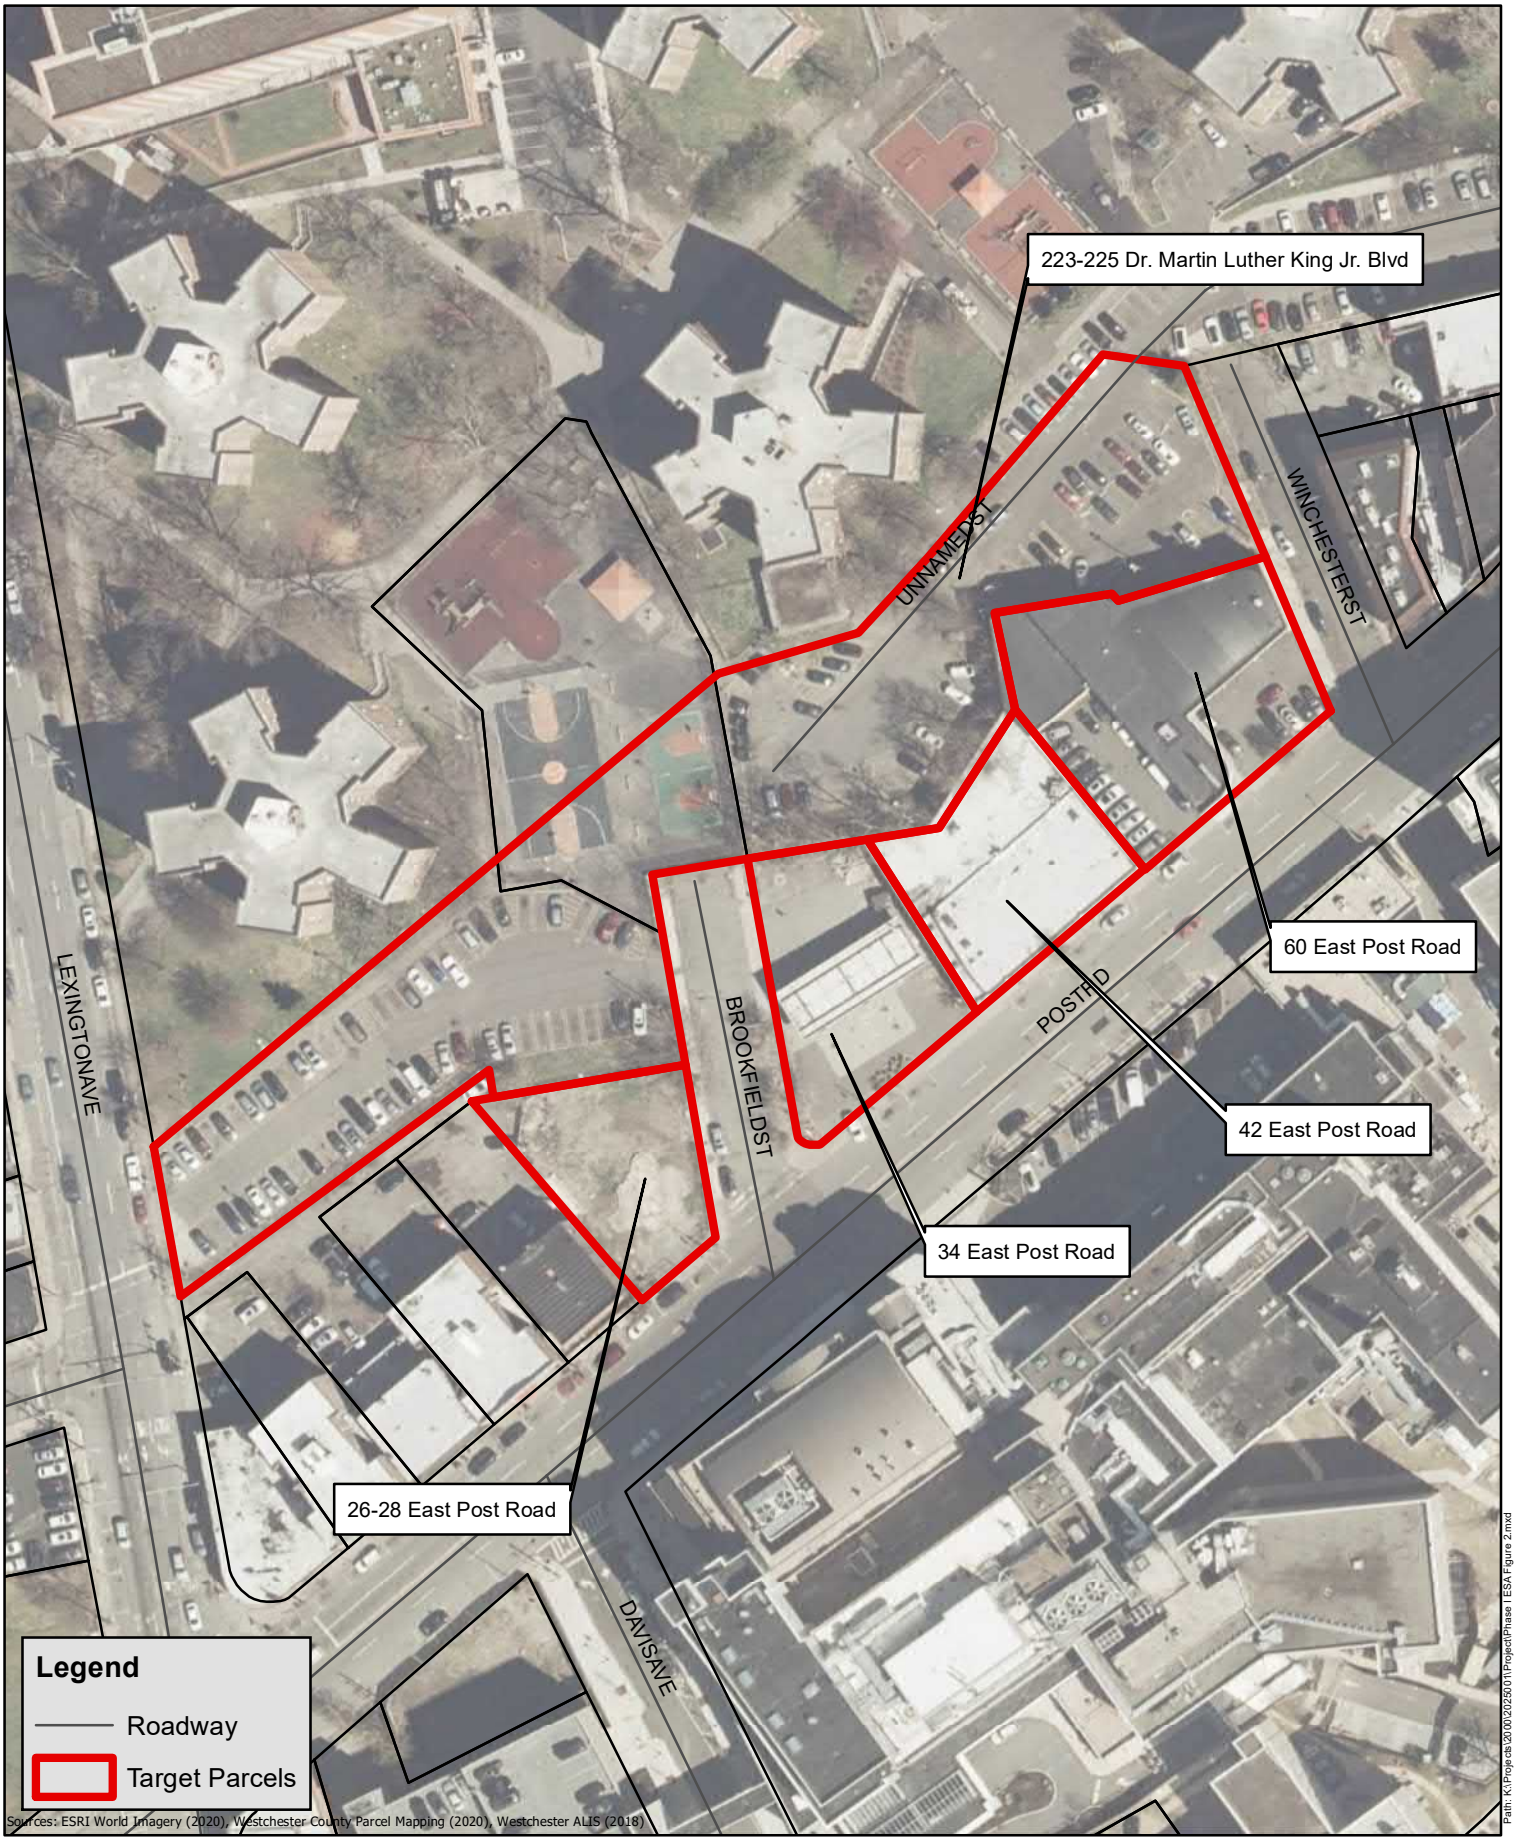
FIGURE 2
Site Plan

Figure 2 depicts the sampling locations.

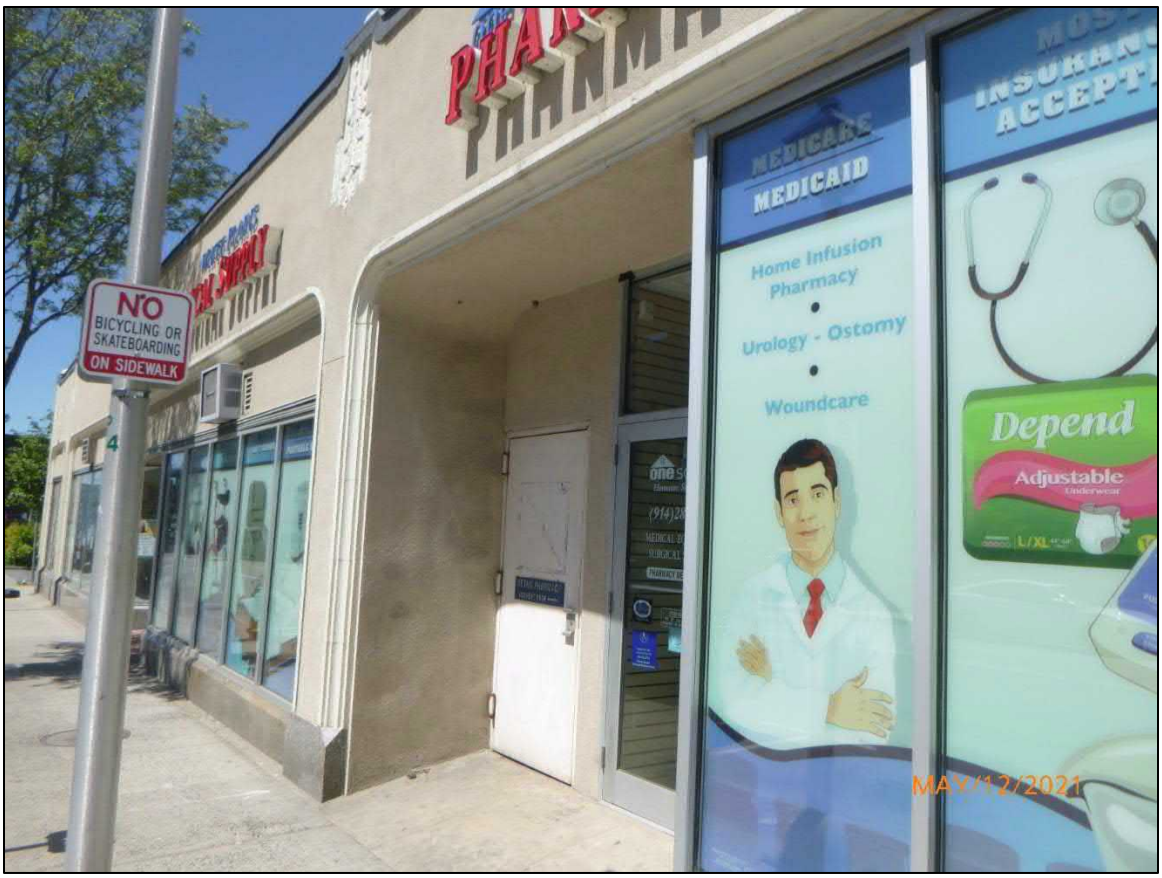
Photograph 10: Storefront at 42 East Post Road, photograph looking northeast.
