# PHASE I ENVIRONMENTAL SITE ASSESSMENT

# 1 Vine Street
# Larchmont, New York

**Report Date:** **28 April 2026**
**180-Day Viability Date:** **3 October 2026**
**192019101**

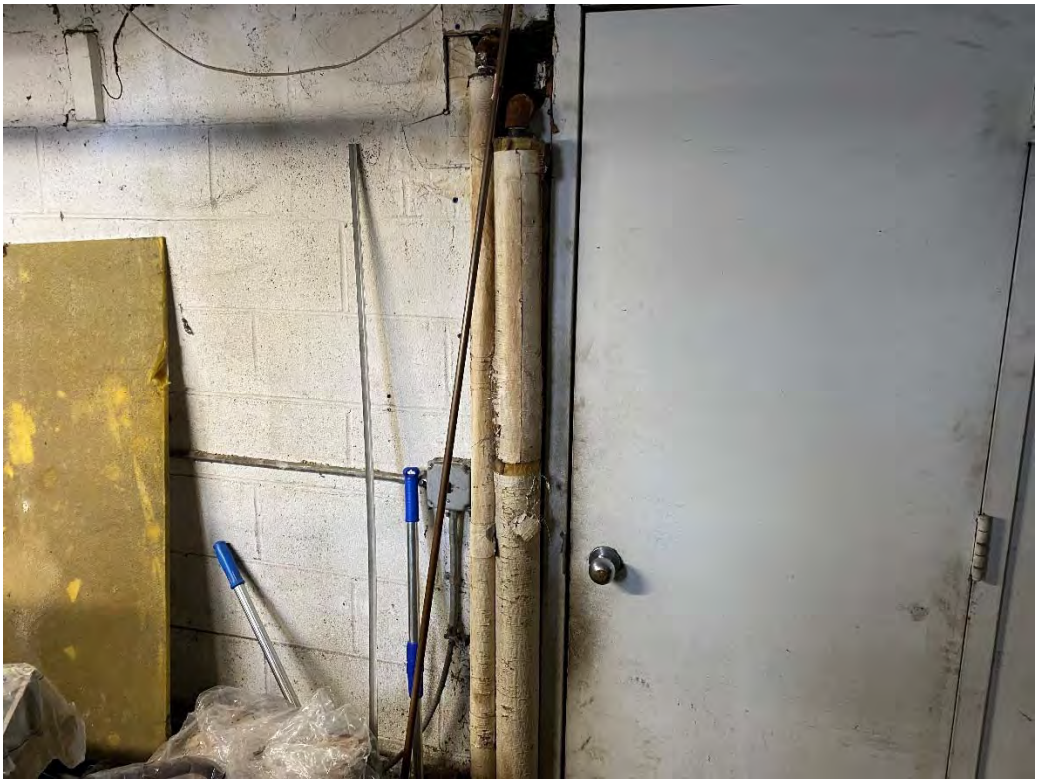
P.13 Magic Touch Cleaners – Secondary Dry-Cleaning Machine

P.14 Magic Touch Cleaners – Pipe Wrap

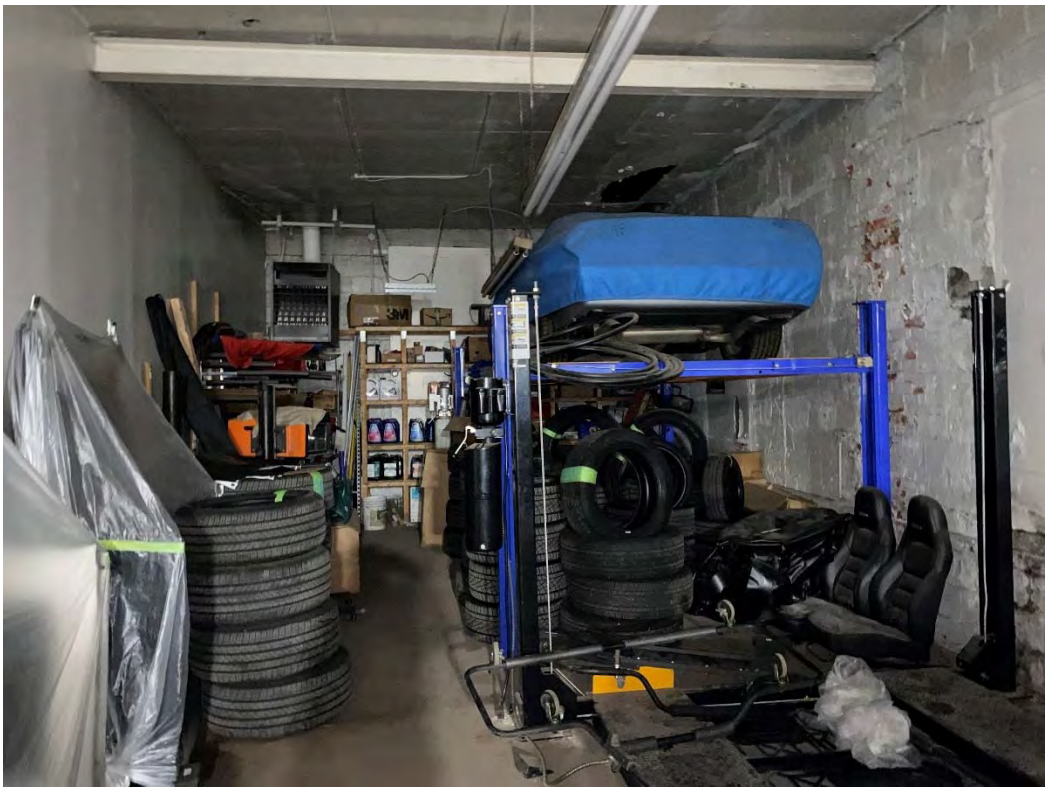
P. 18 Magic Touch Cleaners – Basement Mechanical

P.19 Garage

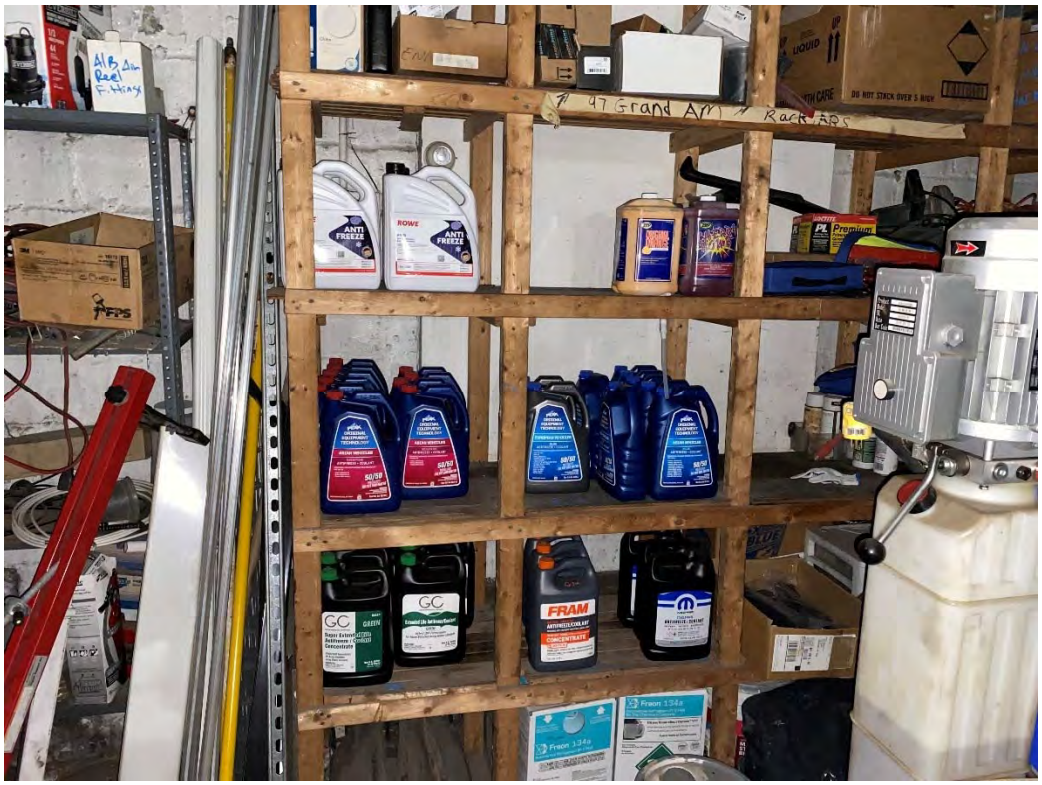
P.20 Garage Floor Drain

P.21 Garage Stored Auto Fluids

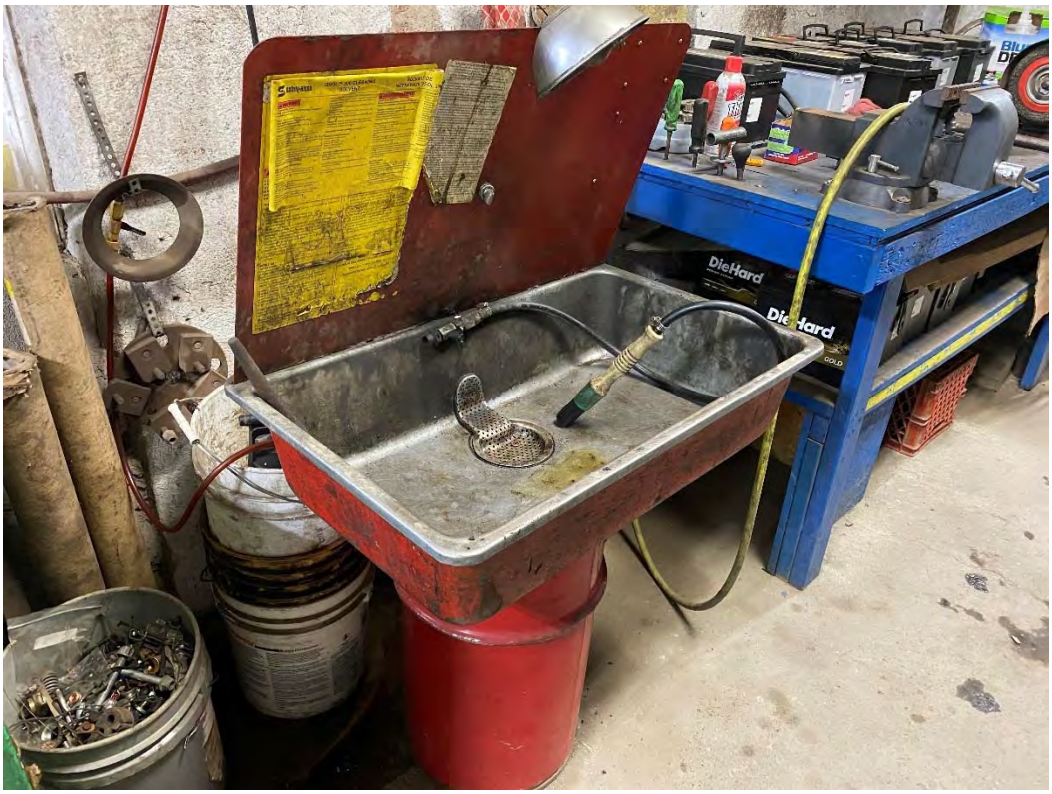
P.23 Auto Repair Shop – Parts Washer

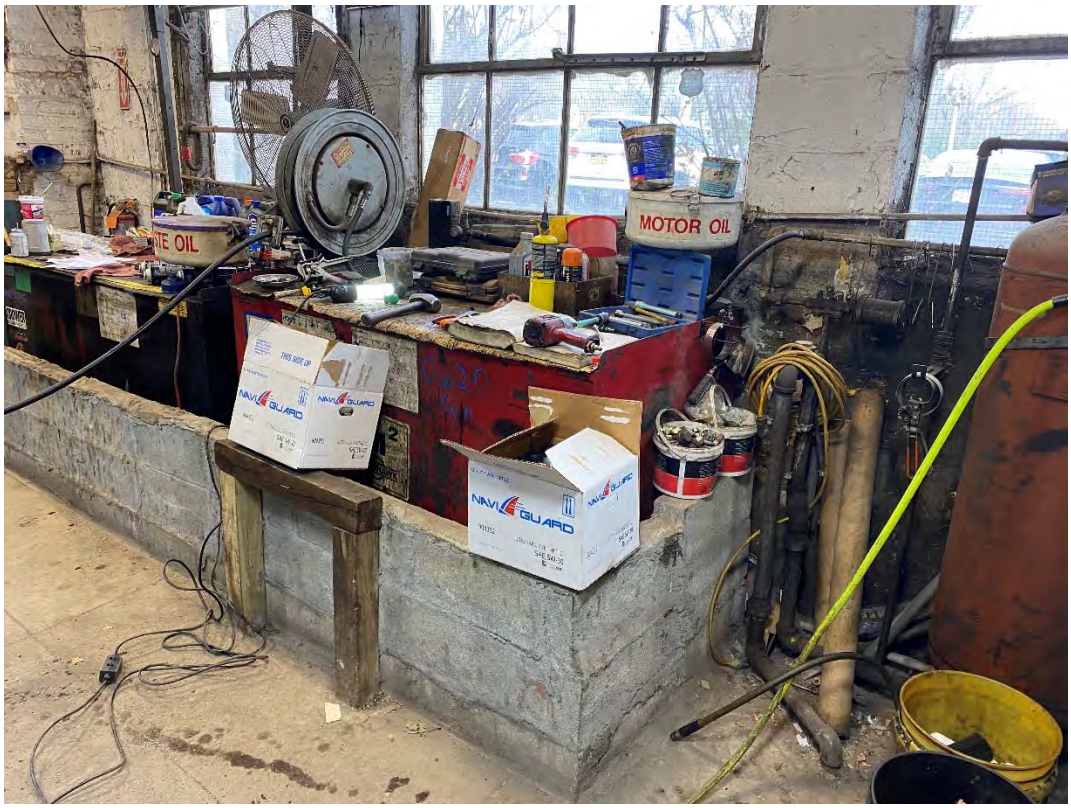
Langan observed four petroleum ASTs at the subject property. An active 250-gallon motor oil AST was present in the eastern part of the autobody garage. An active 250-gallon waste oil AST and second active 250-gallon motor oil AST were present along the rear wall of the autobody garage and are surrounded by a concrete berm for secondary containment. A fourth AST, an about 75-gallon hydraulic oil AST was observed along the rear wall of the autobody garage. The hydraulic oil AST is out-of-service and previously supplied the in-ground lifts in the autobody garage.

Langan did not observe significant staining in the areas of the ASTs.

P.27 Auto Repair Shop - Waste Oil ASTs and Containment

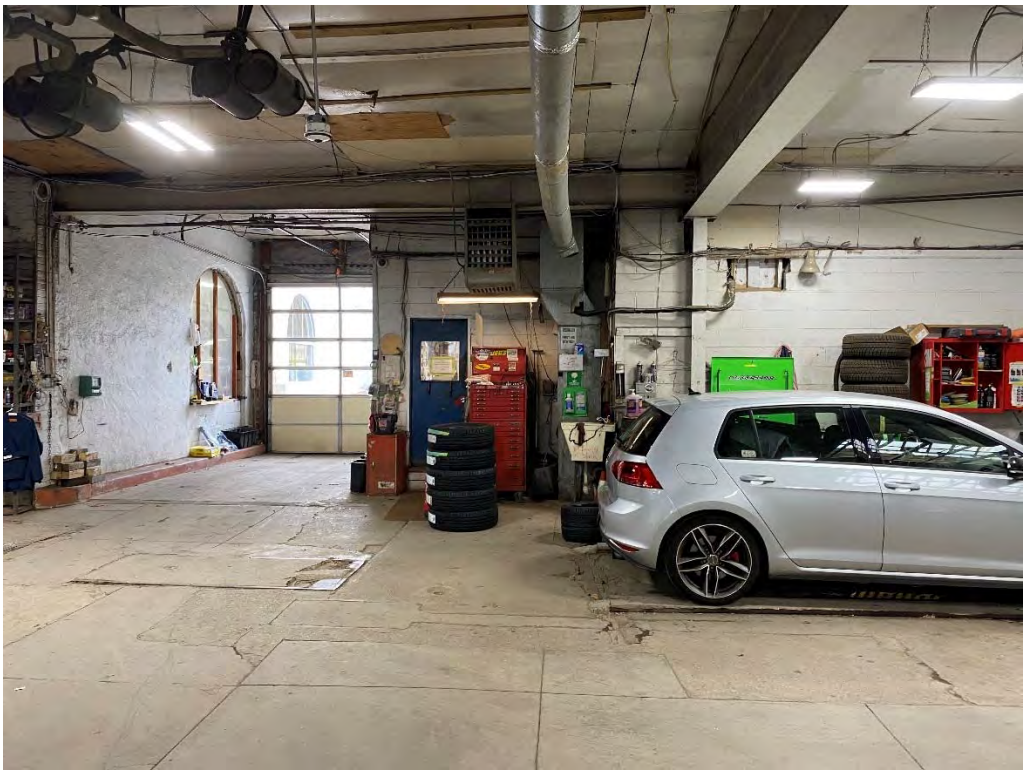
The key site manager reported that there was an abandoned UST in the central garage space. An apparent sealed fill port was observed in the area described by the key site manager. It was unknown what the tank previously contained and if the tank was properly closed.

P.35 Auto Repair Shop – Suggested UST Location

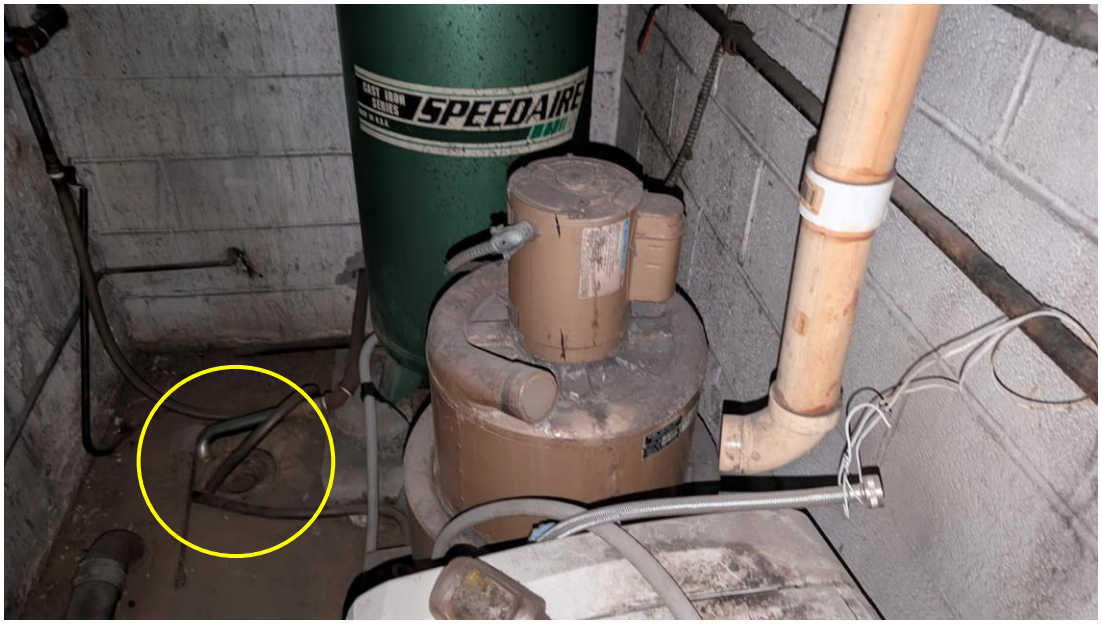
An apparent floor drain in a utility area in the drycleaning unit
