STERLING
Sterling Environmental Engineering, P.C.

Subject: Vapor Mitigation System (VMS) Construction Completion Report (CCR) & OM&M Plan
BCP Site No. C401067
Troy Belting & Supply Company, Colonie, New York
STERLING File #2011-31 (Task 910)

VAPOR MITIGATION SYSTEM CONSTRUCTION COMPLETION REPORT

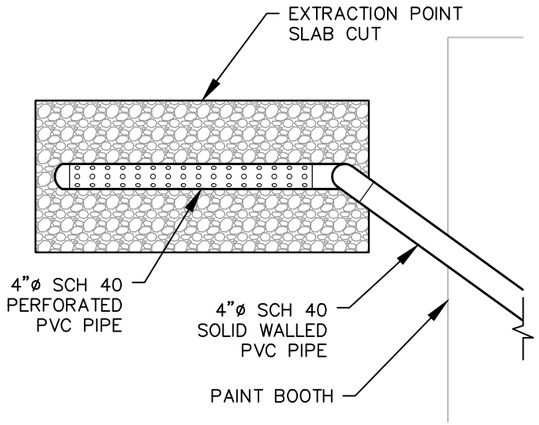
2 WEST EXTRACTION AREA DETAIL
SCALE: 1" = 2'

The Western Extraction Area (WEA) sub-slab soil vapor withdrawal system consists of a rectangular-shaped excavation located to the west of the former Pilot Test hole, located off the northwest corner of the main paint booth. The WEA is situated with its longest dimension extending east to west, approximately 4.4 feet in length by 2 feet in width (see Detail 2 on Figure 3 and Photograph 2).

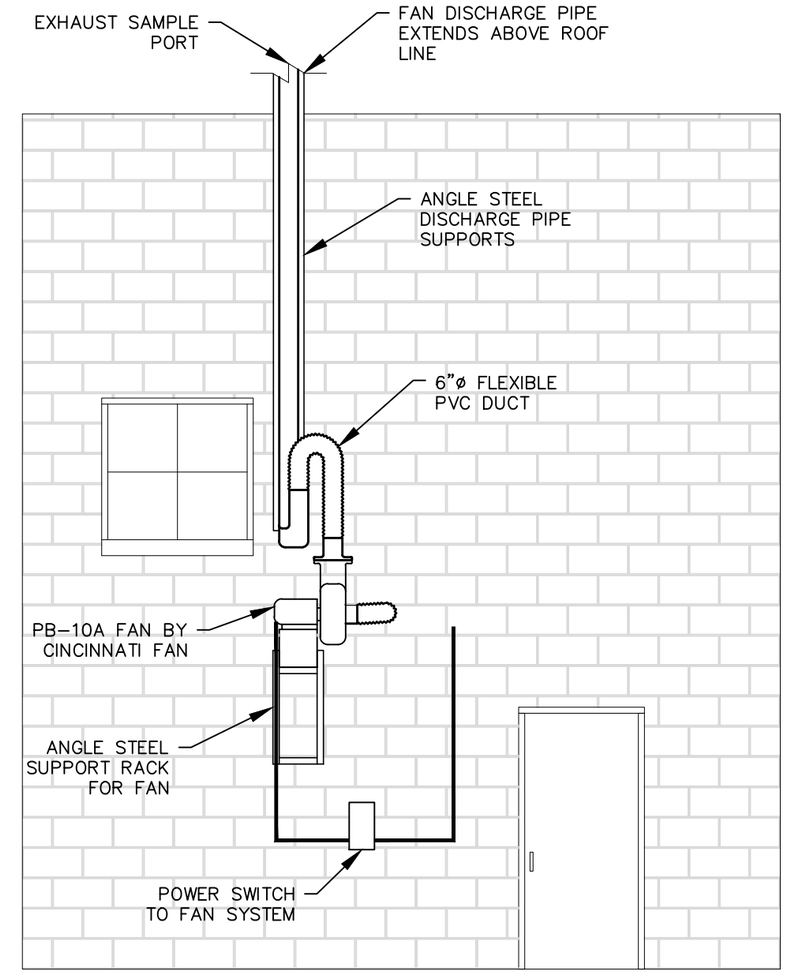
3 SECTION A-A
CARBON CANISTER DETAIL
SCALE: 1" = 4'

Three (3) tee connections are available on the 6-inch diameter manifold duct. One tee on the manifold duct is connected to the WEA air flow, one tee is connected to the EEA air flow and the third tee is capped off and available for a future installation if necessary. The manifold duct is situated approximately 8.5 feet above the concrete slab and is designed to carry the combined flows at approximately the same velocity as exists in the 4-inch diameter ducts (see Detail 3 on Figure 3 and Photograph 11).

The 6-inch diameter PVC manifold duct is connected to an Electro Industries Model EM-WX 10 Electric Heater using one (1) foot of flexible 6-inch diameter duct and using a 6-inch x 10-inch rubber reducer at the inlet. From the exit of the heater, approximately four (4) feet of 6-inch flexible duct and PVC ducting is connected to another 6-inch x 10-inch rubber reducer, where the air flow is then directed into one of the two (2) G-10P Steel Vapor Phase Carbon Canisters containing 600 pounds of Carbon Type CSV high capacity virgin carbon (CCLA No. 60). The canisters are supported approximately 1.2 feet above the concrete slab and are connected in series. A sample port was installed before the first carbon canister for measuring and sampling purposes (see Detail 3 on Figure 3 and Photographs 14 through 16).

Following the Activated Carbon System, the final 6-inch diameter PVC ducting system extends 28.5 feet and penetrates the exterior wall approximately nine (9) feet above the slab. Flexible ducting is attached to the end of the solid duct to direct the air flow into a Model PB-10A Cincinnati Fan. A condensation port is installed at the base of the fan to permit the periodic removal of condensation from the fan housing. Six (6) inch PVC ducting is connected from the fan to the outlet to additional flexible ducting, through two (2) 90° PVC elbows, creating a "U" in the duct to permit the capture of the majority of the condensation. The final duct extends vertically so that the emission point is approximately 11.4 feet above the roofline. The height of the stack was designed to conform to the recommendation in the NYSDEC Air Guide 1 that a stack discharging at 1.5 times the building height will avoid the emission entering the cavity which forms downwind of a building (see Detail 5 on Figure 3 and Photographs 17 through 20).

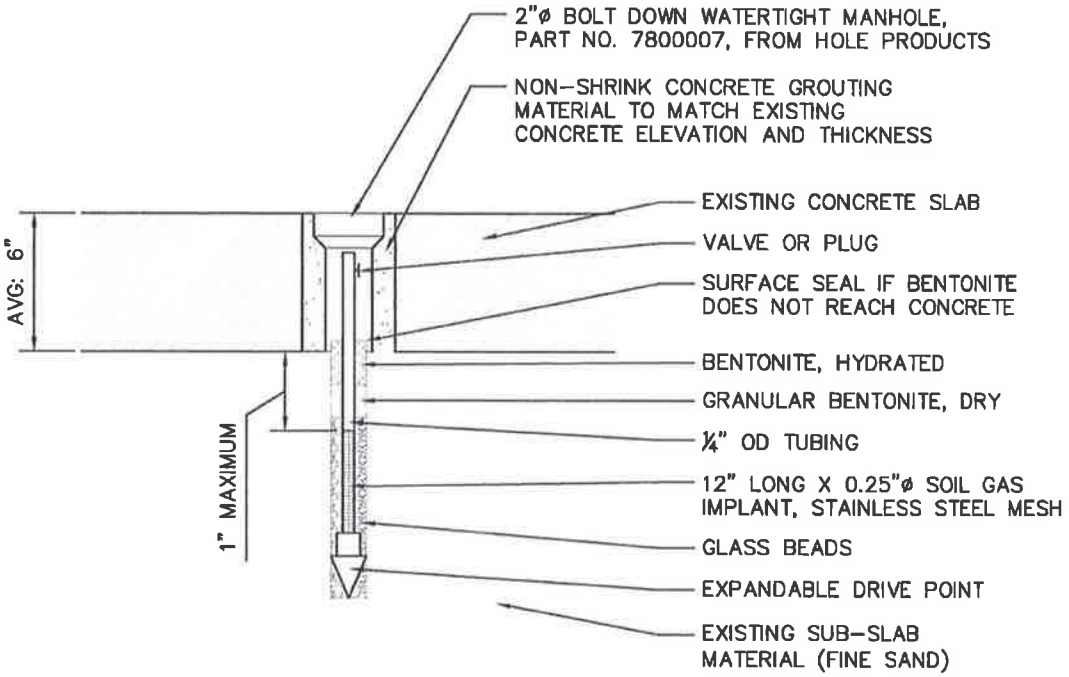
PROJ. No.: 2011-31	DATE: 3/28/16	SCALE: N.T.S.	DWG. NO. 2011-31105	FIGURE 5

The sub-slab soil vapor (permanent) sampling ports for the VMS were installed in mid-2014 by coring a 4-inch diameter hole through the existing concrete slab, measuring approximately 6-8 inches thick. Each sample port was installed at least five (5) feet from any exterior wall. A one-quarter (1/4) inch diameter soil-gas implant was installed below the concrete slab, allowing the 12-inch screened mesh to be entirely below the concrete slab. Glass beads were used to surround the implant below the slab to allow for soil vapor to be collected through the implant. The implant was sealed to the concrete slab using a non-volatile, non-shrinking bentonite to reduce the potential for infiltration of indoor air into the sub-slab during sub-slab vapor sample collection. A 2-inch bolt-down flush mount cover was installed at the same grade as the surface of the concrete slab to cap and protect the implant when not in use (see Figure 5 for details).

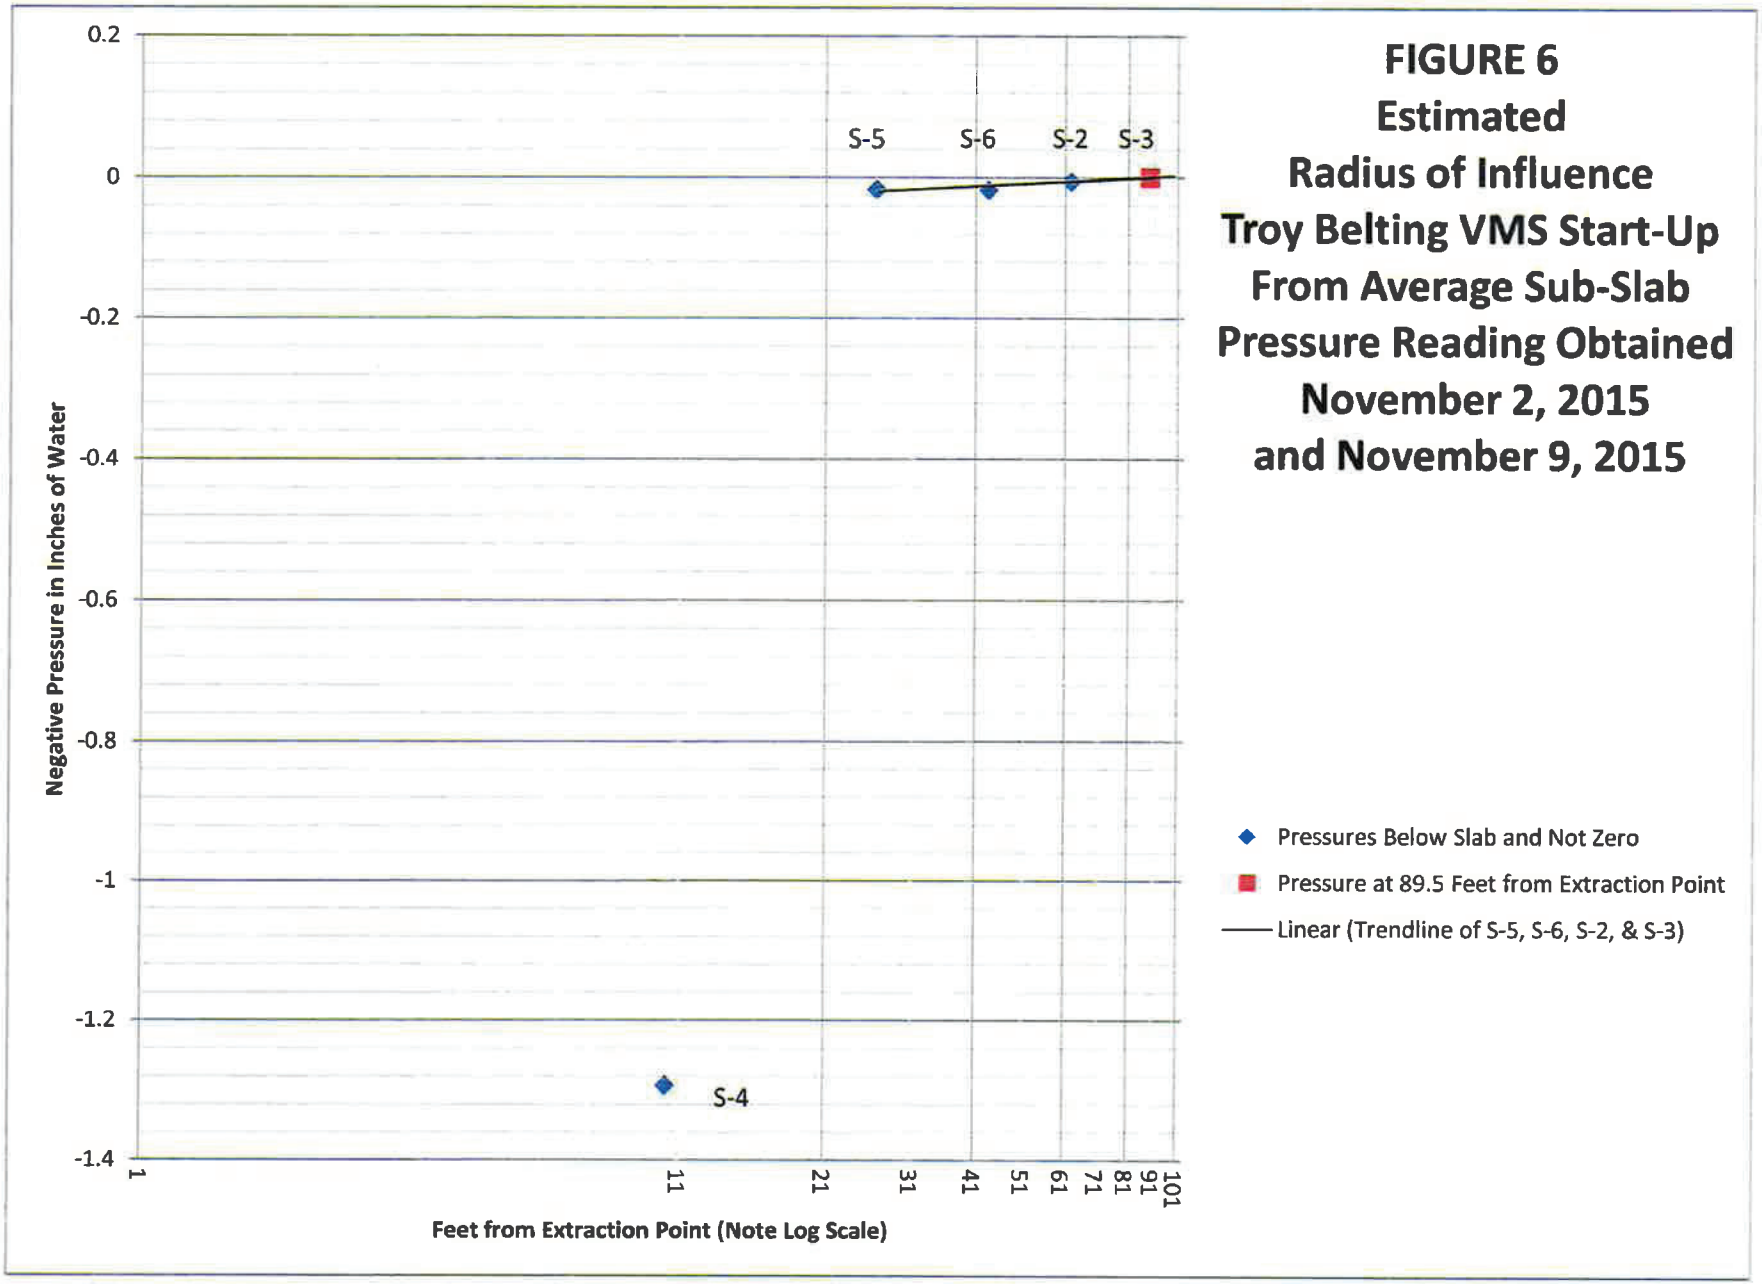
FIGURE 6
Estimated
Radius of Influence
Troy Belting VMS Start-Up
From Average Sub-Slab
Pressure Reading Obtained
November 2, 2015
and November 9, 2015

As a result of operating the fan at 100% power, the detectable negative pressures have extended as far as 62.9 feet from the EEA location (see Figure 6), increasing the radius of influence and creating a larger area for vapor extraction.

Table 1 provides the differential pressure readings at the sub-slab soil vapor sampling ports. Figure 6 provides the graph of negative pressure readings vs. distance to determine the estimated radius of influence of the VMS from the EEA withdrawal area. The trend line shown on Figure 6 indicates the radius of influence is approximately 81 feet from the EEA, corresponding to the distance where there is no discernable pressure differential.

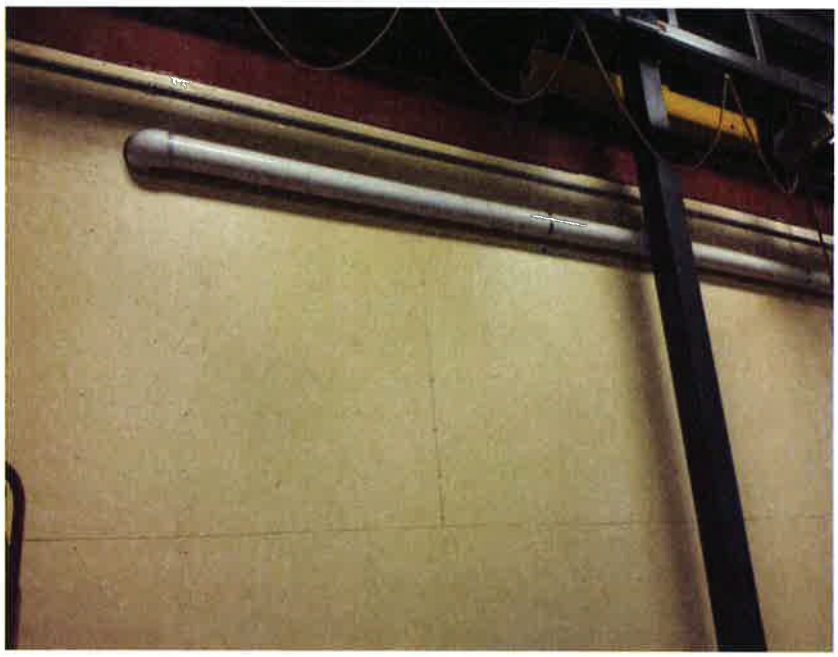
Photograph 8: View looking at the EEA duct extending from the right to the left of the photograph. The 90° elbow in the top left is observed to protrude through the 7-inch east wall, into the 6-inch manifold.

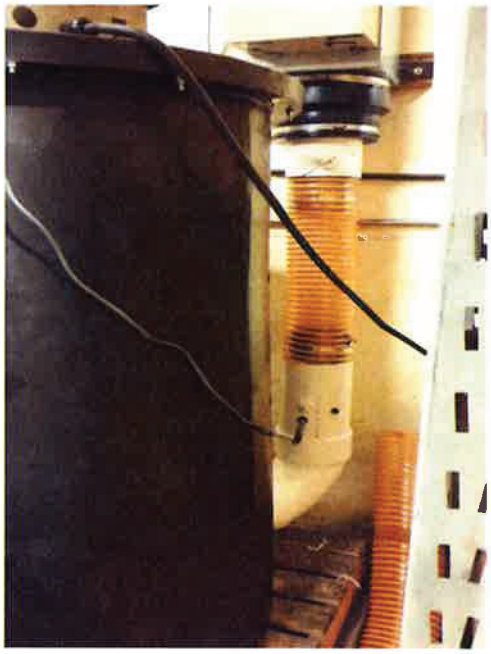
Photograph 15: View of the 6-inch flex duct connected to the 6-inch PVC duct at the outlet of the EM-HX 10 Electric Heater. A 90° PVC elbow is observed entering the inlet of the first G-10P carbon canister in the bottom of the photograph.

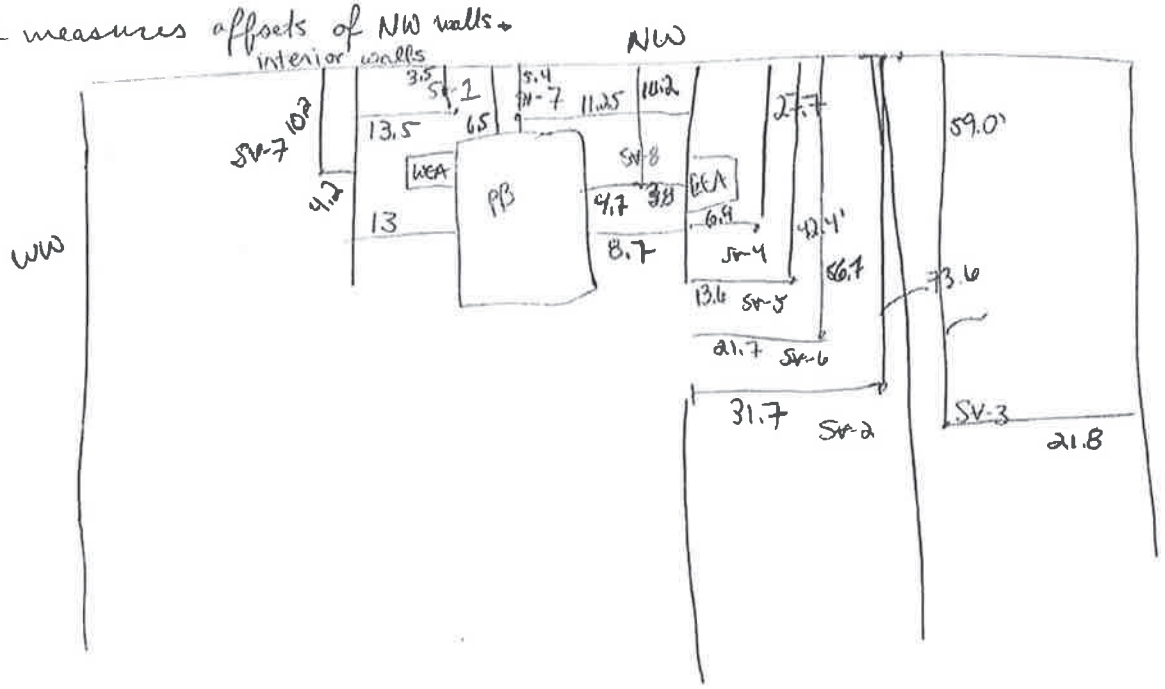
10am AC views crack near St-1 & paint booth. Crack appears to be sealed.

- Cracks sealed RTV Silicone per JH
