PERIODIC REVIEW REPORT

700 Out Parcel, LLC
701-709 East Water Street
Syracuse, New York 13202

NYSDEC Site No. C734111

Report Date
April 2, 2026

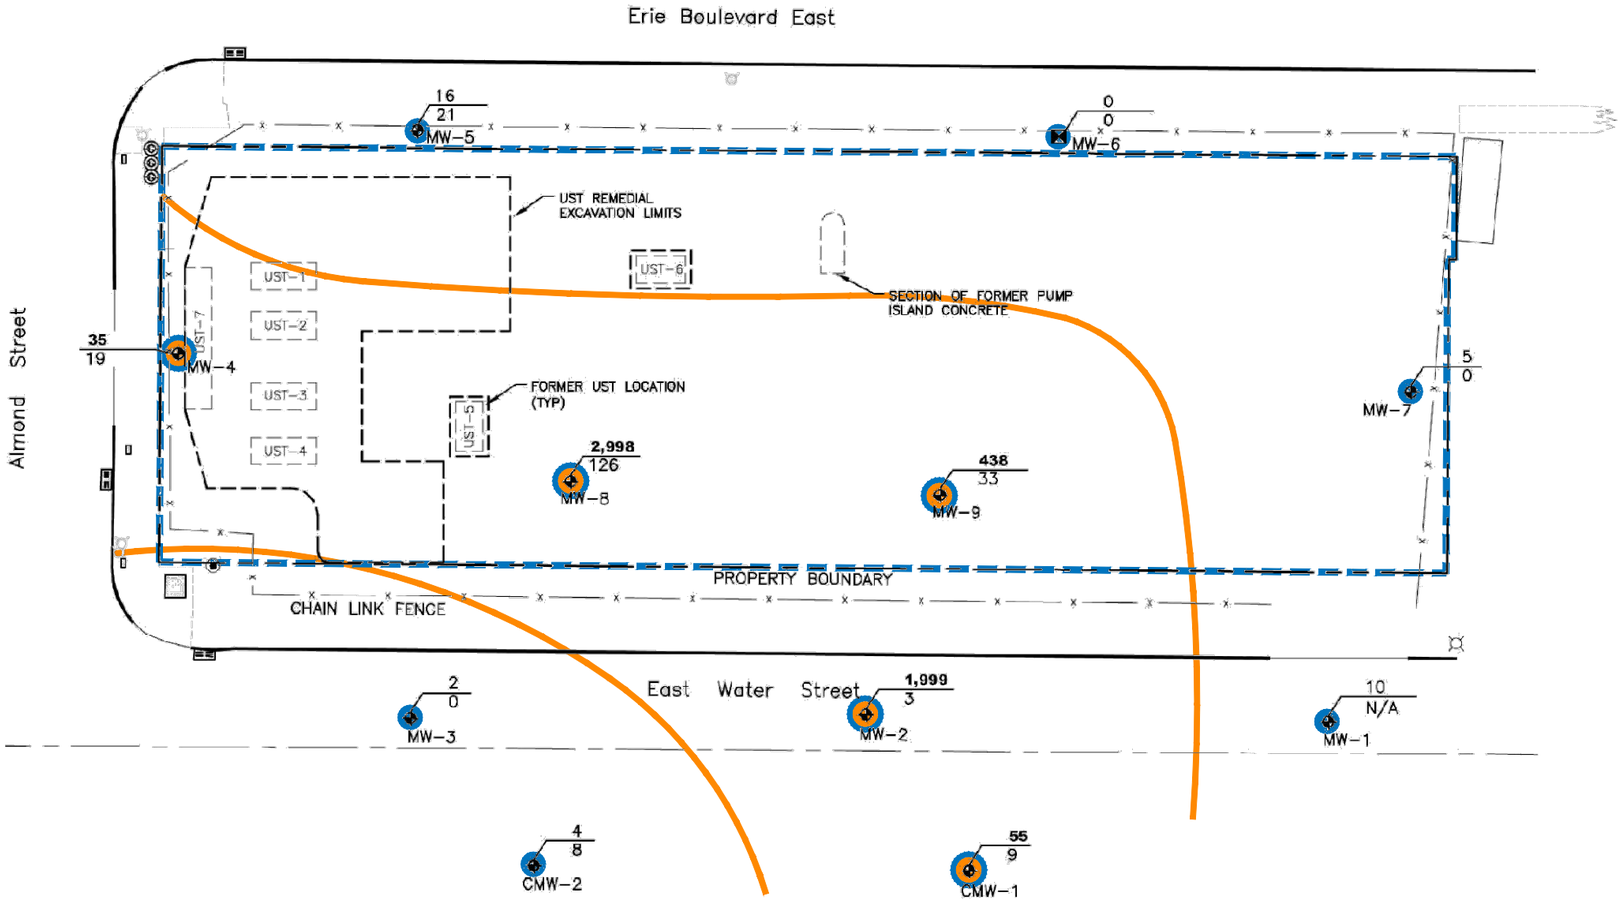
Note: MW-6 and MW-7 were damaged/lost and could not be gauged and are not included in this contour map.
