Phase II Environmental Site Assessment

Latimer Terrace Apartments
301- 311 East Taylor Street, Syracuse, New York 13202

April 2024
C&S Project#: AI8.001.002

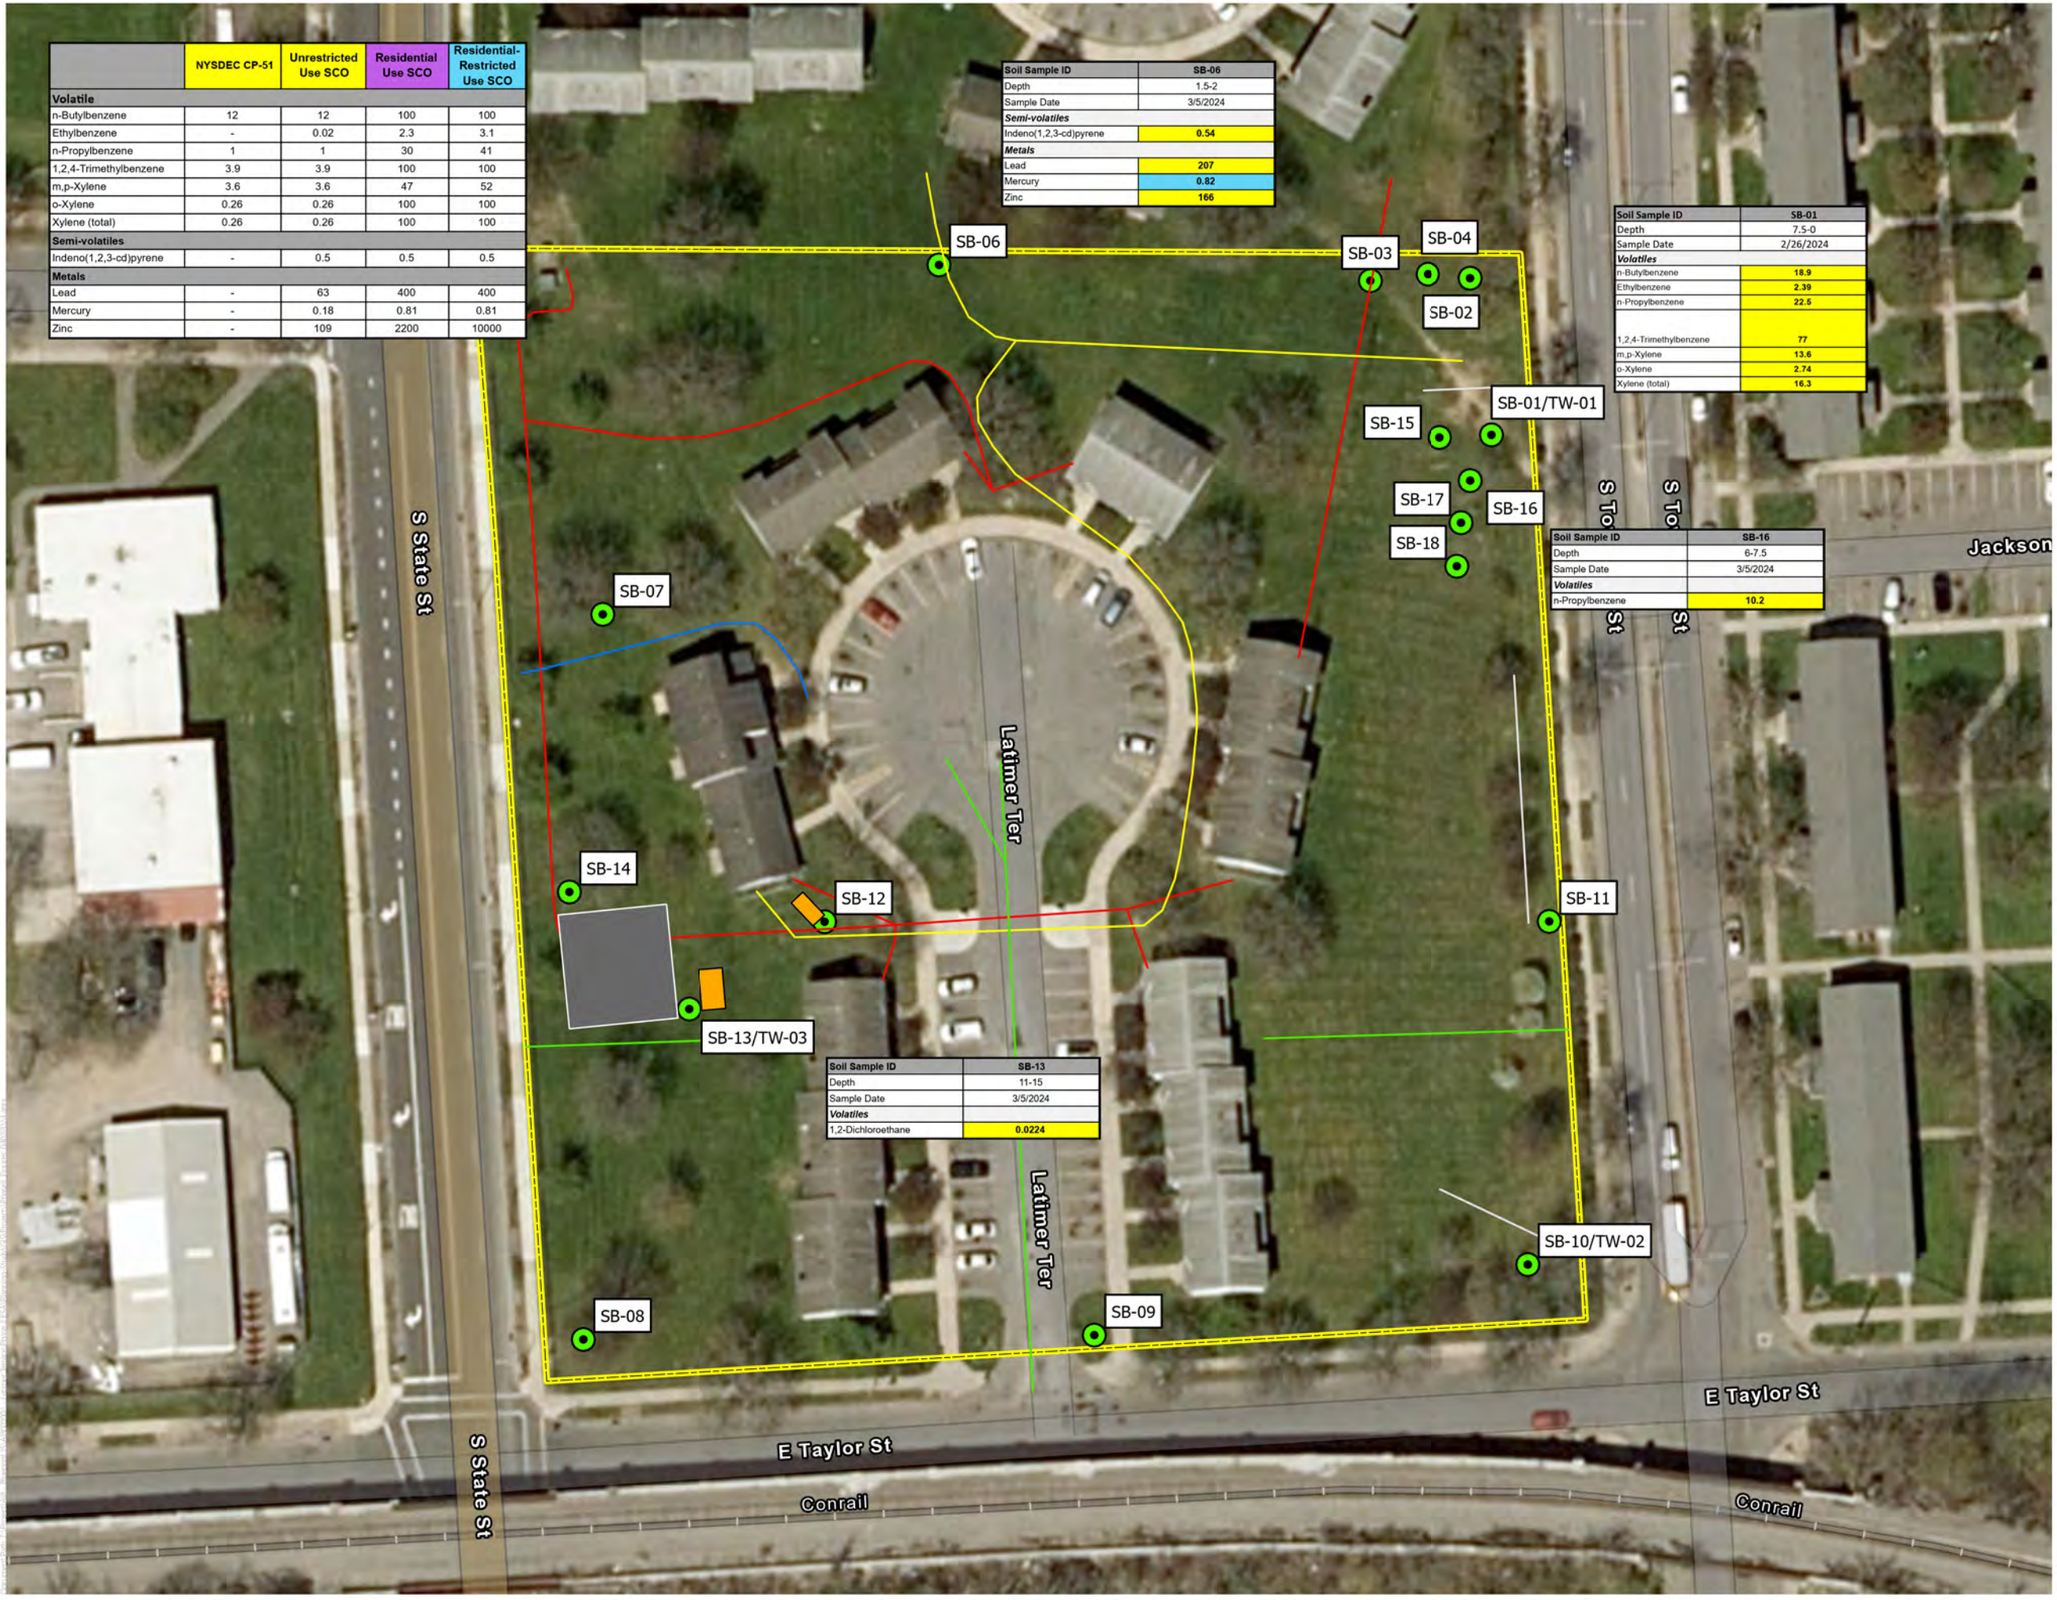
Figure 2

Soil Sample ID	SB-16
Depth	6-7.5
Sample Date	3/5/2024
Volatiles	
n-Propylbenzene	**10.2**

Soil Sample ID	SB-13
Depth	11-15
Sample Date	3/5/2024
Volatiles	
1,2-Dichloroethane	**0.0224**

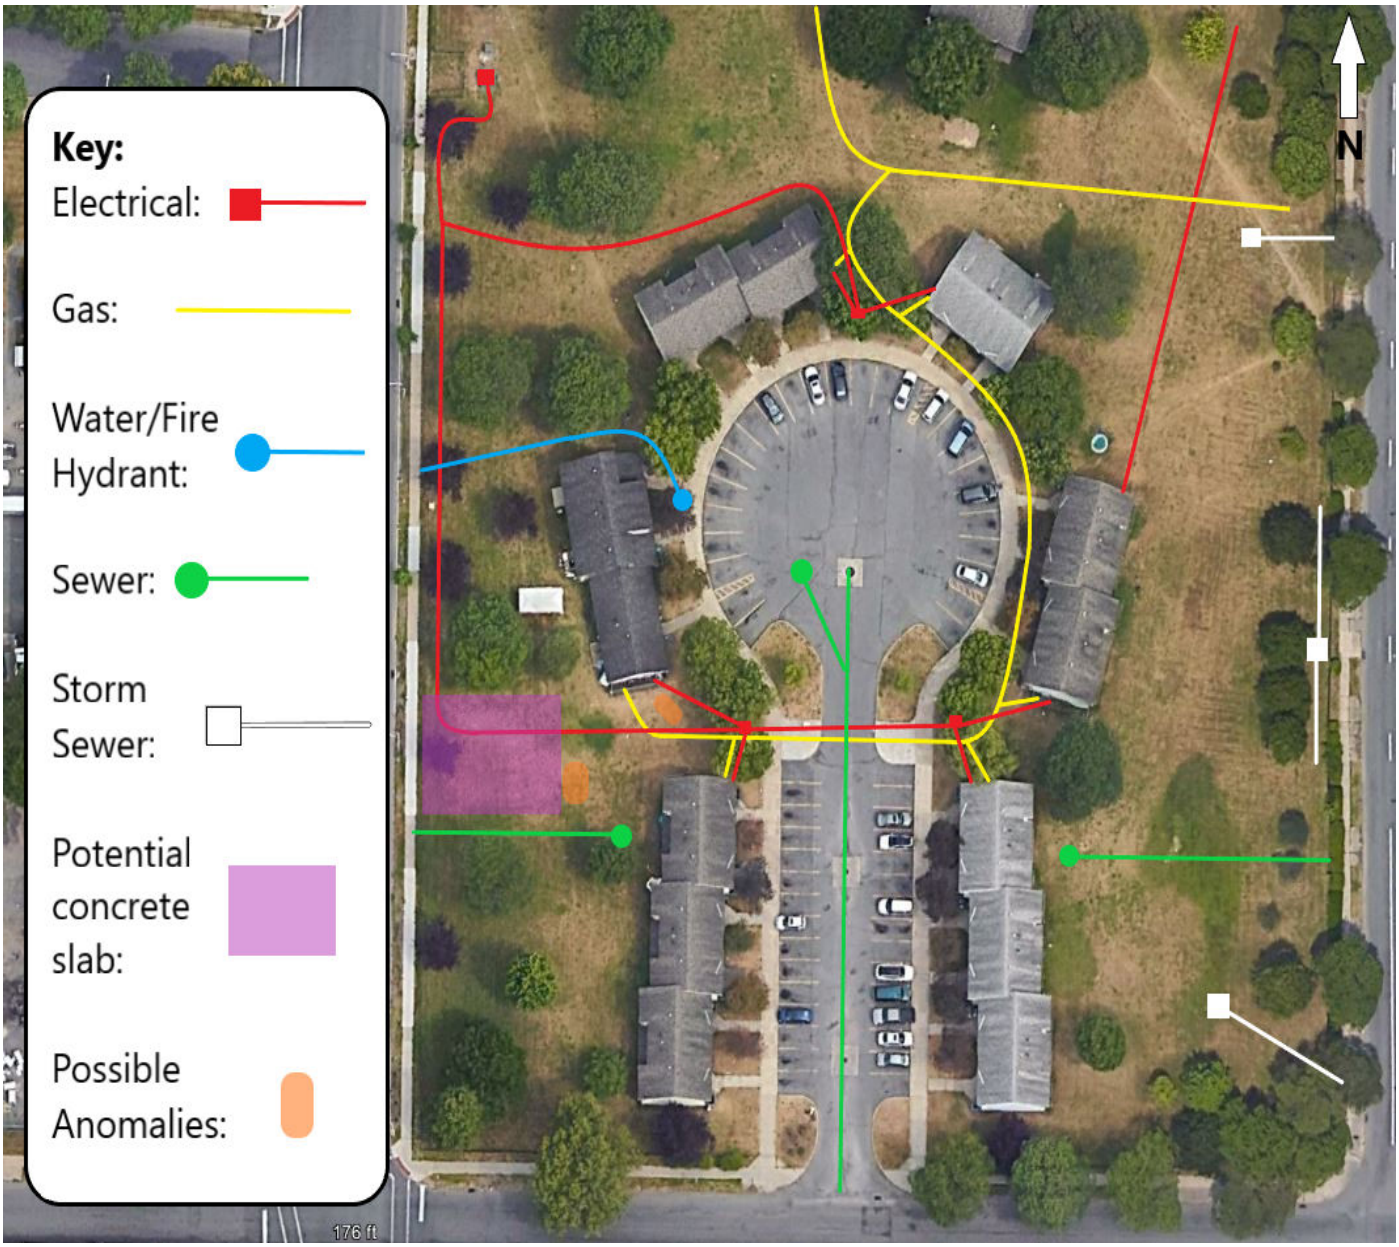
Key:
Electrical:
Gas:
Water/Fire Hydrant:
Sewer:
Storm Sewer:
Potential concrete slab:
Possible Anomalies:
N
176 ft

Multiple Utilities were located across the site, refer to the attached site map for their locations. The water service to the complex was unable to be located, this is most likely due to the line being a poly material with no-tracer wire or other means of location being attached. The water line for the on-site fire hydrant was located, refer to attached site map. No anomalies or other structures were observed when performing the GPR survey across the Northeastern corner of the site. When performing the GPR survey on the Western portion of the site, several areas of interest were identified.

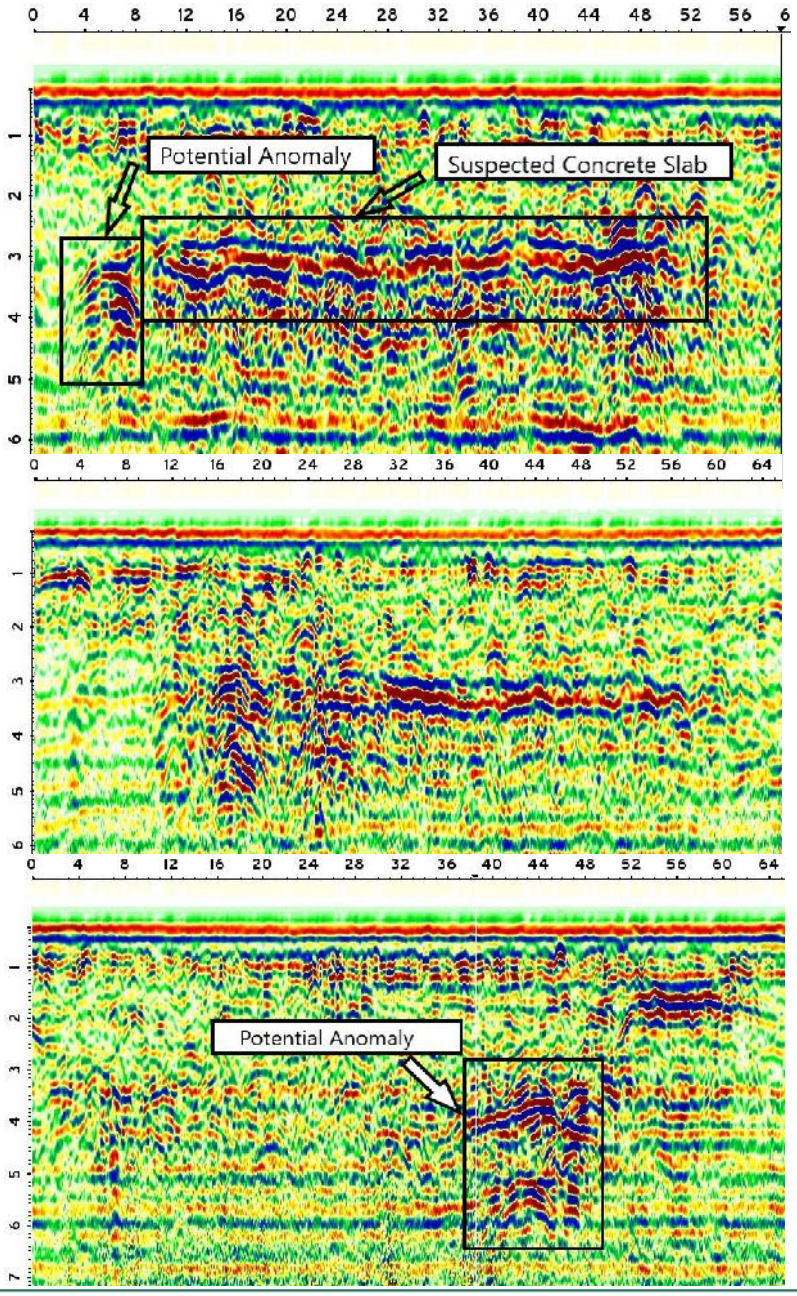
Potential Concrete Slab and Anomaly:

These screen grabs were all taken during the GPR survey on the Western portion of the site. The first two images are scans reading East to West (Left to Right on the image), while the third image is a scan North to South. The first two images clearly depict a densely compacted zone approximately 6 inches thick, around 3 feet below ground surface (bgs) which is suspected to be a concrete slab from previous site activities. The approximate dimensions of the slab were noted to be 50ft by 50ft. The anomaly shown off the suspected slab does show some similarities to an underground storage tank (UST). The two features showing it may be a UST are the defined rounded top seen best in the first image, as well as the semi-flat feed back when scanned parallel over the top of the anomaly, shown in image 3. This anomaly was noted to be approximately 10ft long by 4ft wide. Image 2 shows

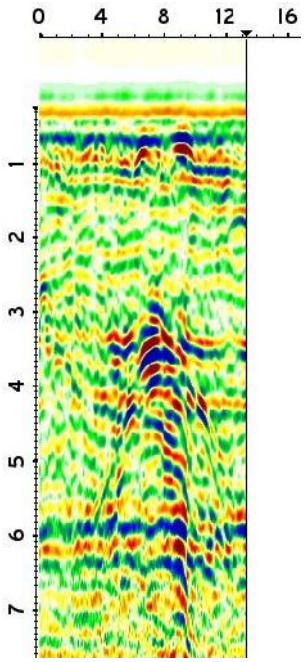
Second Anomaly

This cross section was taken running perpendicular to the easternmost anomaly that was detected, refer to the site map for the location. The anomaly was located between the electrical and gas services for the nearby apartment building. This anomaly was much smaller in size compared to the previously mentioned anomaly with an approximate area of 3ft by 6ft. The 2D scans does shown possible indicators of a UST such as the smooth top shown here.

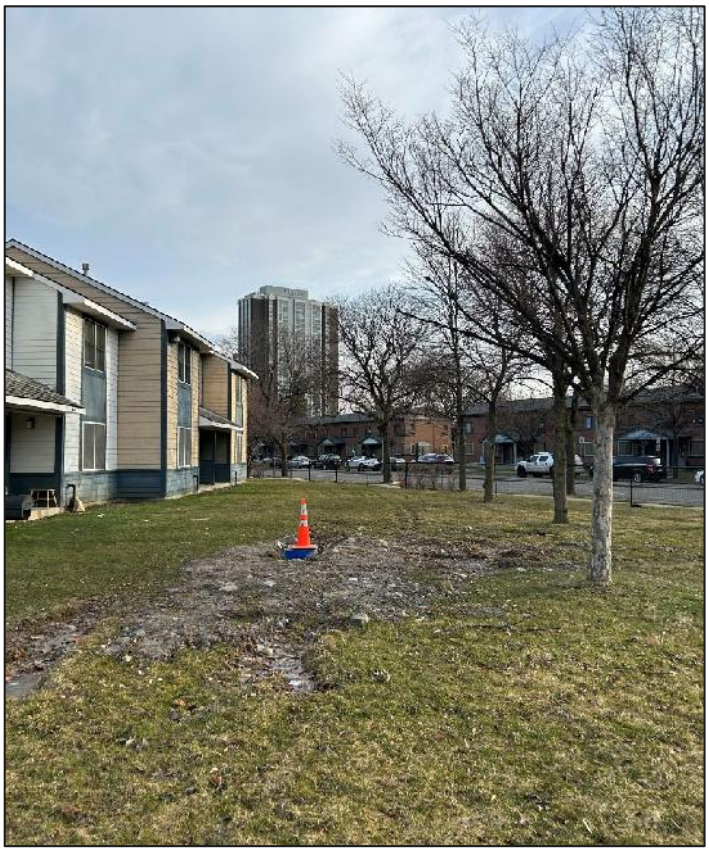
Photo: 11

Description:
View toward S. Townsend Street (northeast); MW-1 location visible beneath traffic cone.

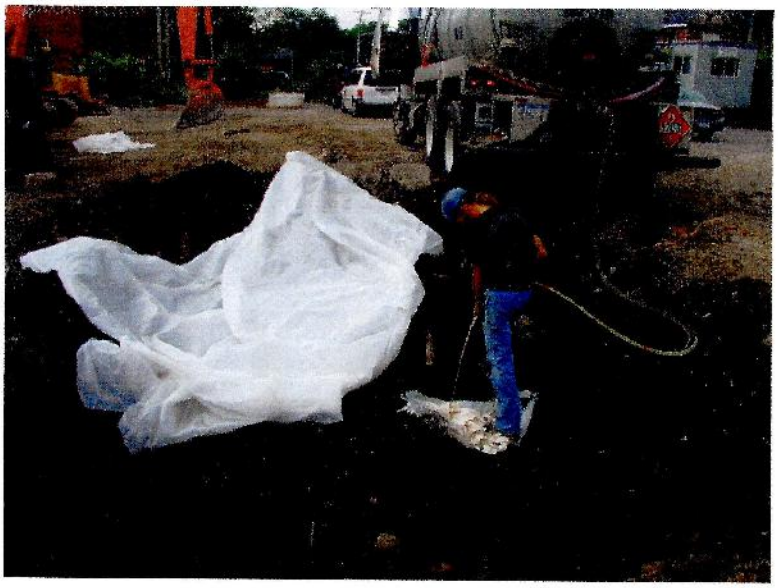
Photo 2: Photograph looking south into the South State Street Side UST (UST-001) excavation. Worker removing UST contents with a vacuum truck.

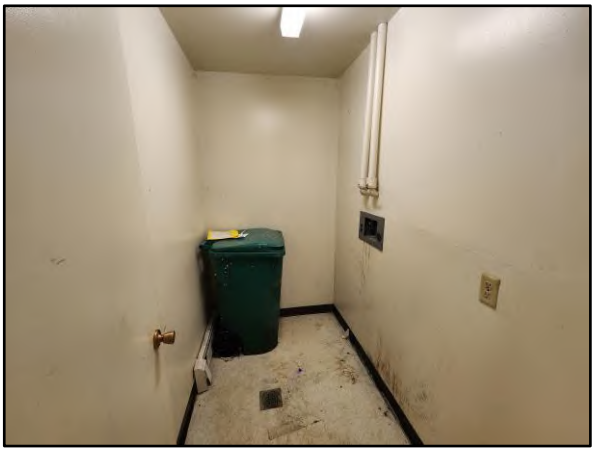
Typical first-floor storage room located under stairs to the second floor
