PHASE II ENVIRONMENTAL SITE ASSESSMENT REPORT

East Adams Redevelopment - Phase VI Area
Radisson Court
Syracuse, New York

December 3, 2025
170875901

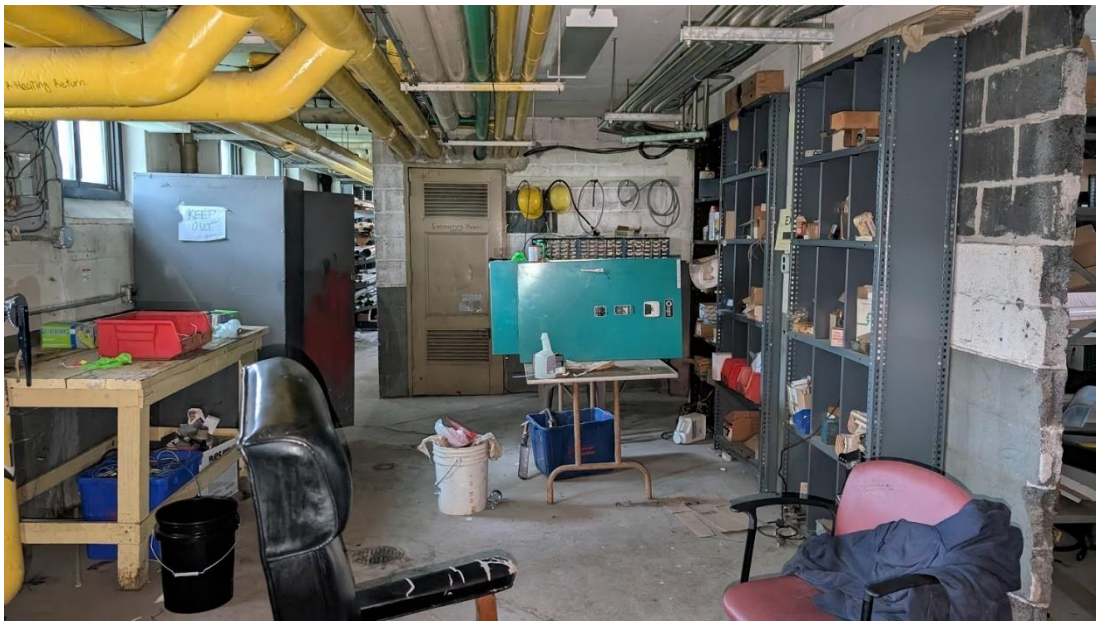
Date	Photo No.
6-24-25	18.

View of the basement in Building 2.

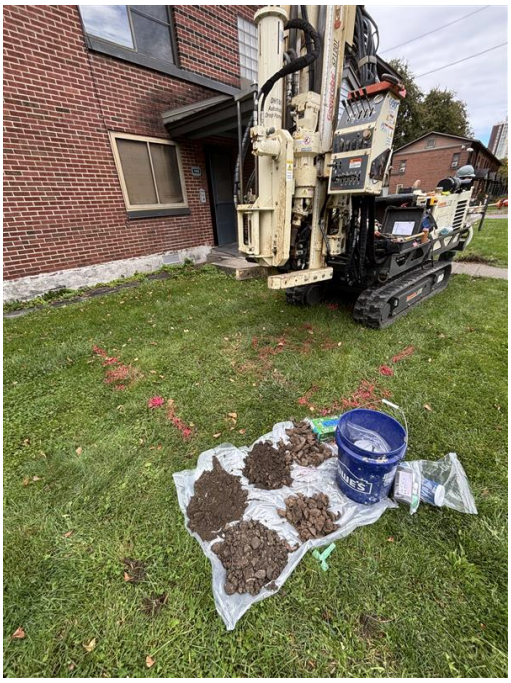
View of utility mark-outs at soil boring P6SB04.
