ASBESTOS/METALS SURVEY
at the

GLASS PLANT
BUILDING 12
ROCHESTER, NEW YORK

October 18 - 20, 1993

PARADIGM ENVIRONMENTAL SERVICES, INC.

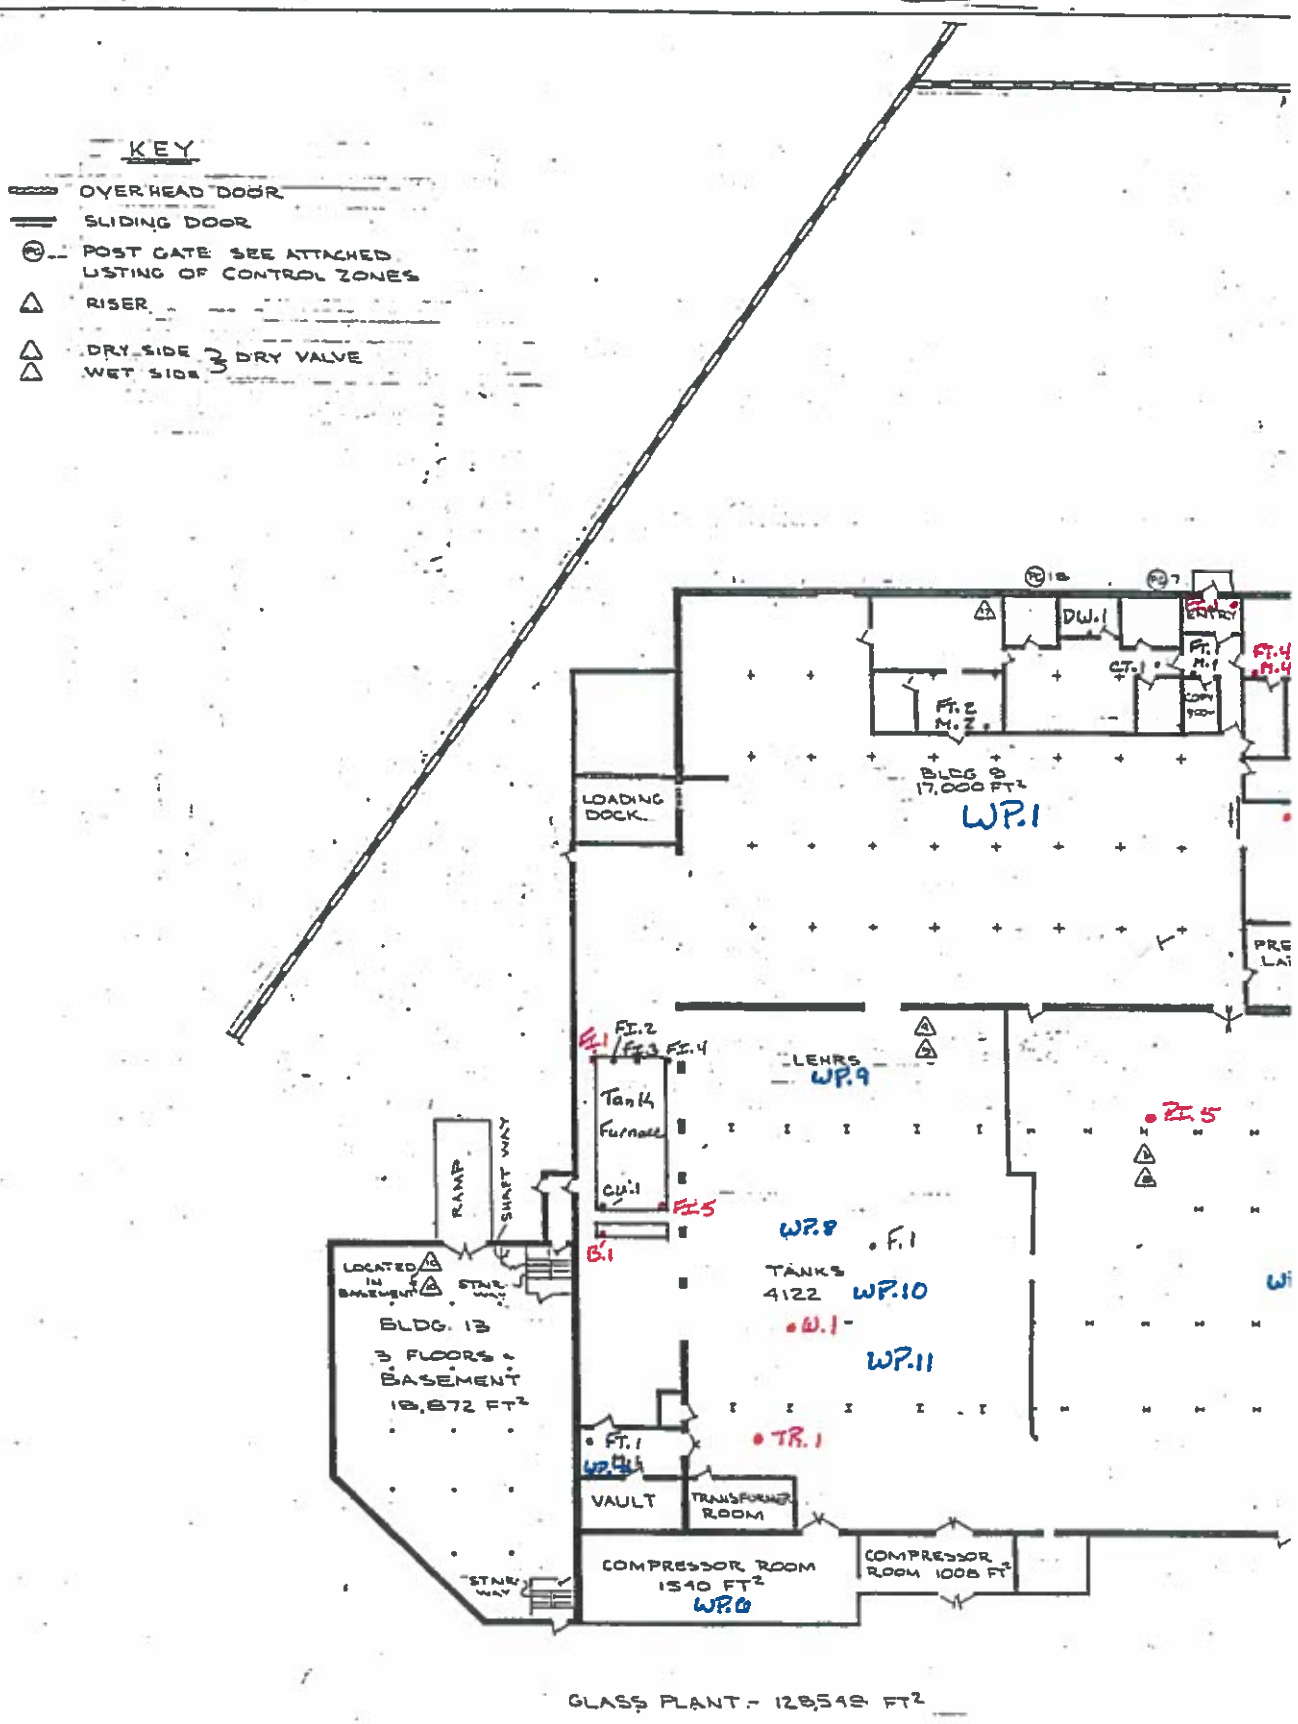
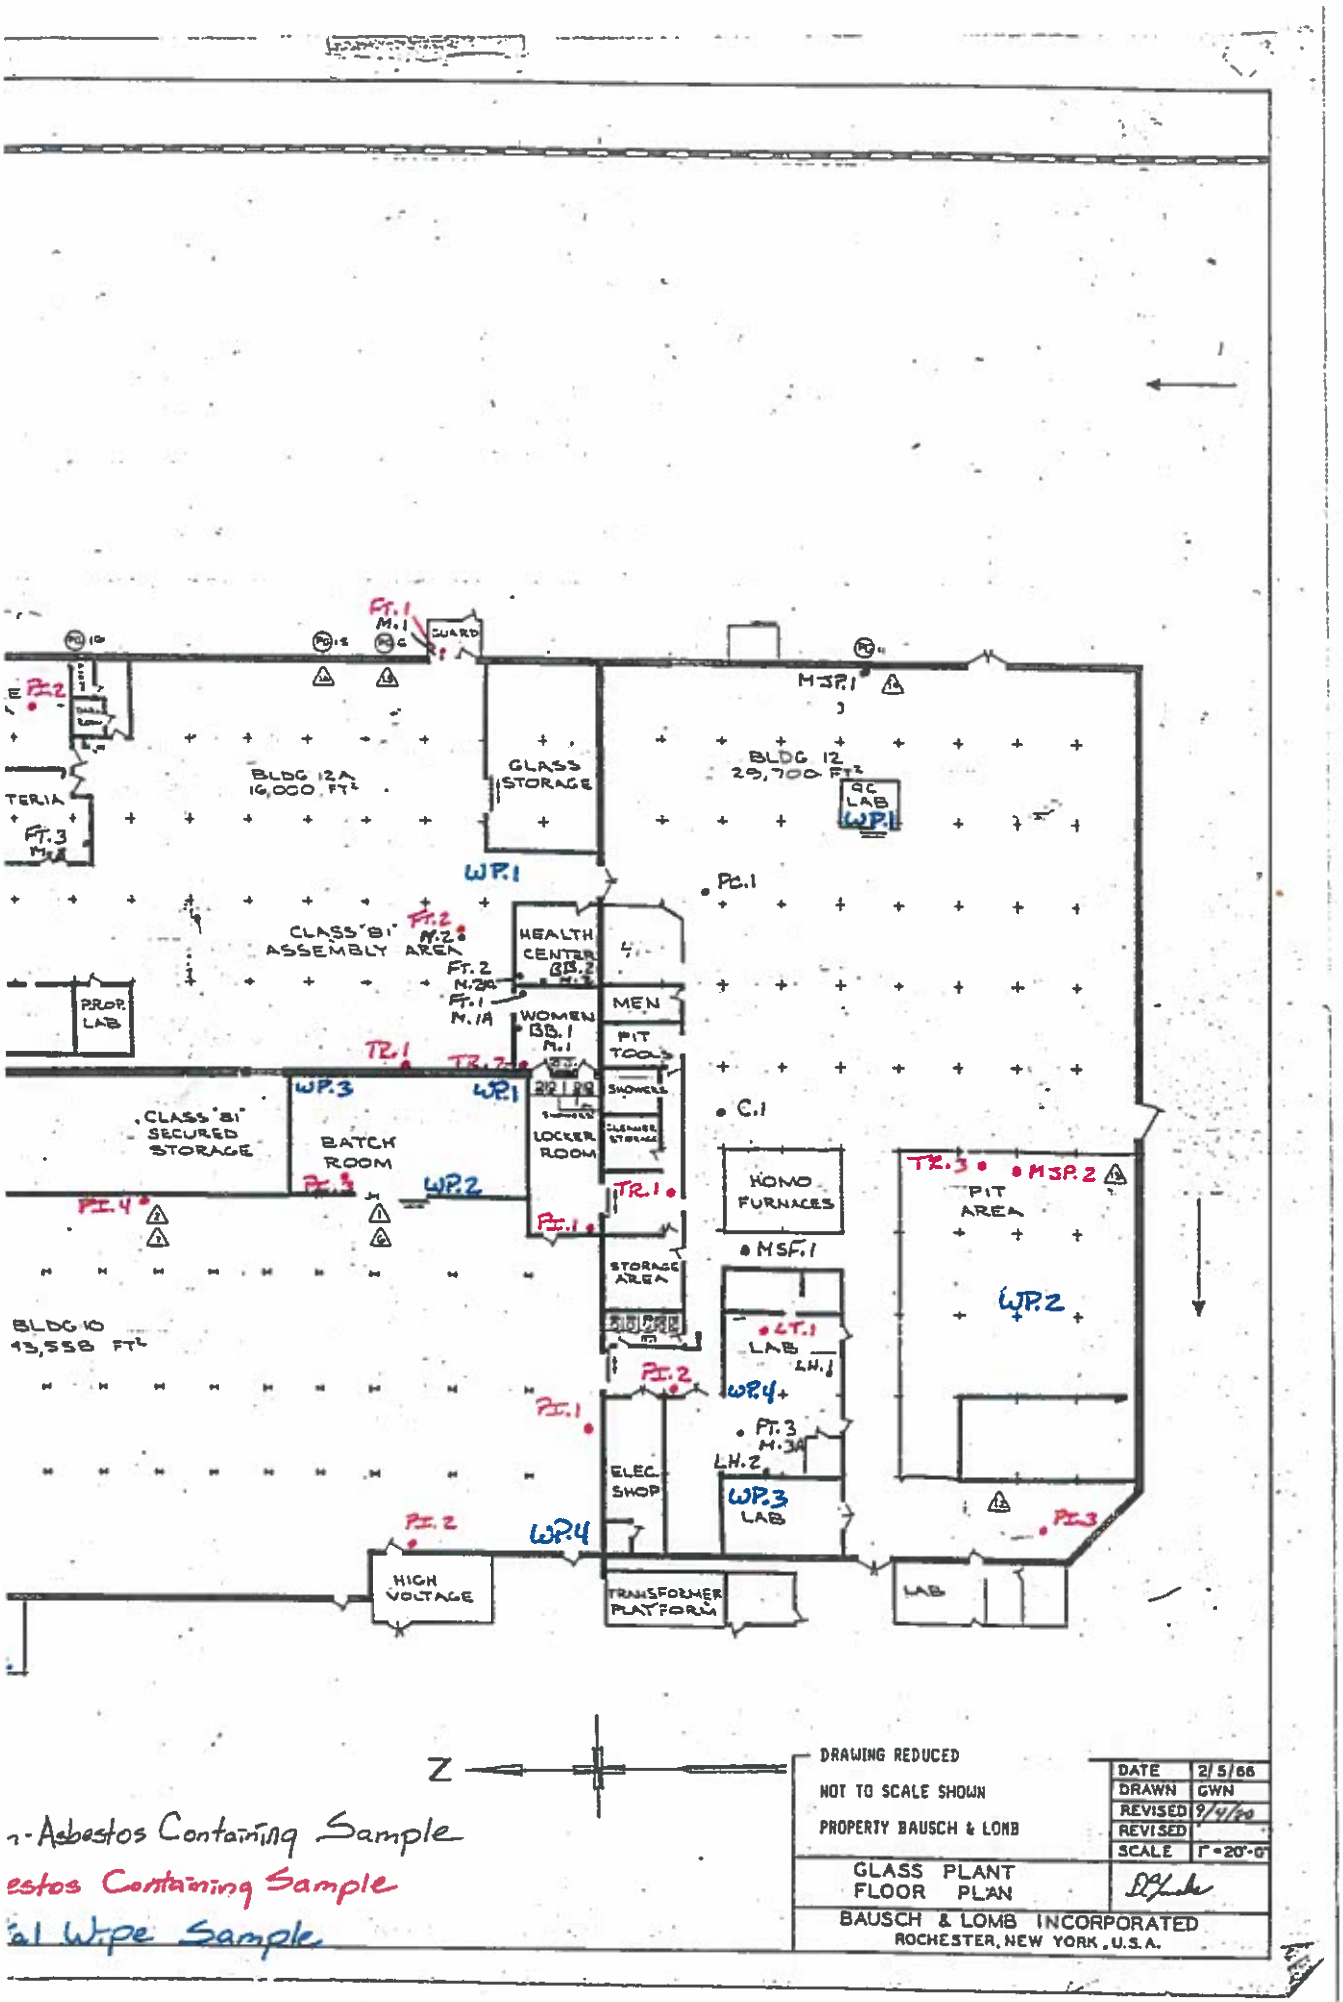
KEY
OVER HEAD DOOR
SLIDING DOOR
POST GATE SEE ATTACHED LISTING OF CONTROL ZONES
RISER
DRY SIDE 3 DRY VALVE
WET SIDE
LOADING DOCK
BLDG 9
17,000 FT²
WP.1
DW.1
CT.1
Fl.2
Fl.3
Fl.4
LEHRS
WP.9
Tank
Furnace
CU.1
Fl.5
B.1
WP.8
F.1
TANKS
4122
WP.10
W.1
WP.11
TR.1
RAMP
SHAFT WAY
LOCATED IN BASEMENT
STAIR WAY
BLDG. 13
3 FLOORS + BASEMENT
18,872 FT²
VAULT
TRANSFORMER ROOM
COMPRESSOR ROOM
1540 FT²
WP.6
COMPRESSOR ROOM 1008 FT²
GLASS PLANT - 128,548 FT²
KEY: Black Lettering
Red Lettering
Blue Lettering

1-Asbestos Containing Sample
