Periodic Review Report

Fmr. American Linen Supply Company Site

BCP Site No. C915241
822 Seneca Street

April 2018 0126-018-003

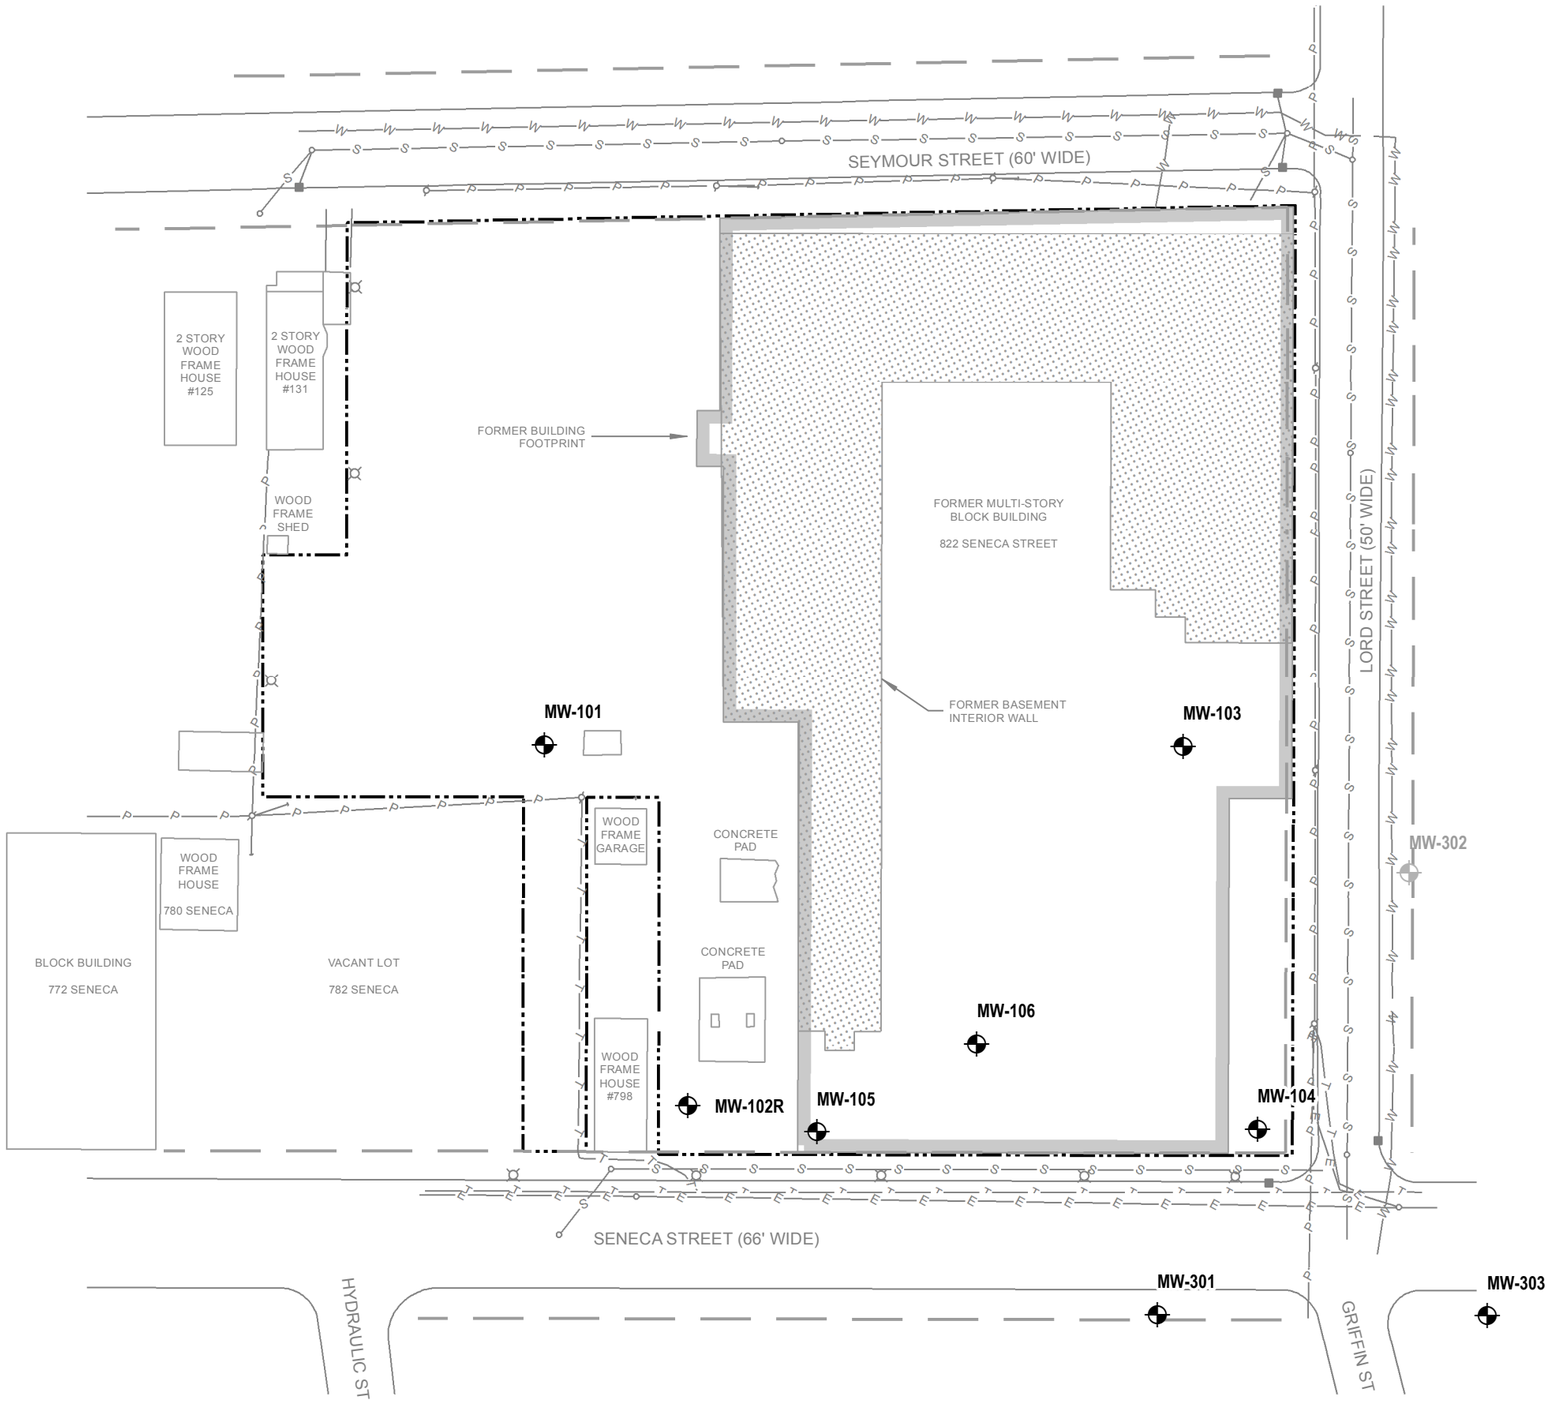
FIGURE 1

Groundwater sampling was performed by Haley & Aldrich for AmeriPride Services, Inc. on 11 July 2017, in accordance with Section 3.3 of the SMP. Monitoring wells MW-101, MW-102R, MW-103, MW-105, MW-106, MW-301, and MW-303 (see Figure 1) were sampled. MW-302 was formerly in the program but was likely destroyed during construction and paving of an adjacent property across Lord Street. The NYSDEC approved removal of well MW-302 from the sampling program on 5 May 2016. Well locations and site features are detailed on the attached site plan, Figure 1.

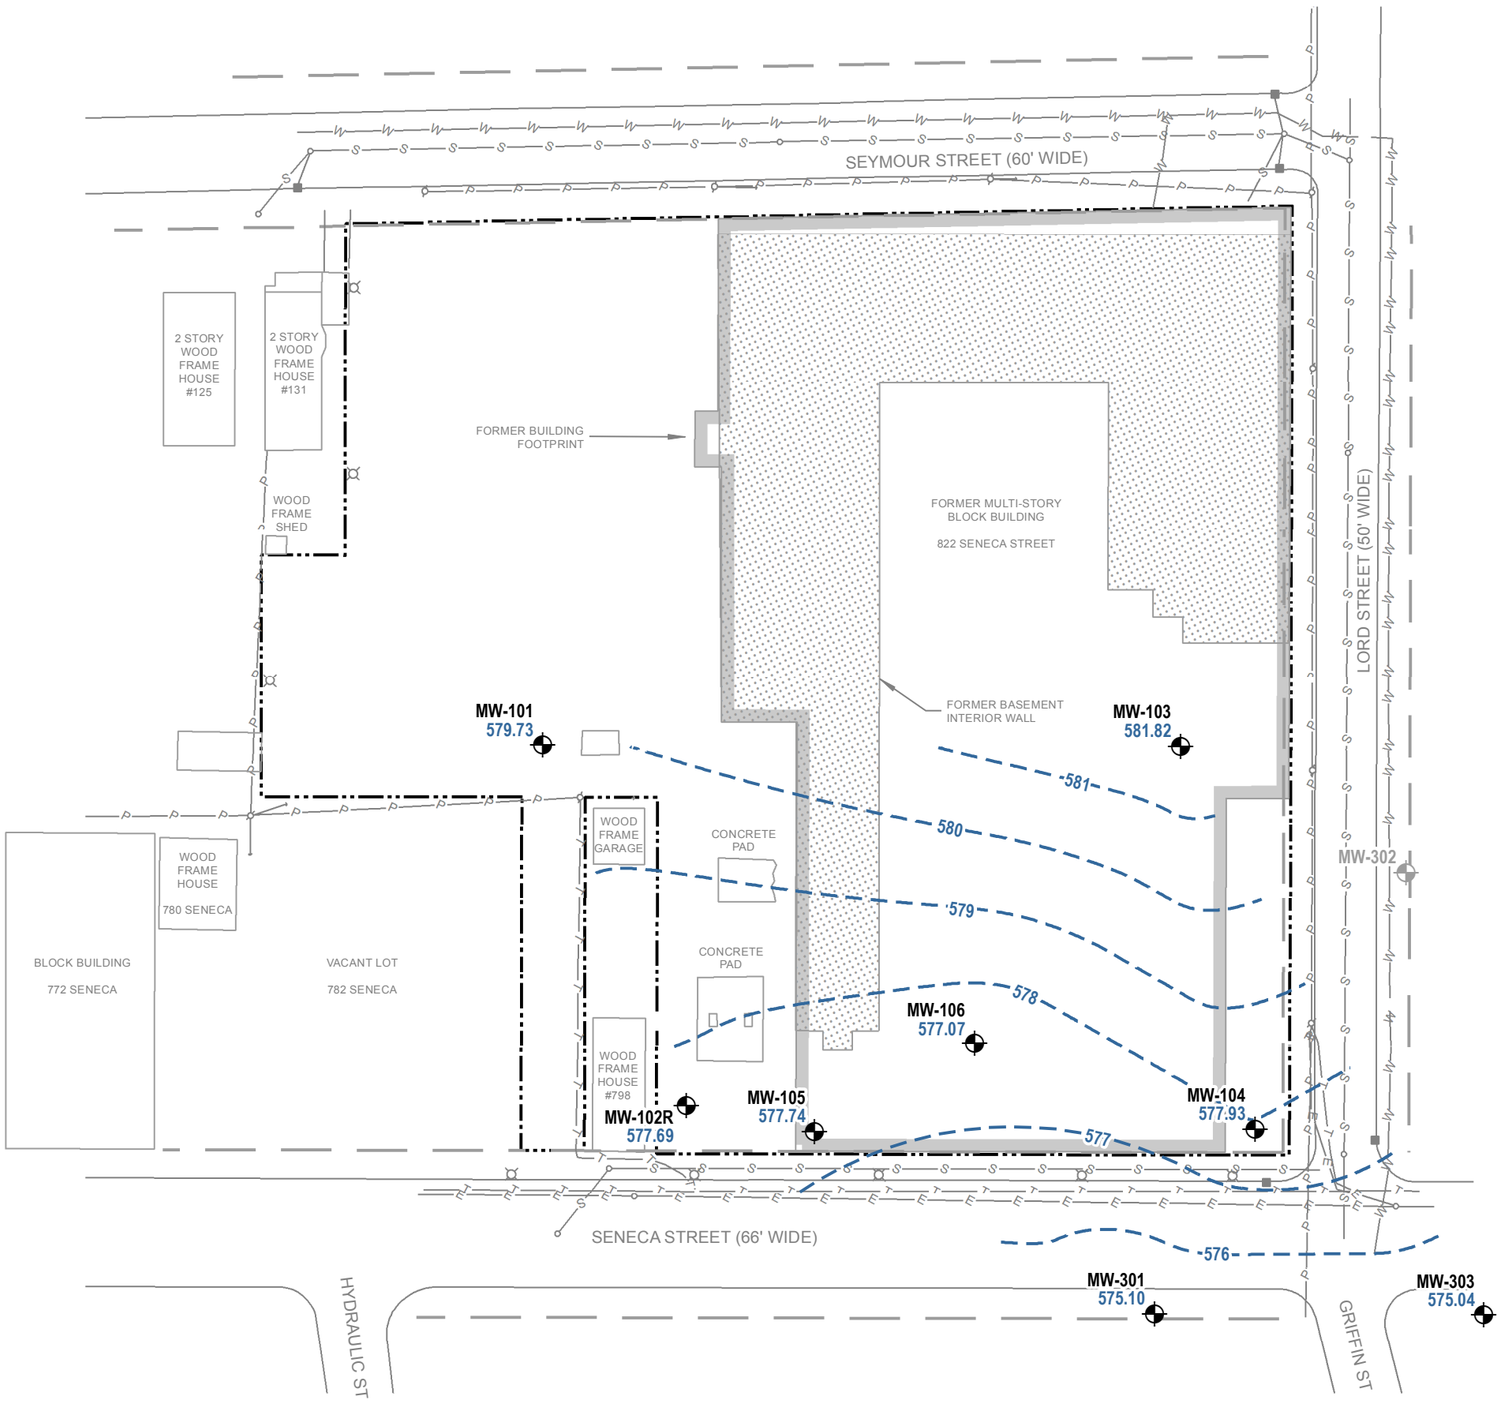
At the start of the sampling event, the depth to groundwater was measured in the wells listed above. The depth to groundwater measurements were used to prepare groundwater contours for the 2017 event, which are shown on Figure 2. Groundwater appears to be flowing in a south-southwest direction, which is a slight shift to the west compared to previous events; though still generally consistent with historical data. The integrity of each well was assessed and the wells appeared to be in good condition and well maintenance and/or repairs were not identified based on observations made during the 2017 event.
