Phase I Environmental Assessment

Kensington Heights, 1827 North Fillmore, Buffalo NY

March 2008

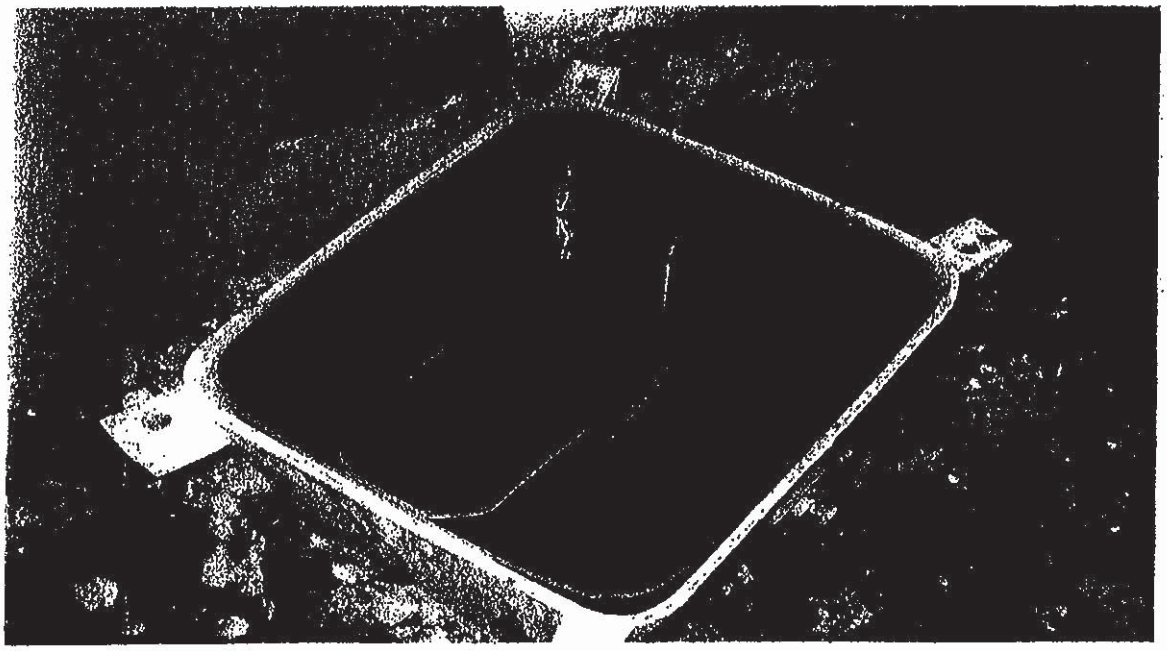
Items that are suspected of containing PCB's were observed on the site during the inspection. The electrical transformers had been vandalized and the oil was spilled on the concrete floors in the basement.

PCB Contamination and Tank

PCB Oil filled tramsformer

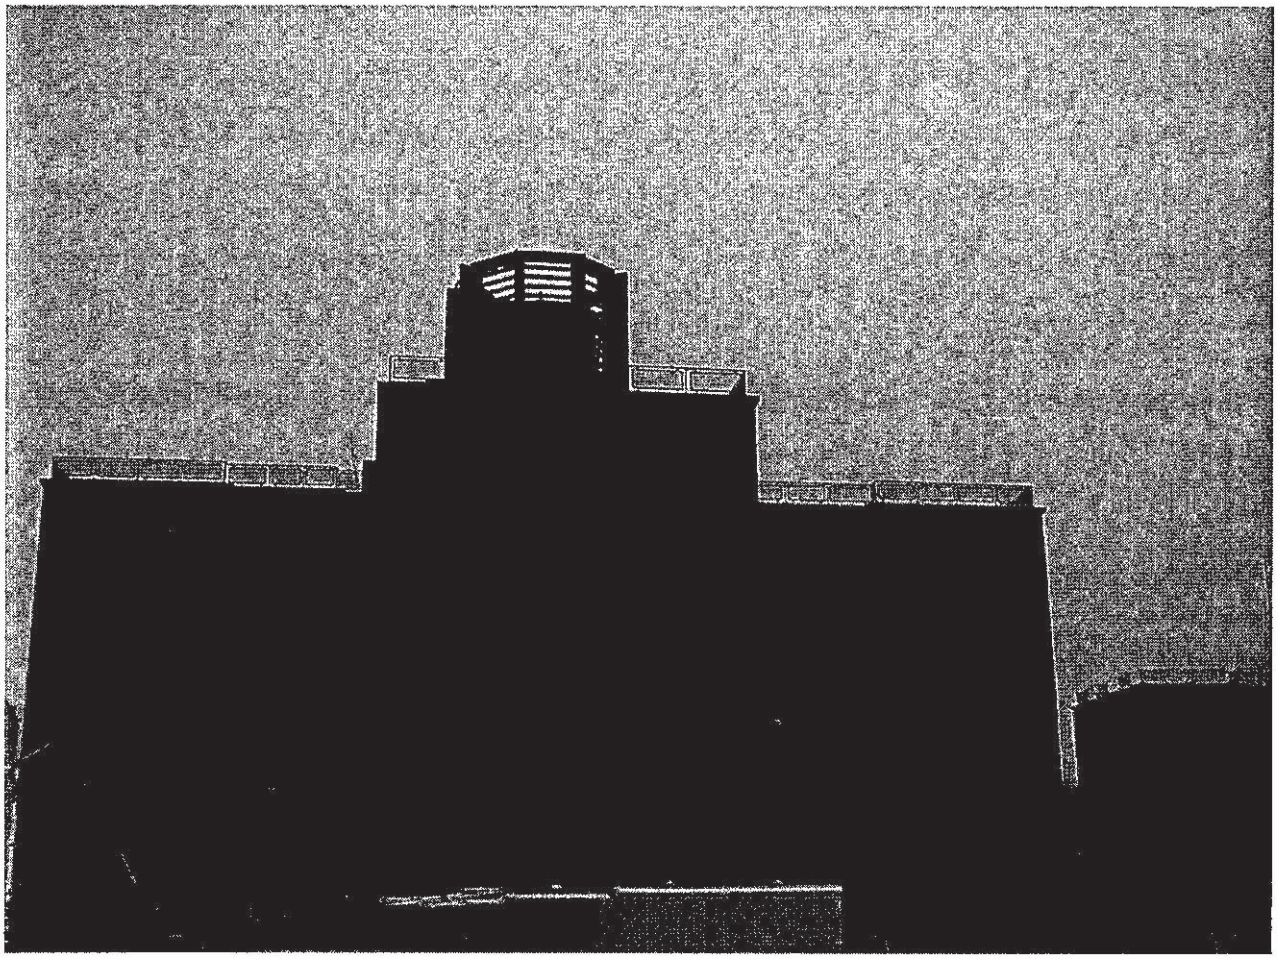
Building B-4: Photo taken from Southeast side of site looking Northwest.

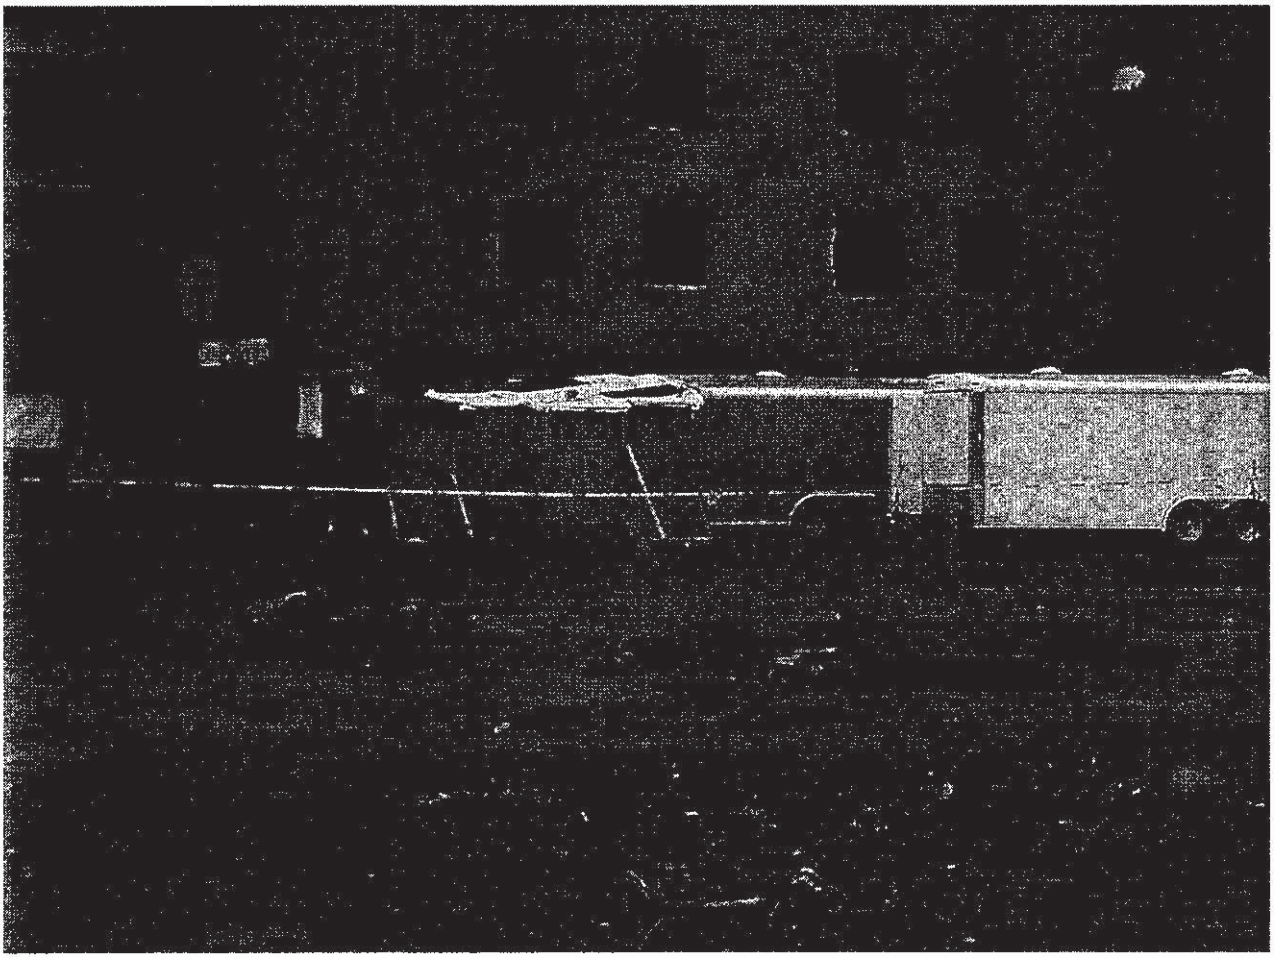
Contractor is prepping the building by removing non-hazardous material from the building. Abatement is scheduled to begin November 30, 2009.

Existing meter pit East of Bldg B-4

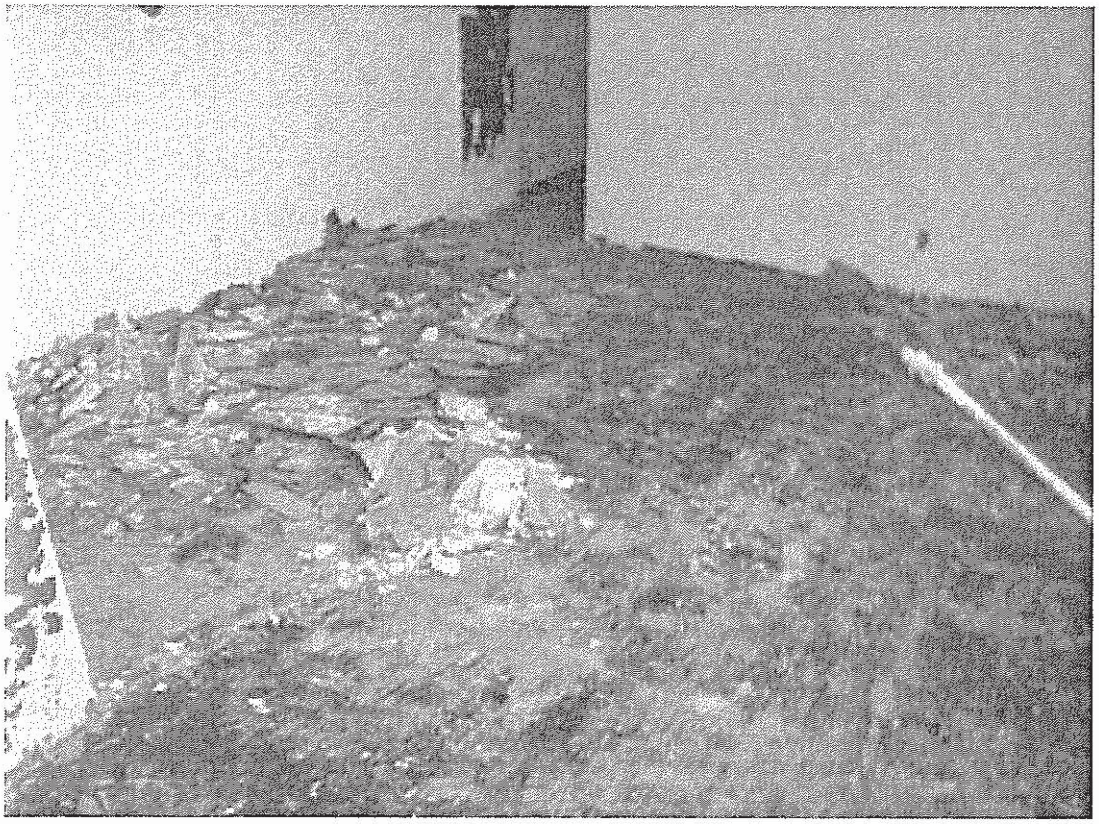
Inside view of existing storm sewer: brick-type construction

Building B-2 - 9x9 tile abatement progress

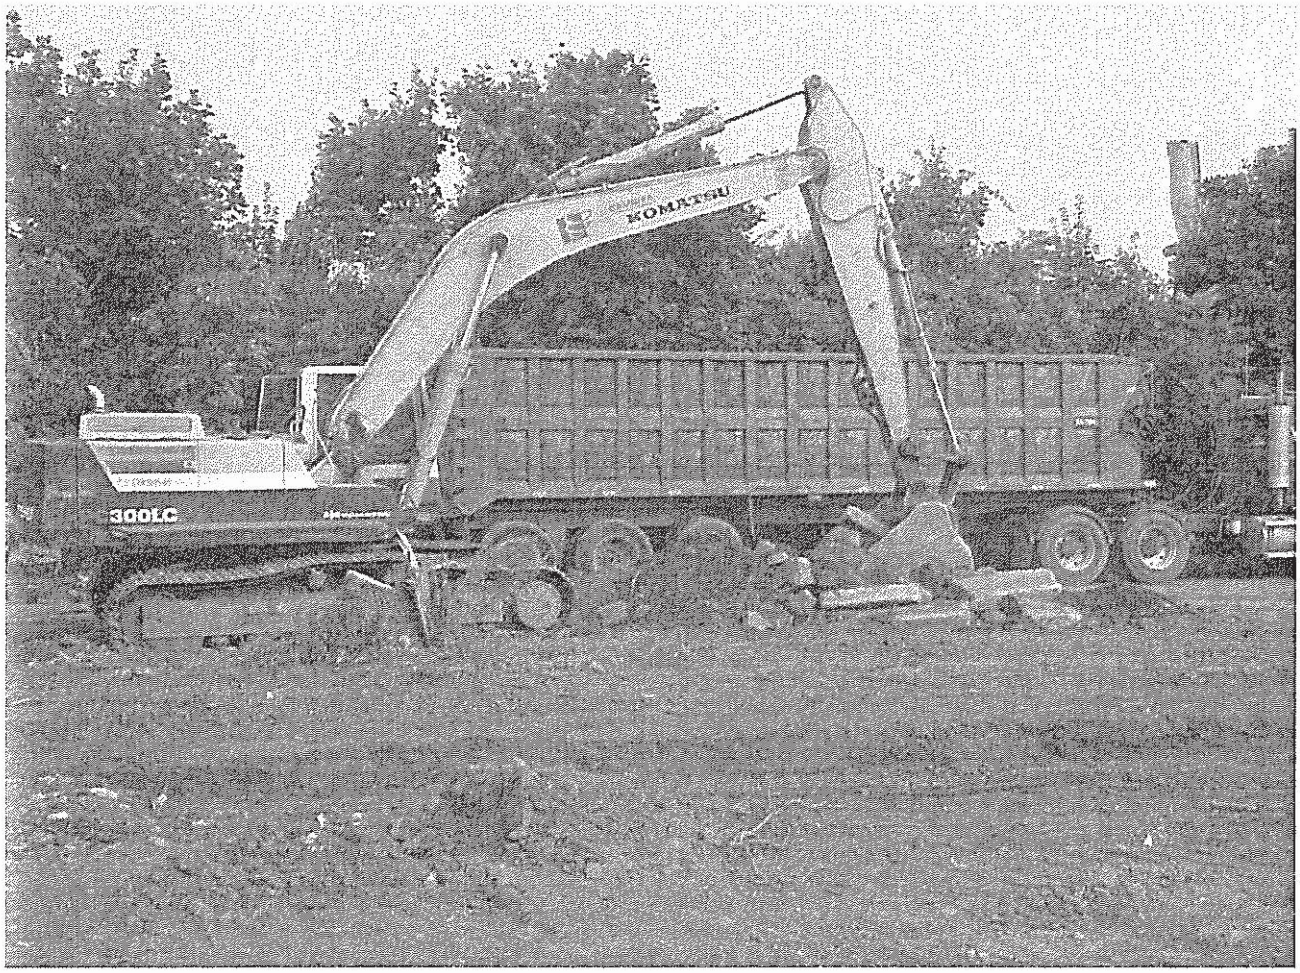
Building A-1, abatement completed - photo looking North

Building A-1, non-hazardous debris awaiting removal - photo at Southeast side of building
