PERIODIC REVIEW REPORT

APRIL 22, 2022, TO AUGUST 1, 2024
NYSDEC SITE NO. C915299
31 TONAWANDA STREET
BUFFALO, NEW YORK 14207

September 2024

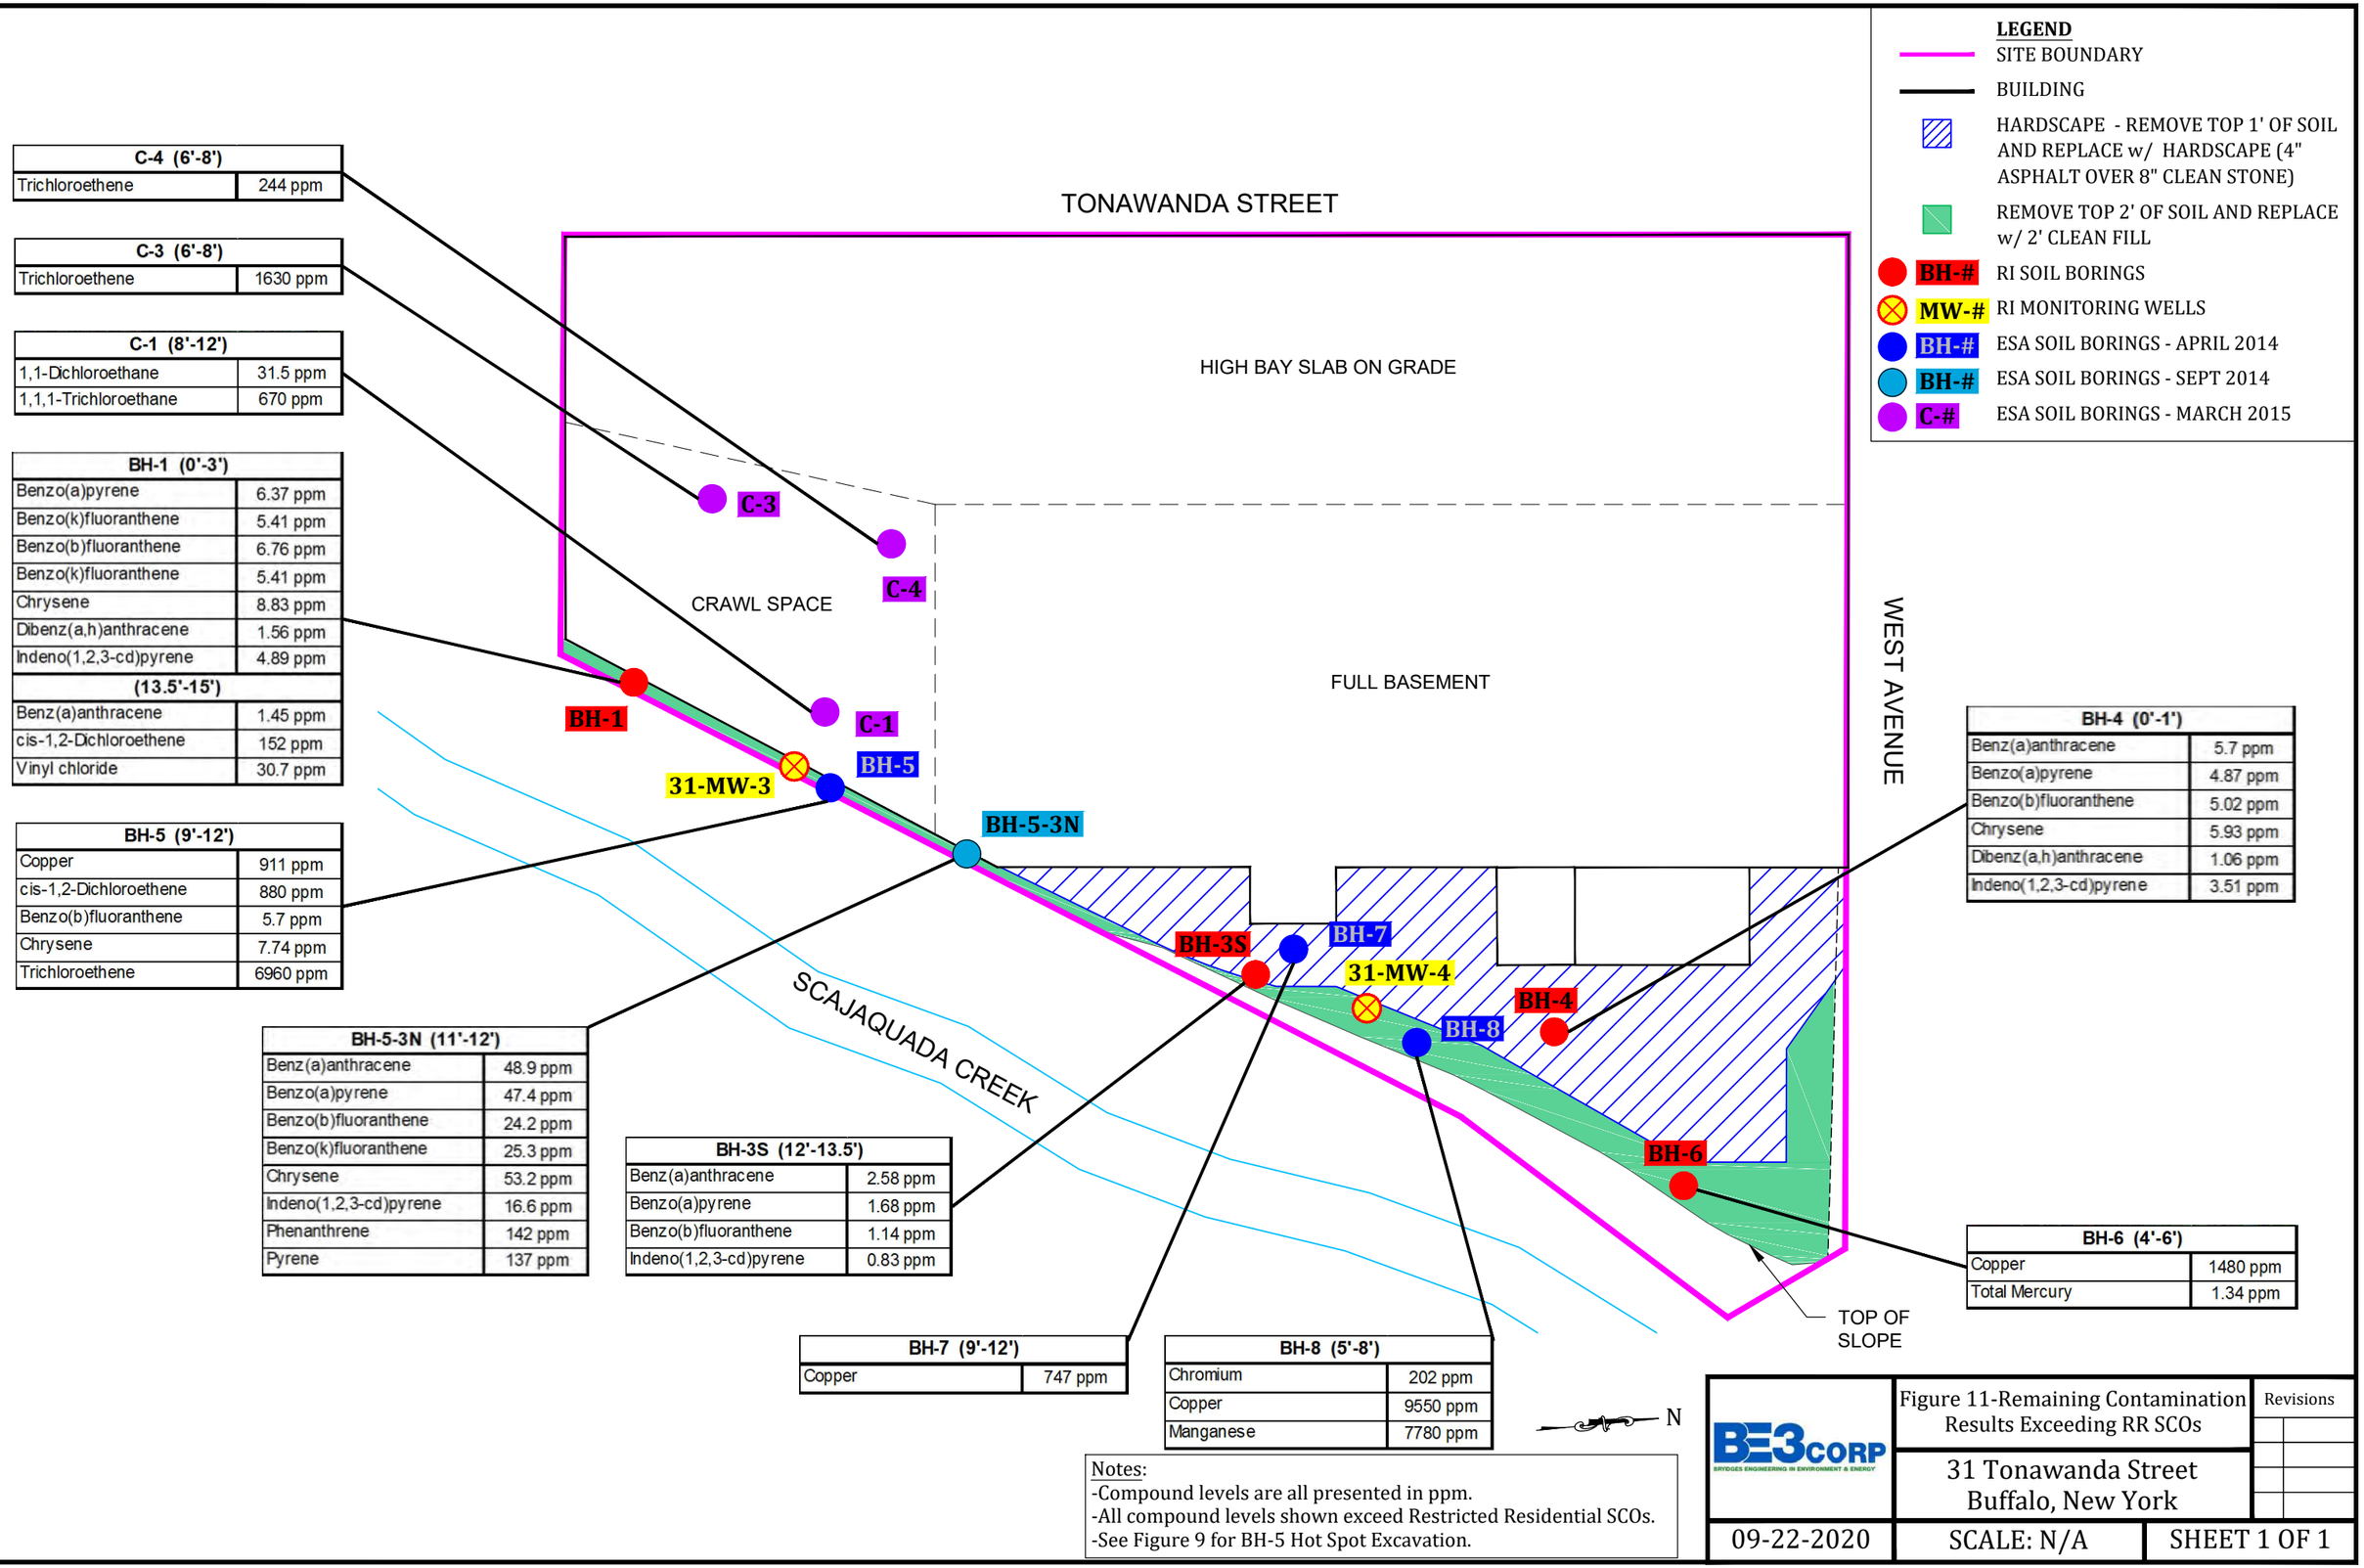
Notes:
-Compound levels are all presented in ppm.
-All compound levels shown exceed Restricted Residential SCOs.
-See Figure 9 for BH-5 Hot Spot Excavation.

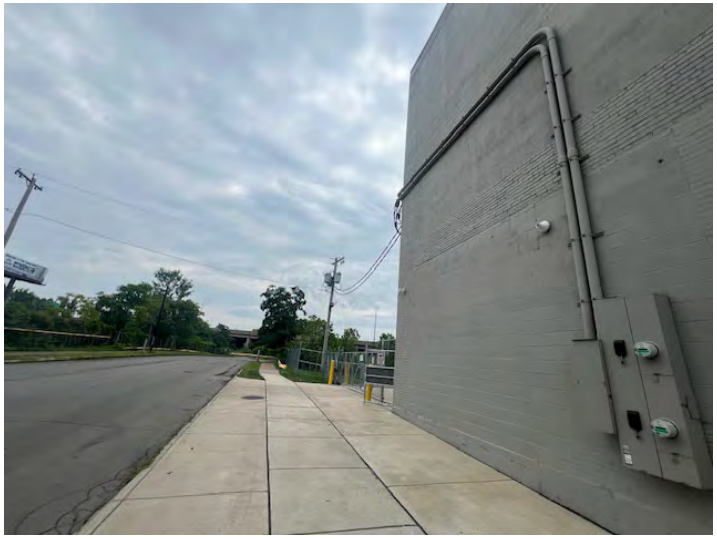
9. Central northern property boundary, facing east.
