RE: Phase I Environmental Site Assessment
Commercial Property
24 Anderson Road
Buffalo (Cheektowaga), Erie County, New York 14225
Farmer Project No.: 235.984

Phase I Environmental Site Assessment

Commercial Property
24 Anderson Road
Buffalo (Cheektowaga), Erie County, New York

Farmer Project No. 235.984

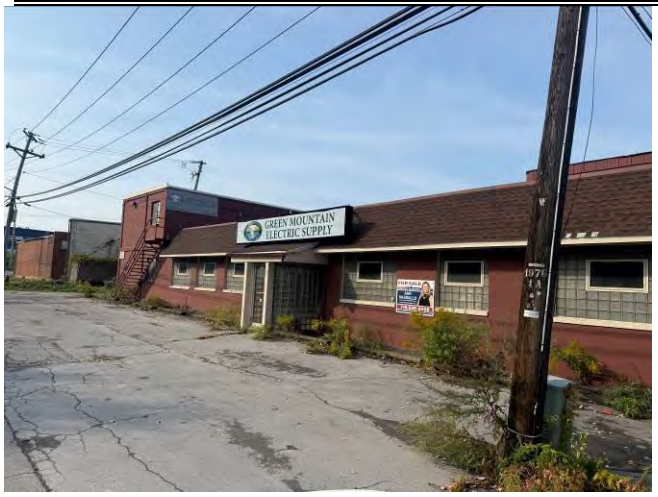
Photo 1: Eastern elevation of the Subject Property building.

Photo 2: Northern elevation of the Subject Property building.

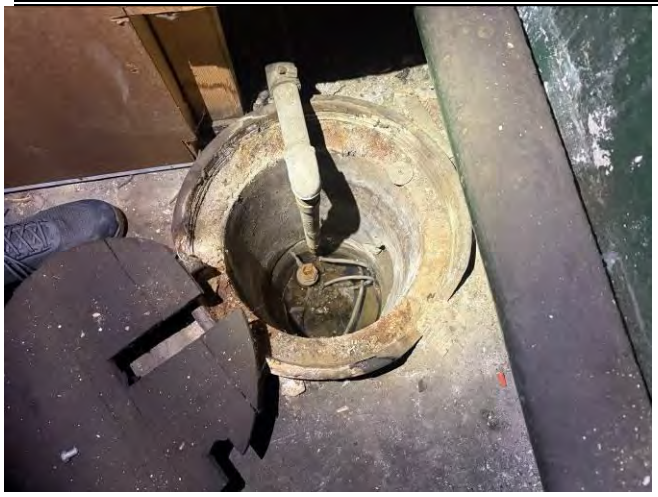
Photo 6: Warehouse sump pit and pump in the warehouse portion of the building.

Photo 7: Inside view of the sump pit and pump in the warehouse.

Photo 8. Unidentified floor penetration near the northern warehouse wall.

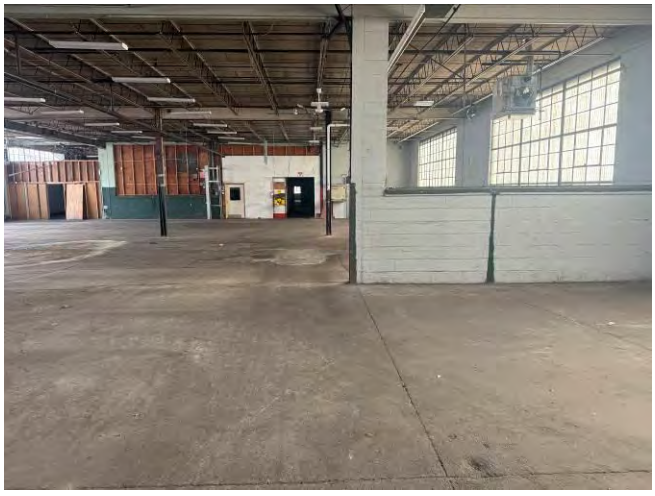
Photo 12: Eastern view inside warehouse.

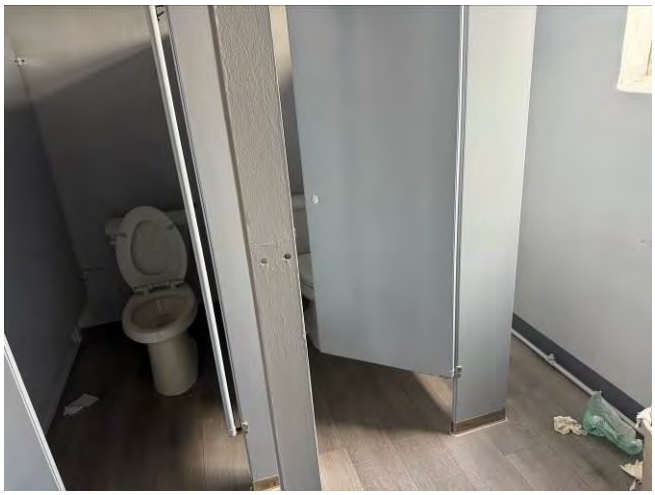
Photo 16: View of the restroom in office portion of the Subject Property.

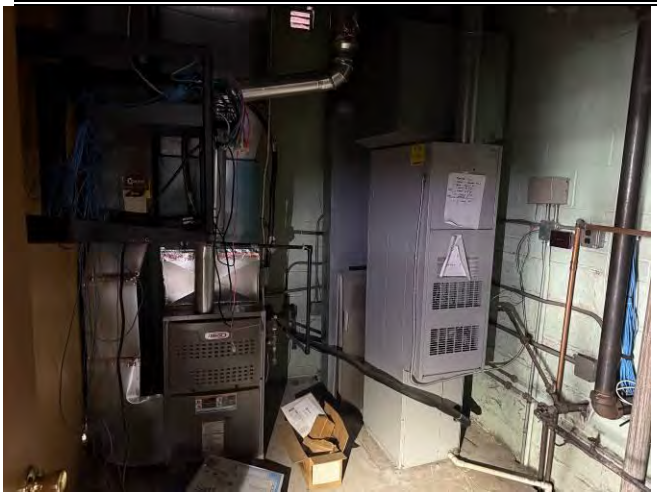
Photo 19: View of HVAC system room in the office area.

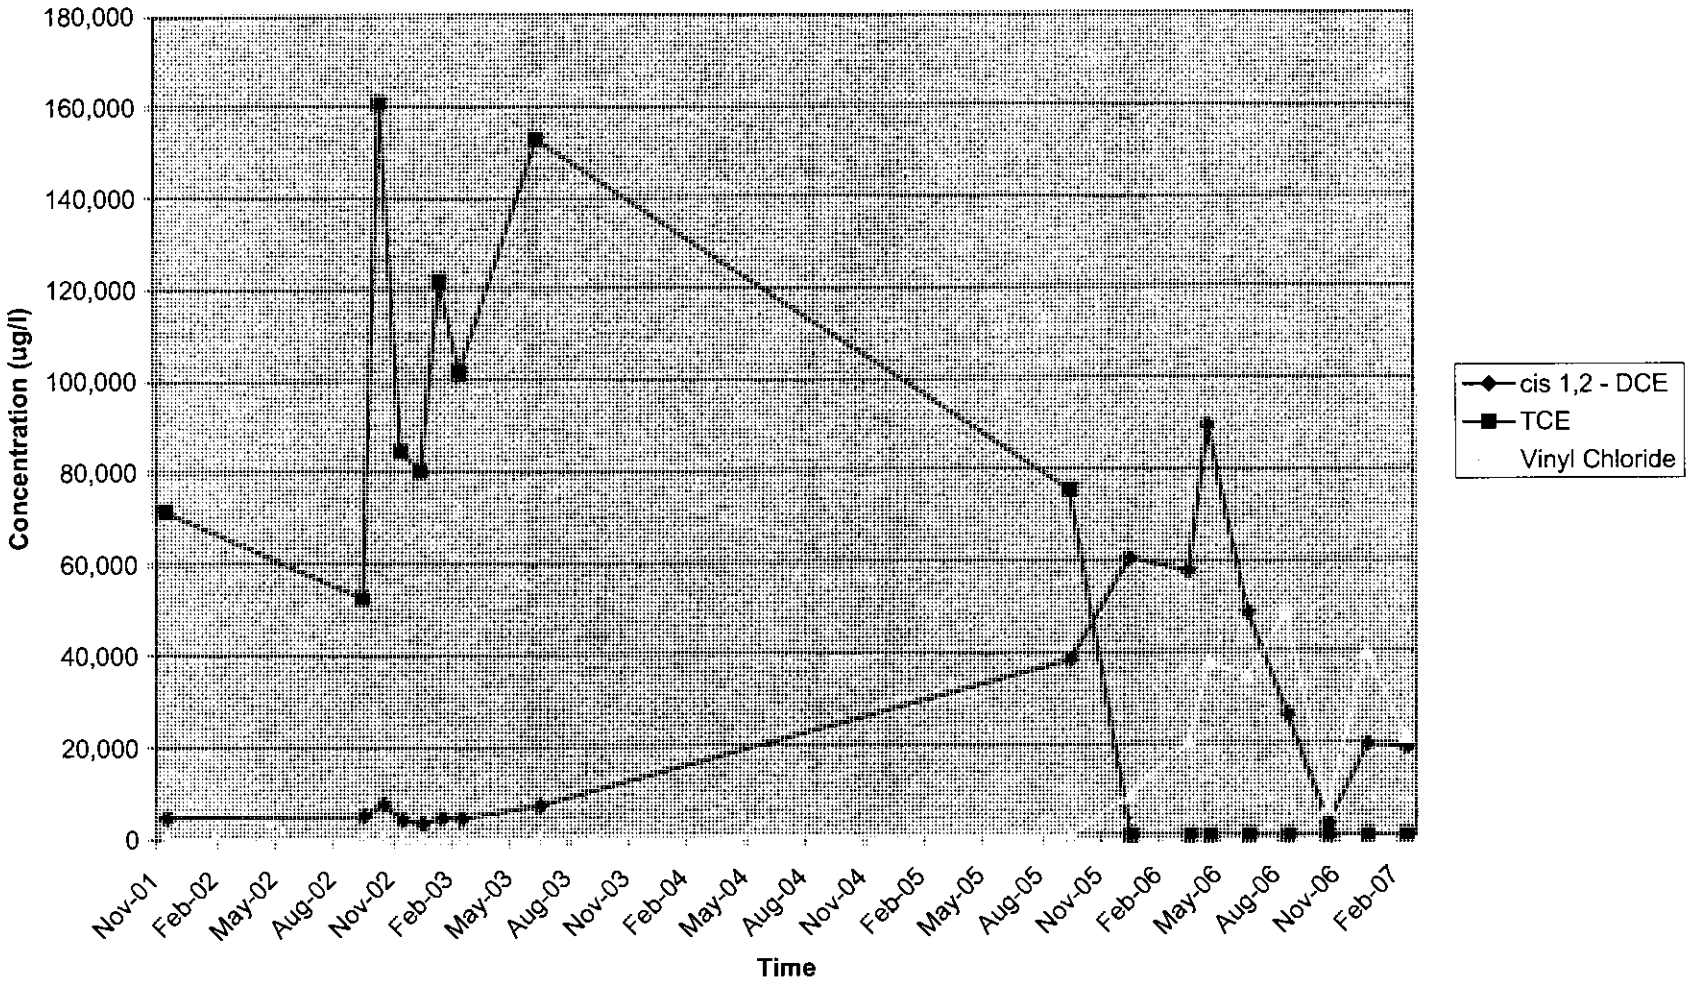
Figure 6
VOC Concentration Data for GW-3

Figure 6 includes the VOC data for GW-3 from 2001 through February 2007. As shown on Figure 6, major VOC concentration changes occurred after the September 2005 HRC®-X injection. TCE concentrations have dropped from the historical high of 161,000 ppb (10/24/02) down to less than 2,000 ppb (2/26/07). The concentrations of the TCE daughter products, cis-1,2-dichloroethene ("DCE") and vinyl chloride ("VC"), have increased orders of magnitude in GW-3 indicating biodegradation at the source. The total VOC concentration in GW-3 has dropped from over 100,000 ppb (TCE and DCE combined) in September 2005 to 40,600 ppb (DCE and VC combined) in February 2007.
