Phase II Environmental Site Assessment

631, 683, 741 and 777 Northland Avenue

City of Buffalo, Erie County, New York

September 2015

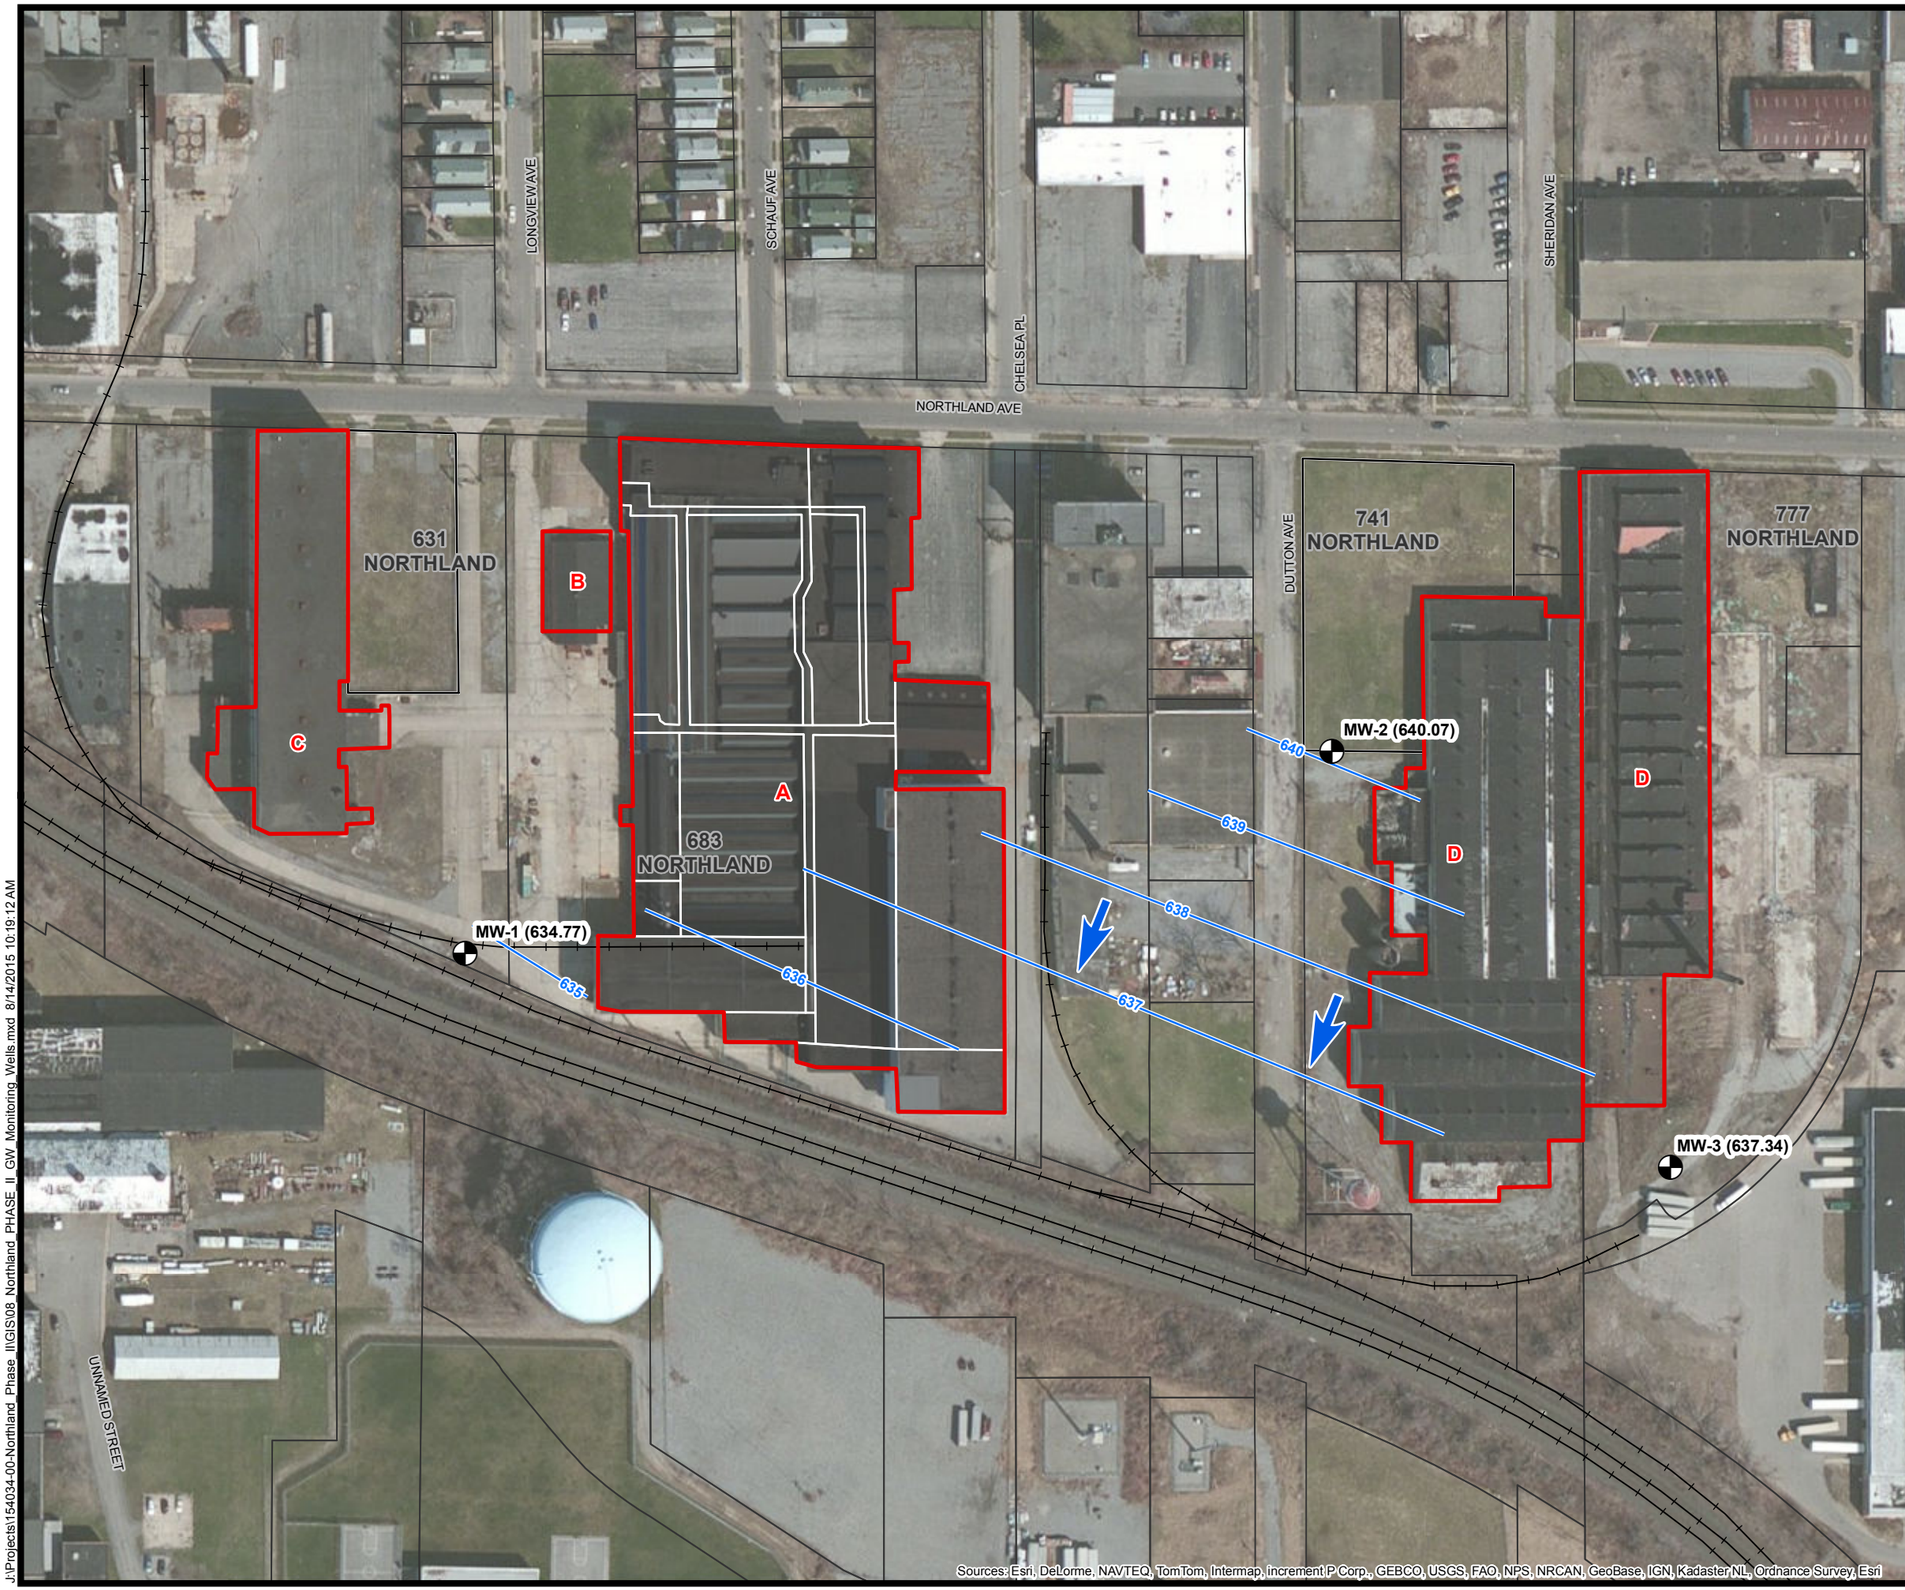
Based on the groundwater analytical results, MW-3 identified concentrations of TCE and cis-1,2 DCE to be above the Groundwater Effluent Limitations. Therefore, it is recommended that MW-1, MW-2 and MW-3 be resampled within three (3) months from issuance of this report to compare the initial findings.

FIGURE 8
GROUNDWATER CONTOUR FLOW MAP
JUNE 29, 2015
NORTHLAND AVENUE PROPERTIES

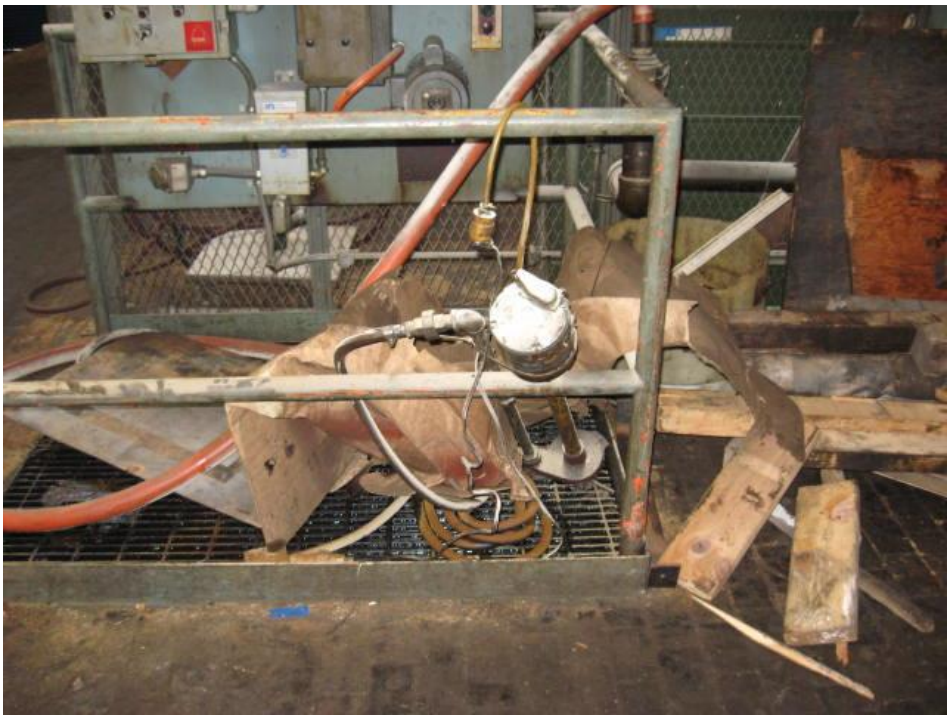
Photo Location No. 7 – AS2 – Waste Oil Tank Basement Secondary Containment Floor

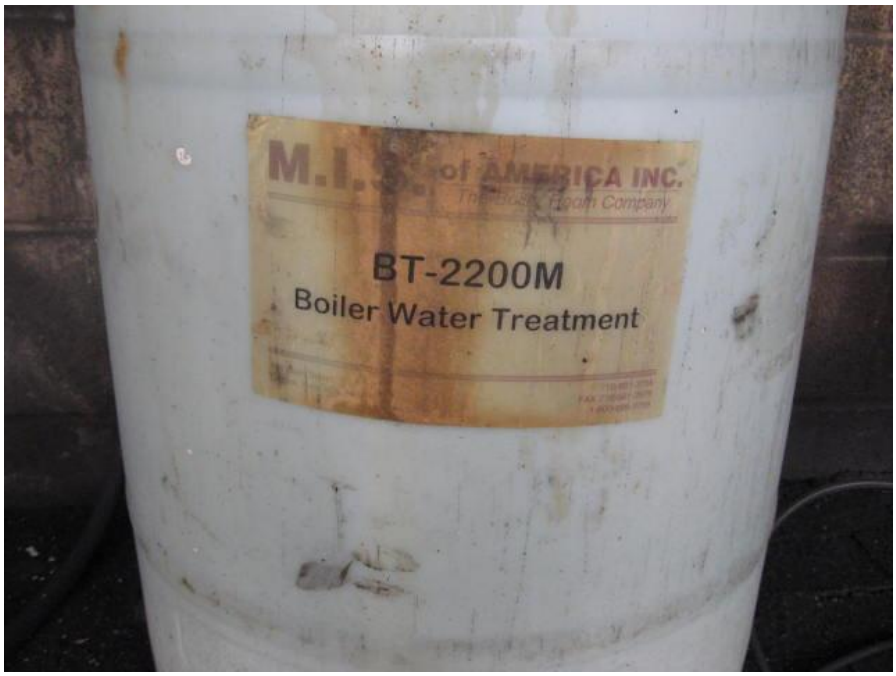
Photo Location No. 1 – Building C - Leftover Chemical Containers
