FINAL REMEDIAL INVESTIGATION –
ALTERNATIVE ANALYSIS REPORT

BROWNFIELD CLEANUP PROGRAM
For
MOD-PAC CORP.
1801 Elmwood, Buffalo 14207
BCP # C915314

Prepared For:
MOD-PAC CORP.
1801-1807 Elmwood Avenue, Buffalo, New York 14207

May 2, 2019

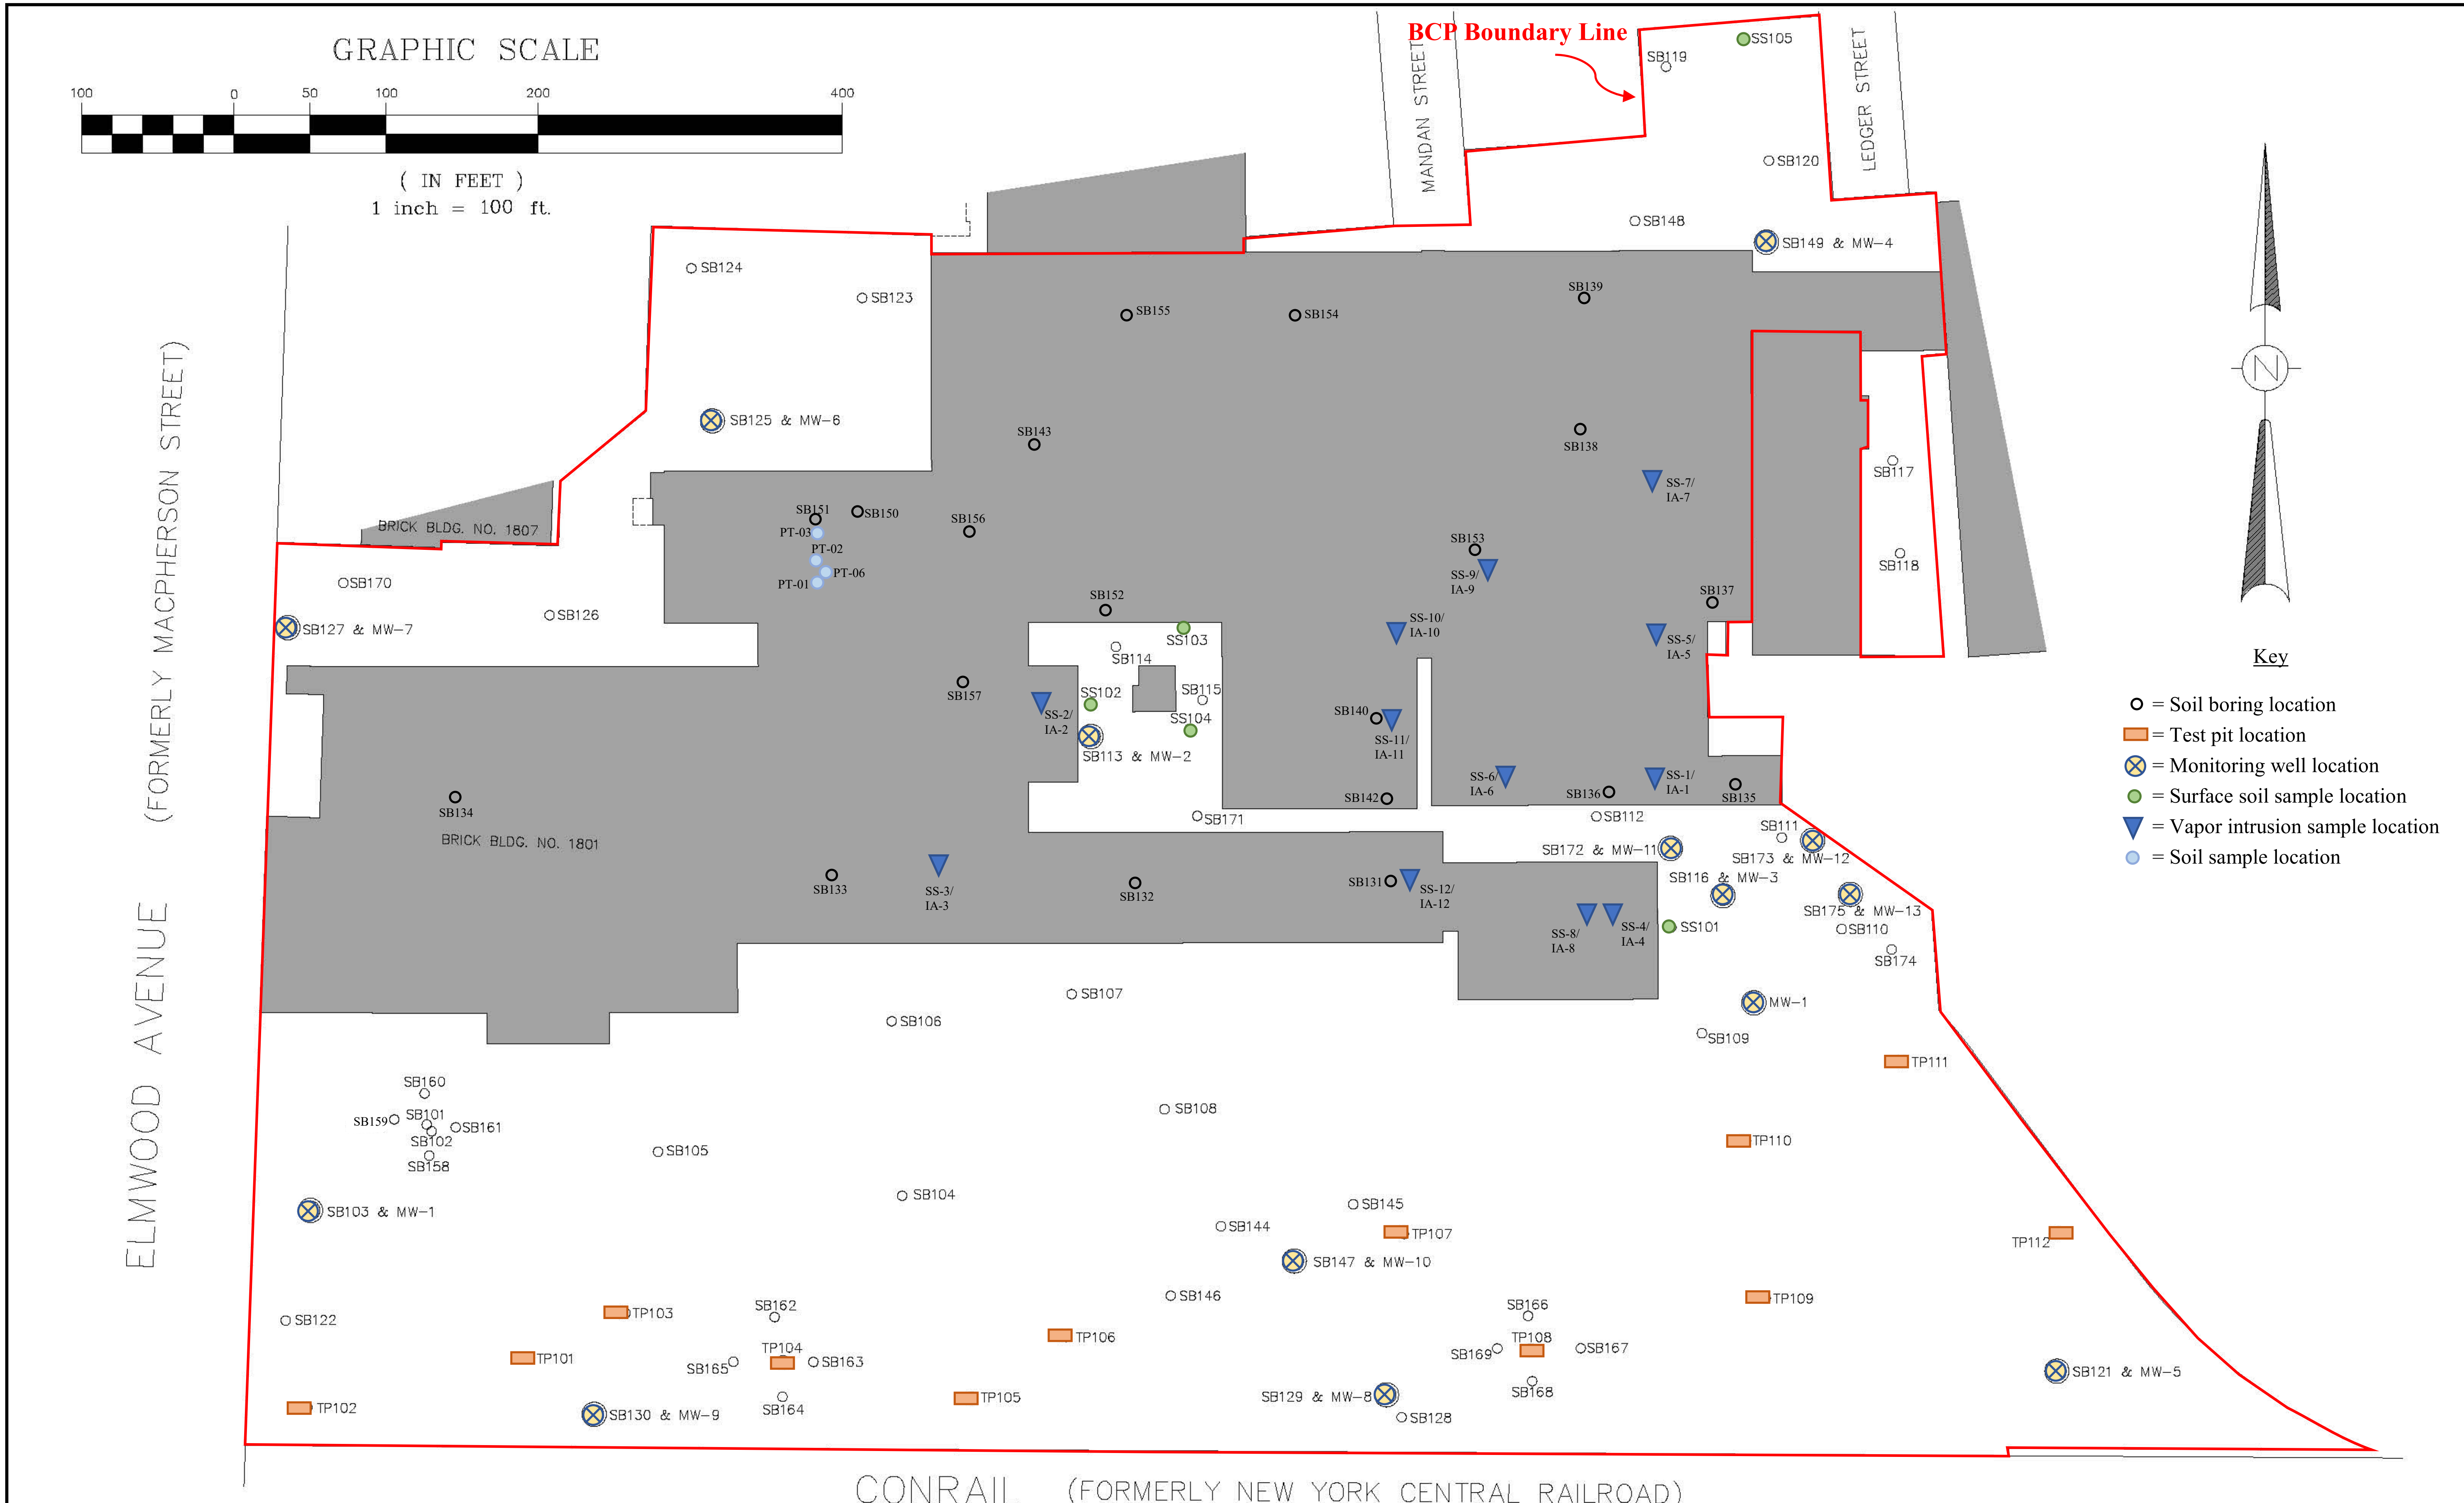
WITTMAN GEOSCIENCES, PLLC	Remedial Investigation Locations	DRAWN BY: MMW	SCALE: 1" = 100'	PROJECT: 18-103
	1801 Elmwood, Buffalo, NY	CHECKED BY: MMW	DATE: 05/2019	FIGURE NO: 3

Exterior Investigation locations located by McIntosh & McIntosh; Interior locations measured in the field.

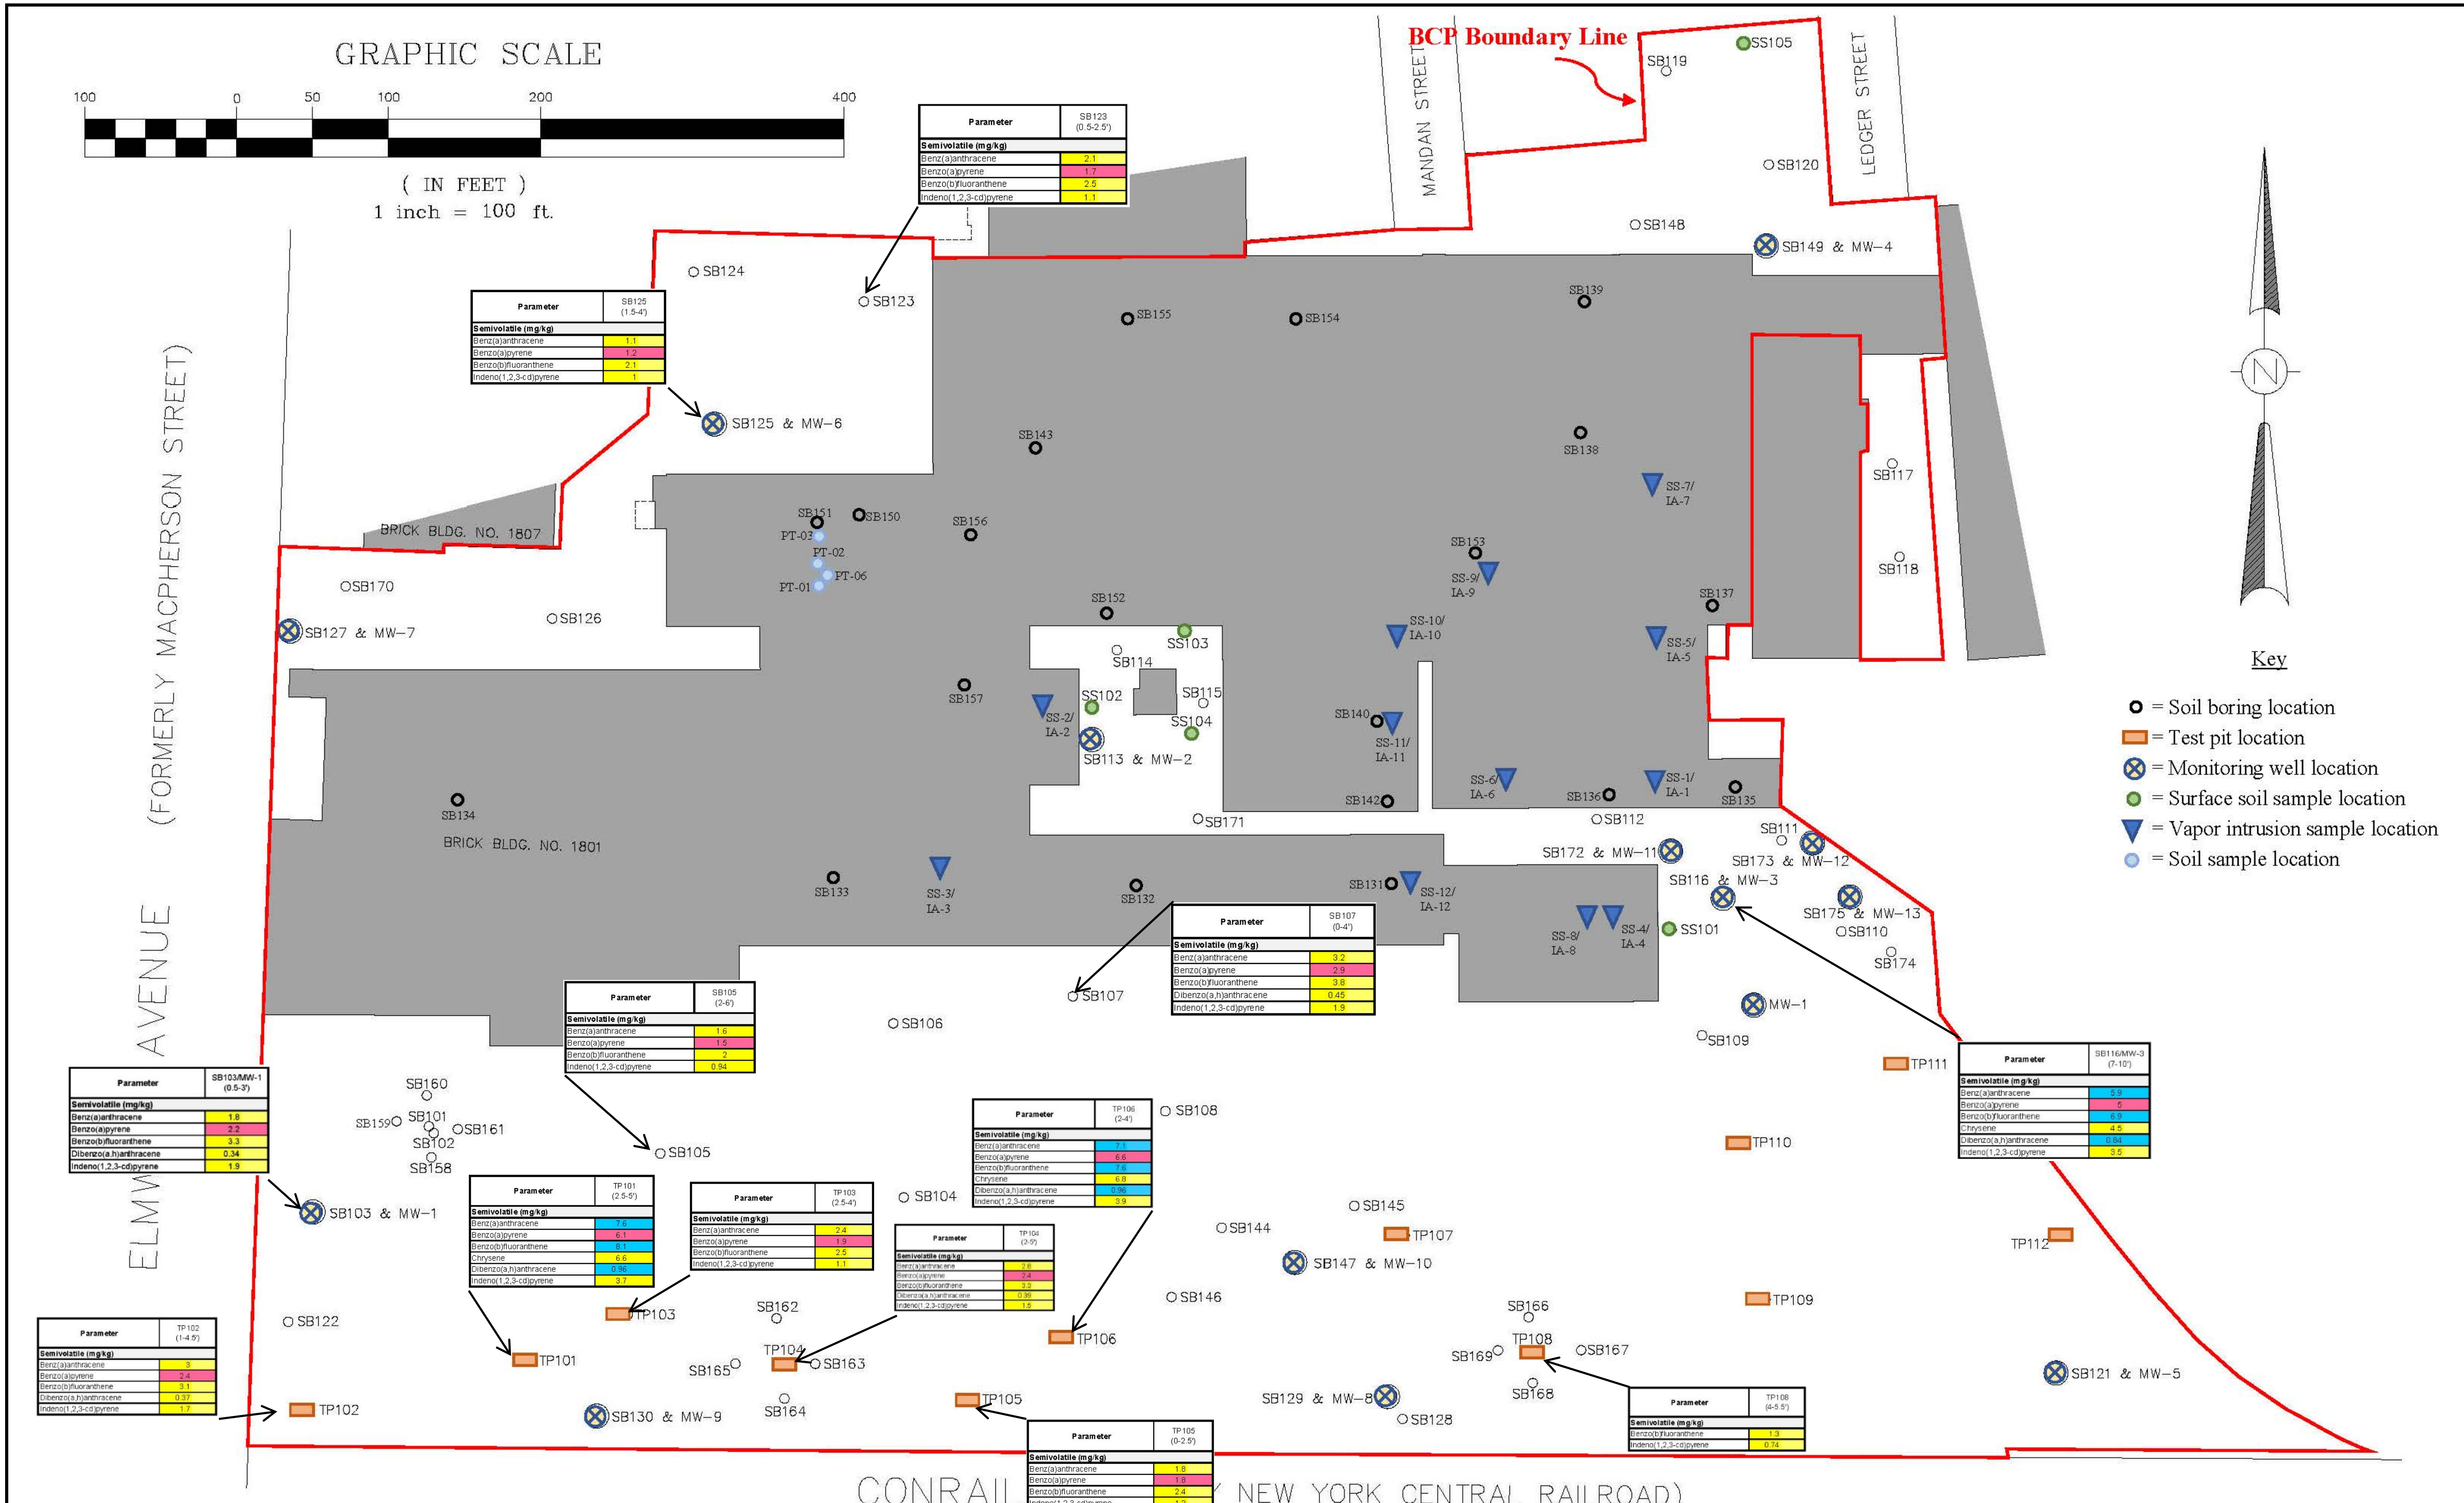
WITTMAN GEOSCIENCES, PLLC	SVOC Subsurface Soil Testing Results exceeded Restricted Residential	DRAWN BY: MMW	SCALE: 1" = 100'	PROJECT: 18-103
	1801 Elmwood, Buffalo, NY	CHECKED BY: MMW	DATE: 05/2019	FIGURE NO: 6

Concentrations of VOCs within the soil samples were below their respective CUSCO. SVOCs, including typical PAHs benzo(a)anthracene, benzo(a)pyrene, benzo(b)fluoranthene and dibenzo(a,h)anthracene were detected at several locations exceeding CUSCO. Additionally, metals including lead and arsenic, were also detected at several locations exceeding CUSCO. The presence of the PAHs and metals is likely due to the large amounts of historical industrial fill present at the Site, and is associated with the foundry sands, cinders, and other miscellaneous materials.

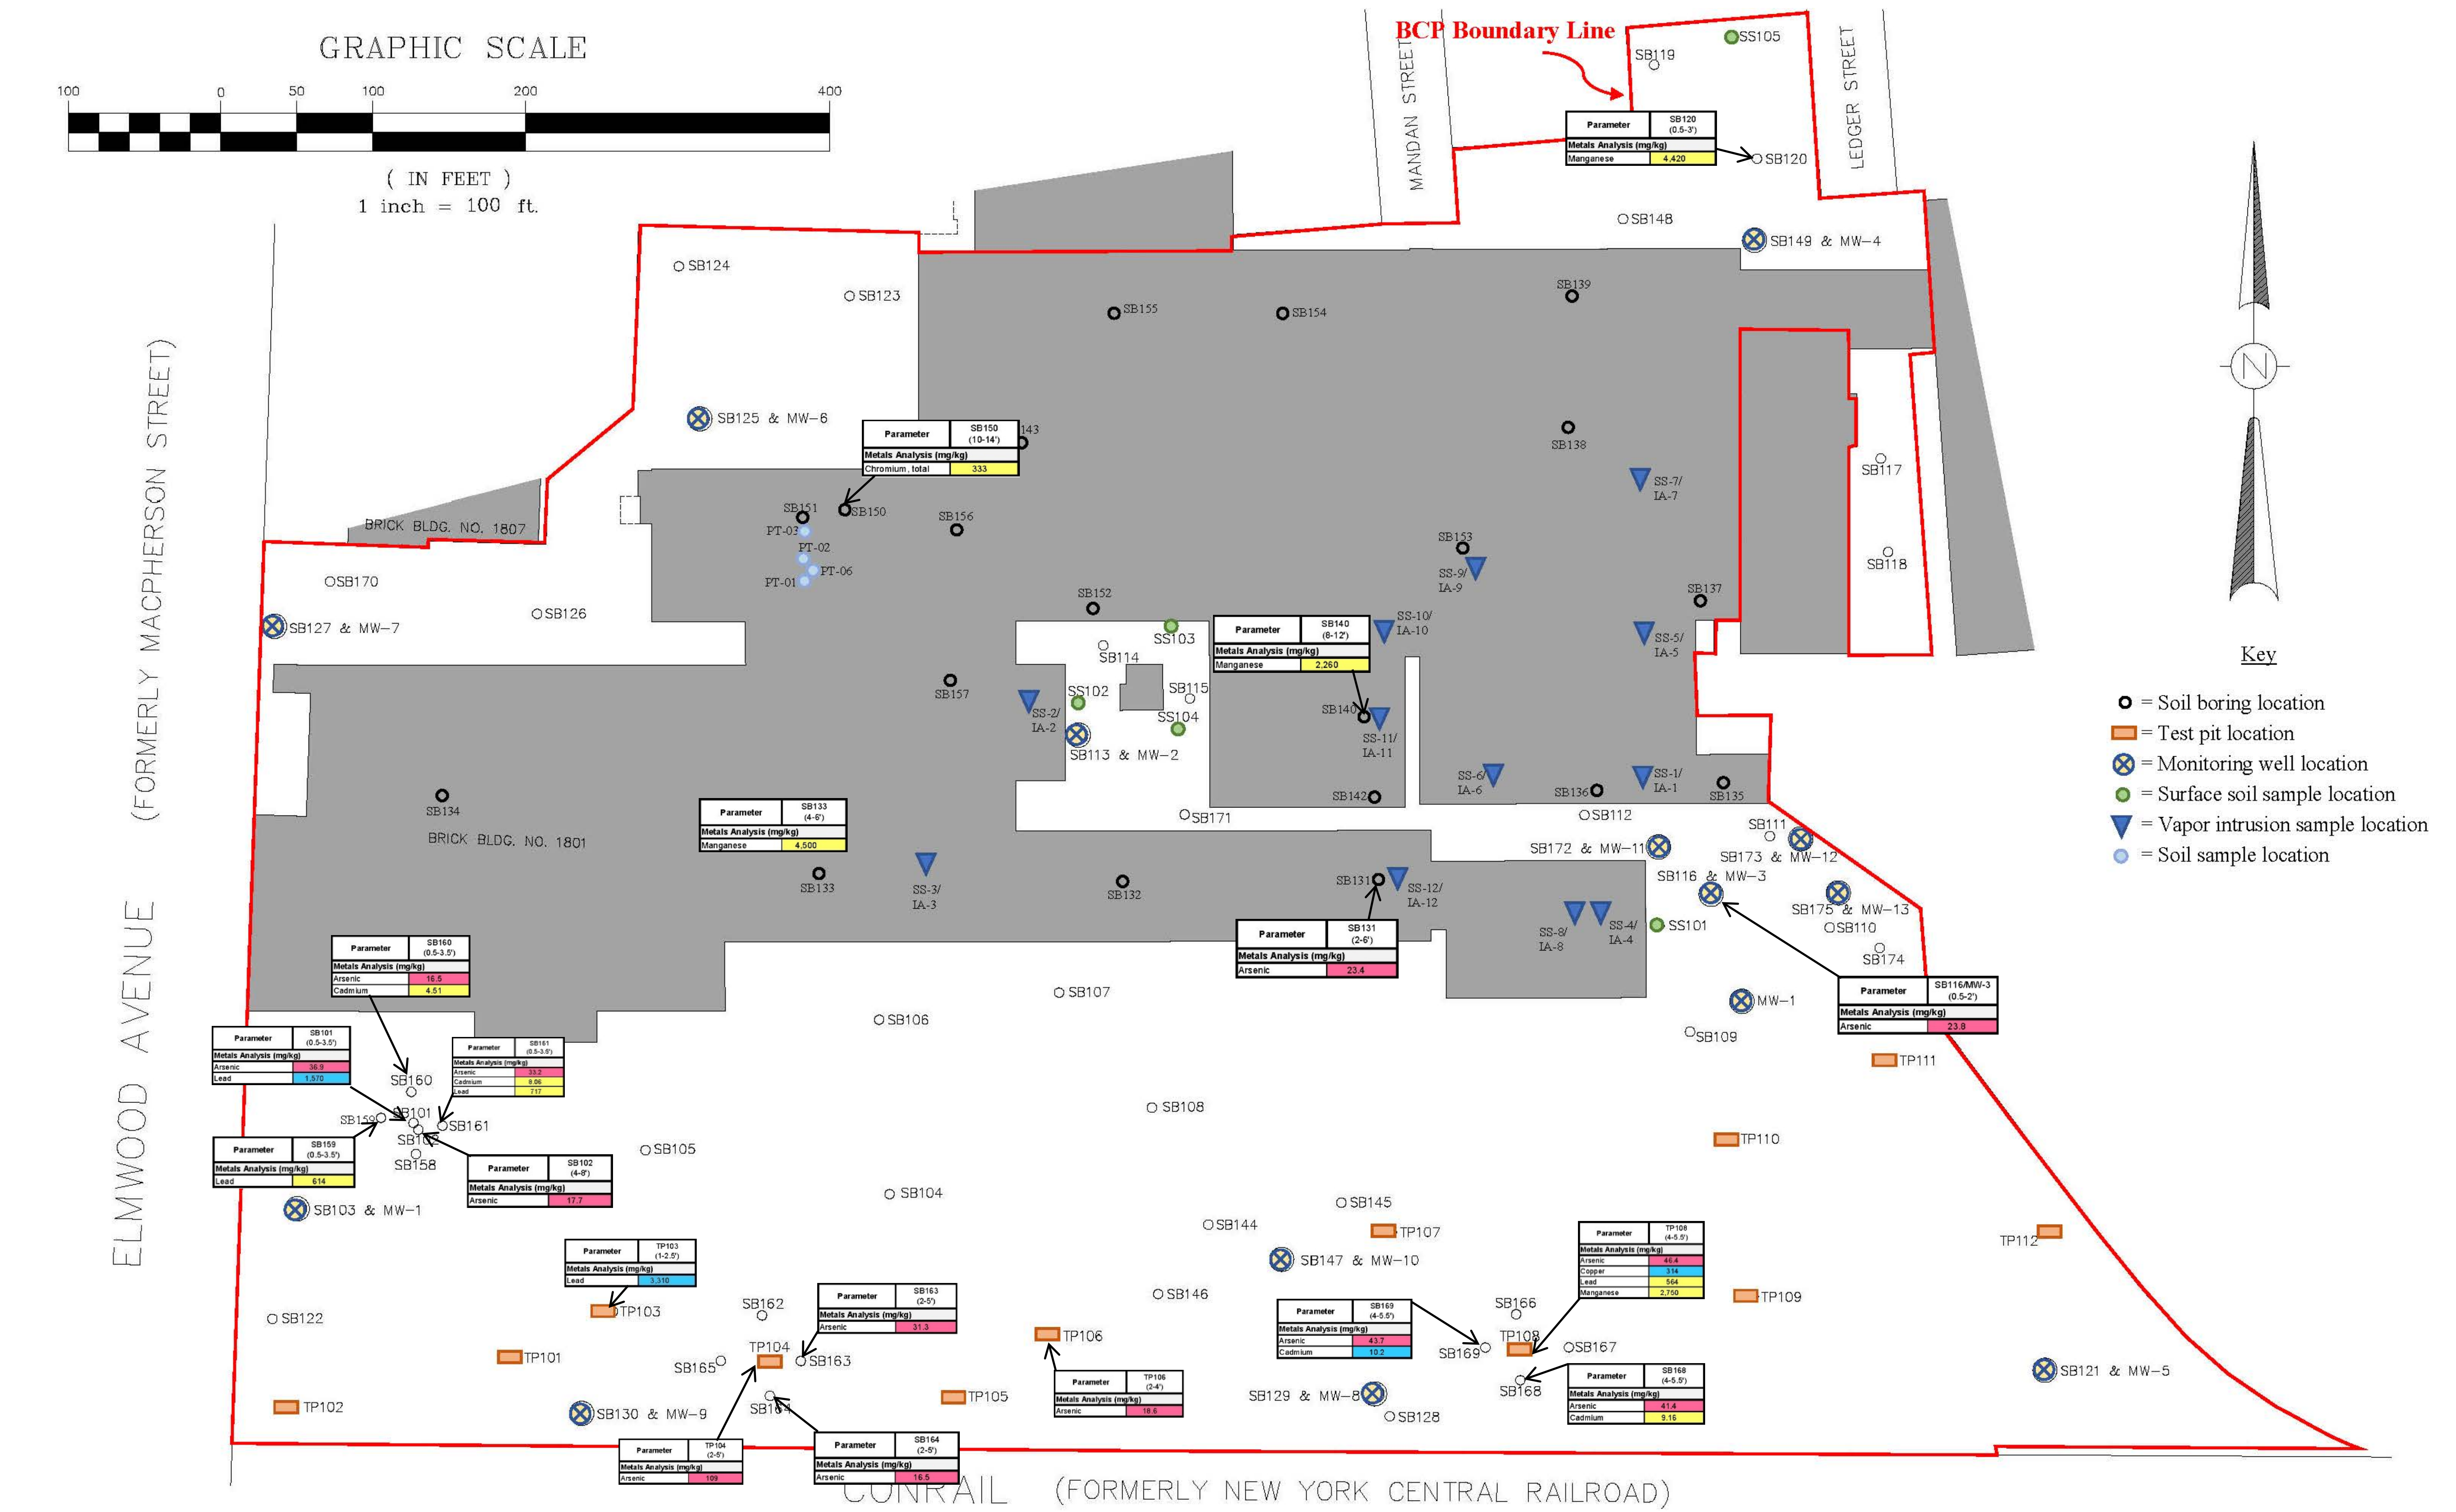
WITTMAN GEOSCIENCES, PLLC	Metals Subsurface Soil Testing Results exceeded Restricted Residential	DRAWN BY: MMW	SCALE: 1" = 100'	PROJECT: 18-103
	1801 Elmwood, Buffalo, NY	CHECKED BY: MMW	DATE: 05/2019	FIGURE NO: 7

As summarized above, concentration of arsenic was identified above CUSCO and IUSCO in locations throughout the historical industrial fill in the southern portion of the Site, but also within remaining area of the Site, under the building and within surface soil samples. The presence of the metals is likely due to the large amounts of historical industrial fill present at the Site, and is associated with the foundry sands, cinders, and other miscellaneous materials.

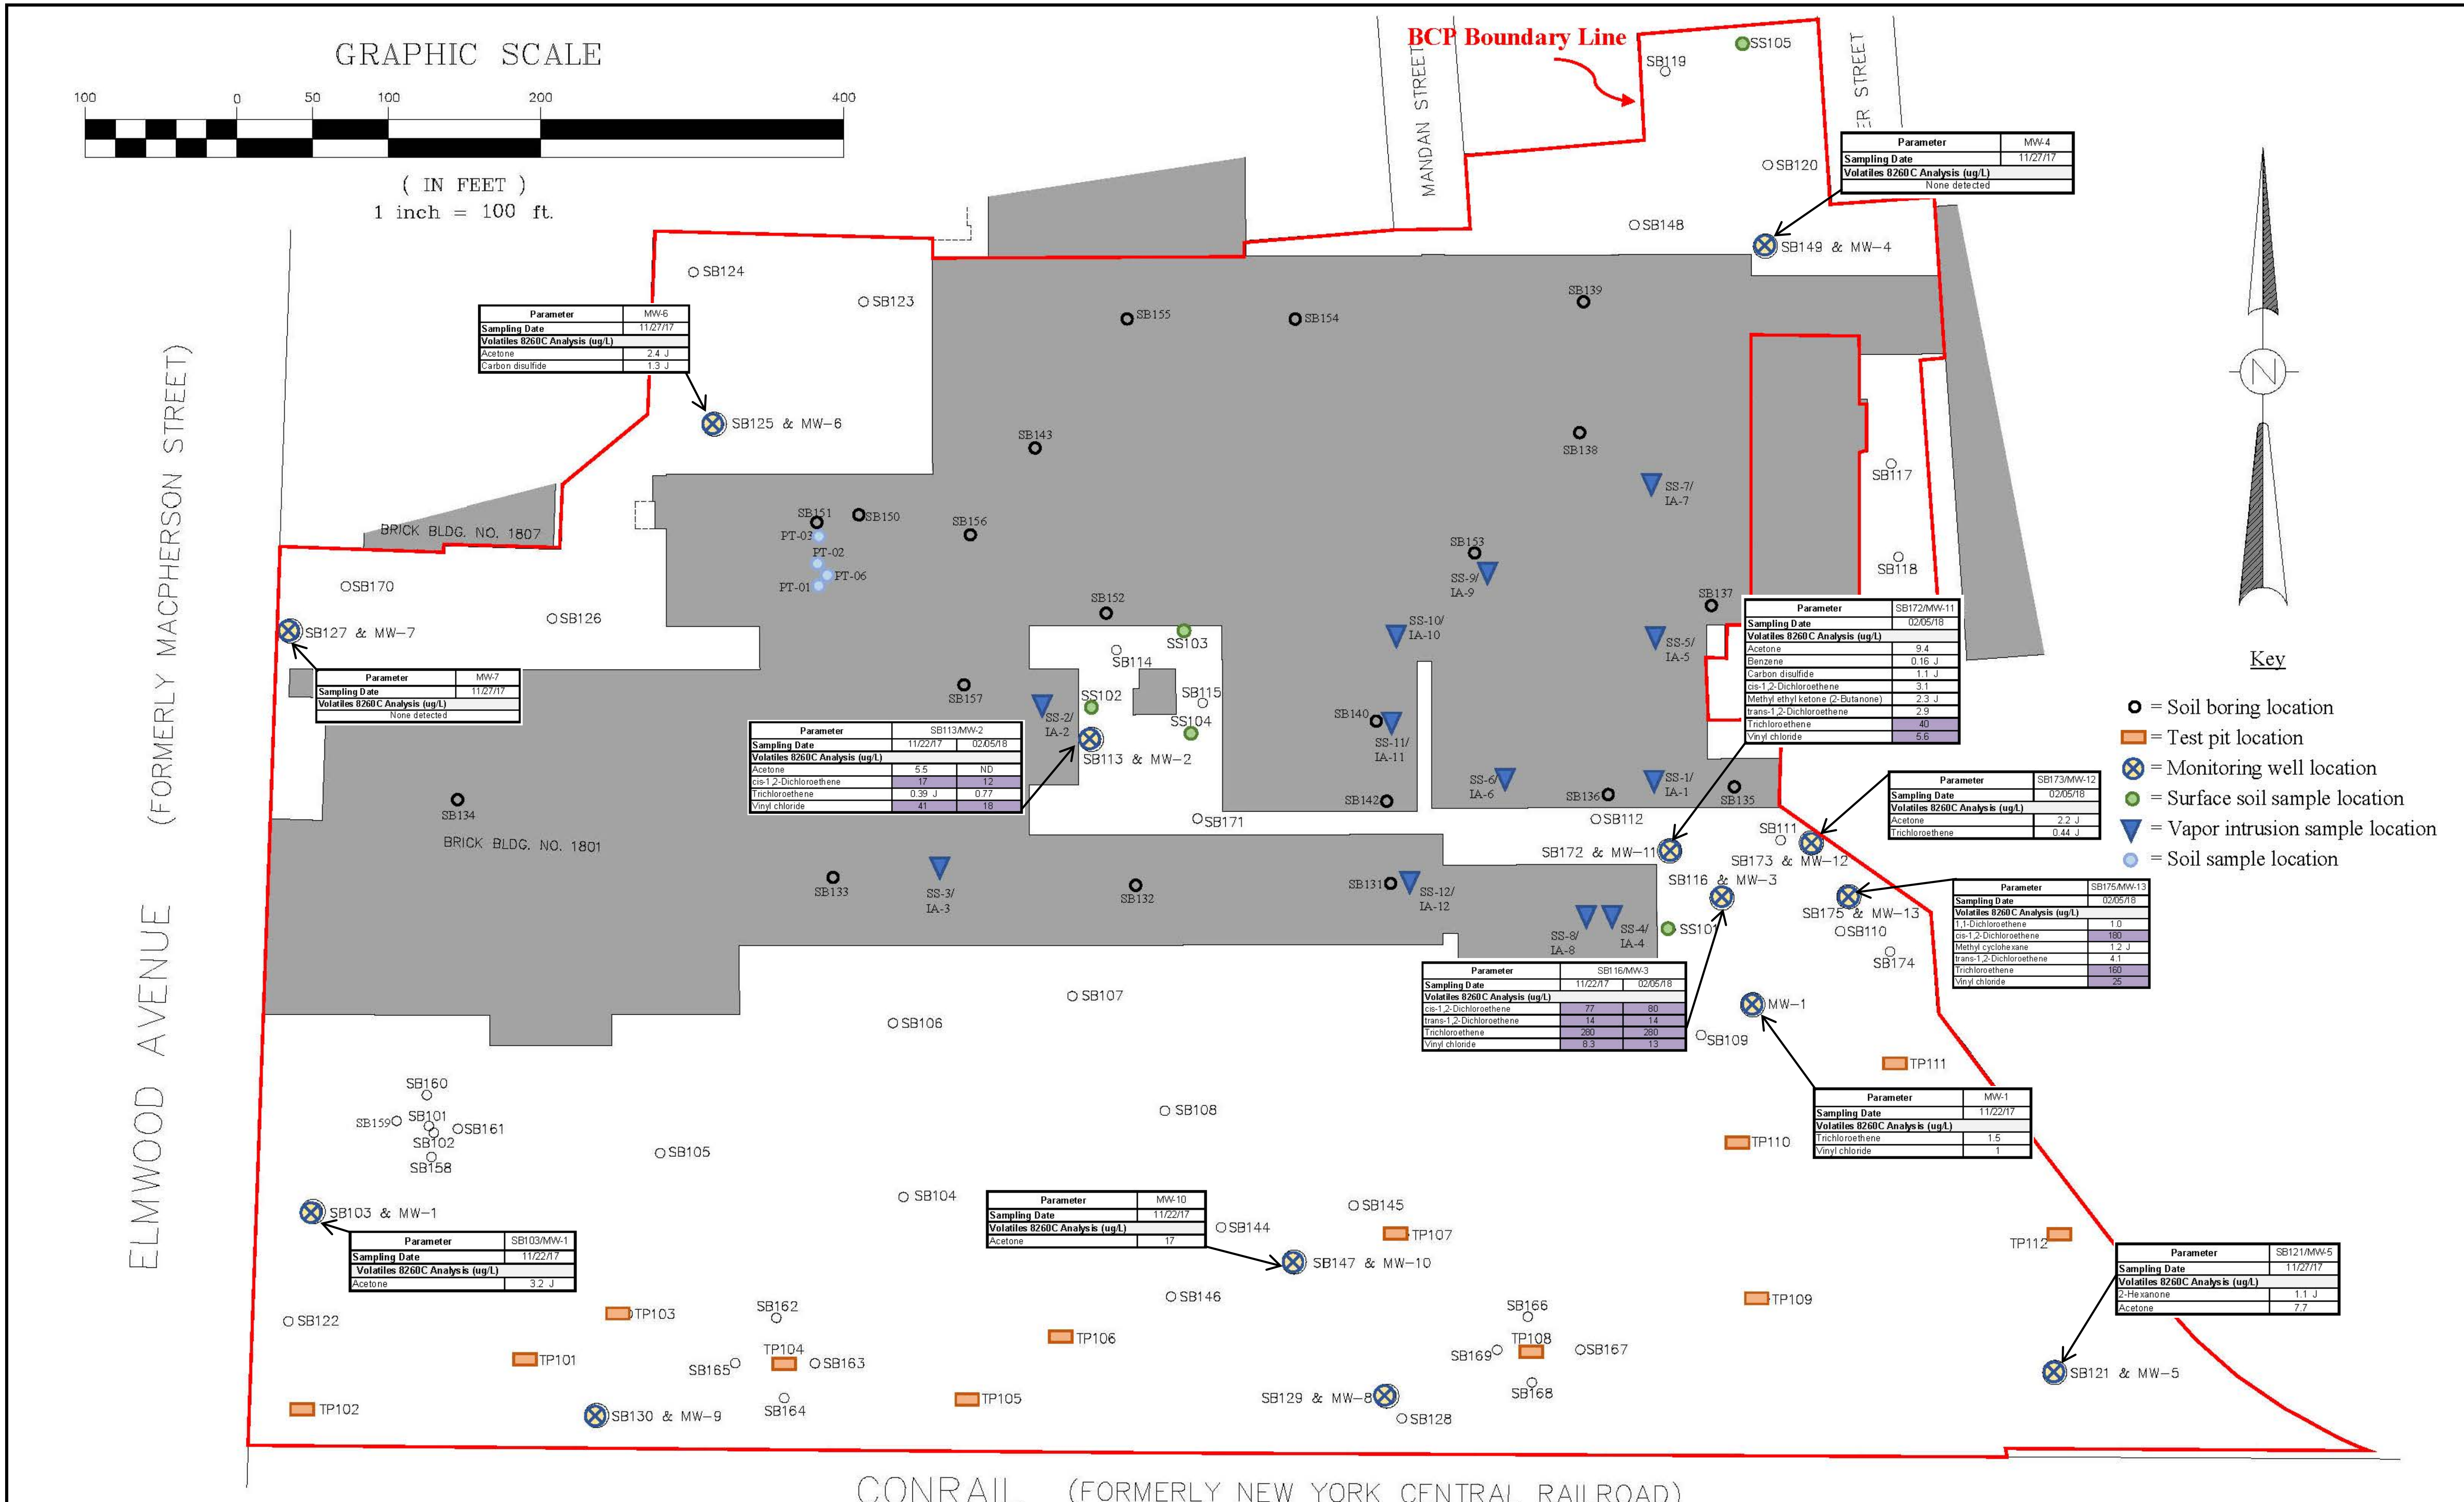
WITTMAN GEOSCIENCES, PLLC	VOC Groundwater Testing Results	DRAWN BY: MMW	SCALE: 1" = 100'	PROJECT: 18-103
	1801 Elmwood, Buffalo, NY	CHECKED BY: MMW	DATE: 05/2019	FIGURE NO: 8

TCE and degradation compounds were detected in the groundwater samples from SB113/MW2 and SB116/MW3, located in the eastern and center areas of the Site, as shown in Figure 8. Based on off-Site sampling results, the TCE impacts are not present east of the Site and appear limited to the eastern portion of the Site.

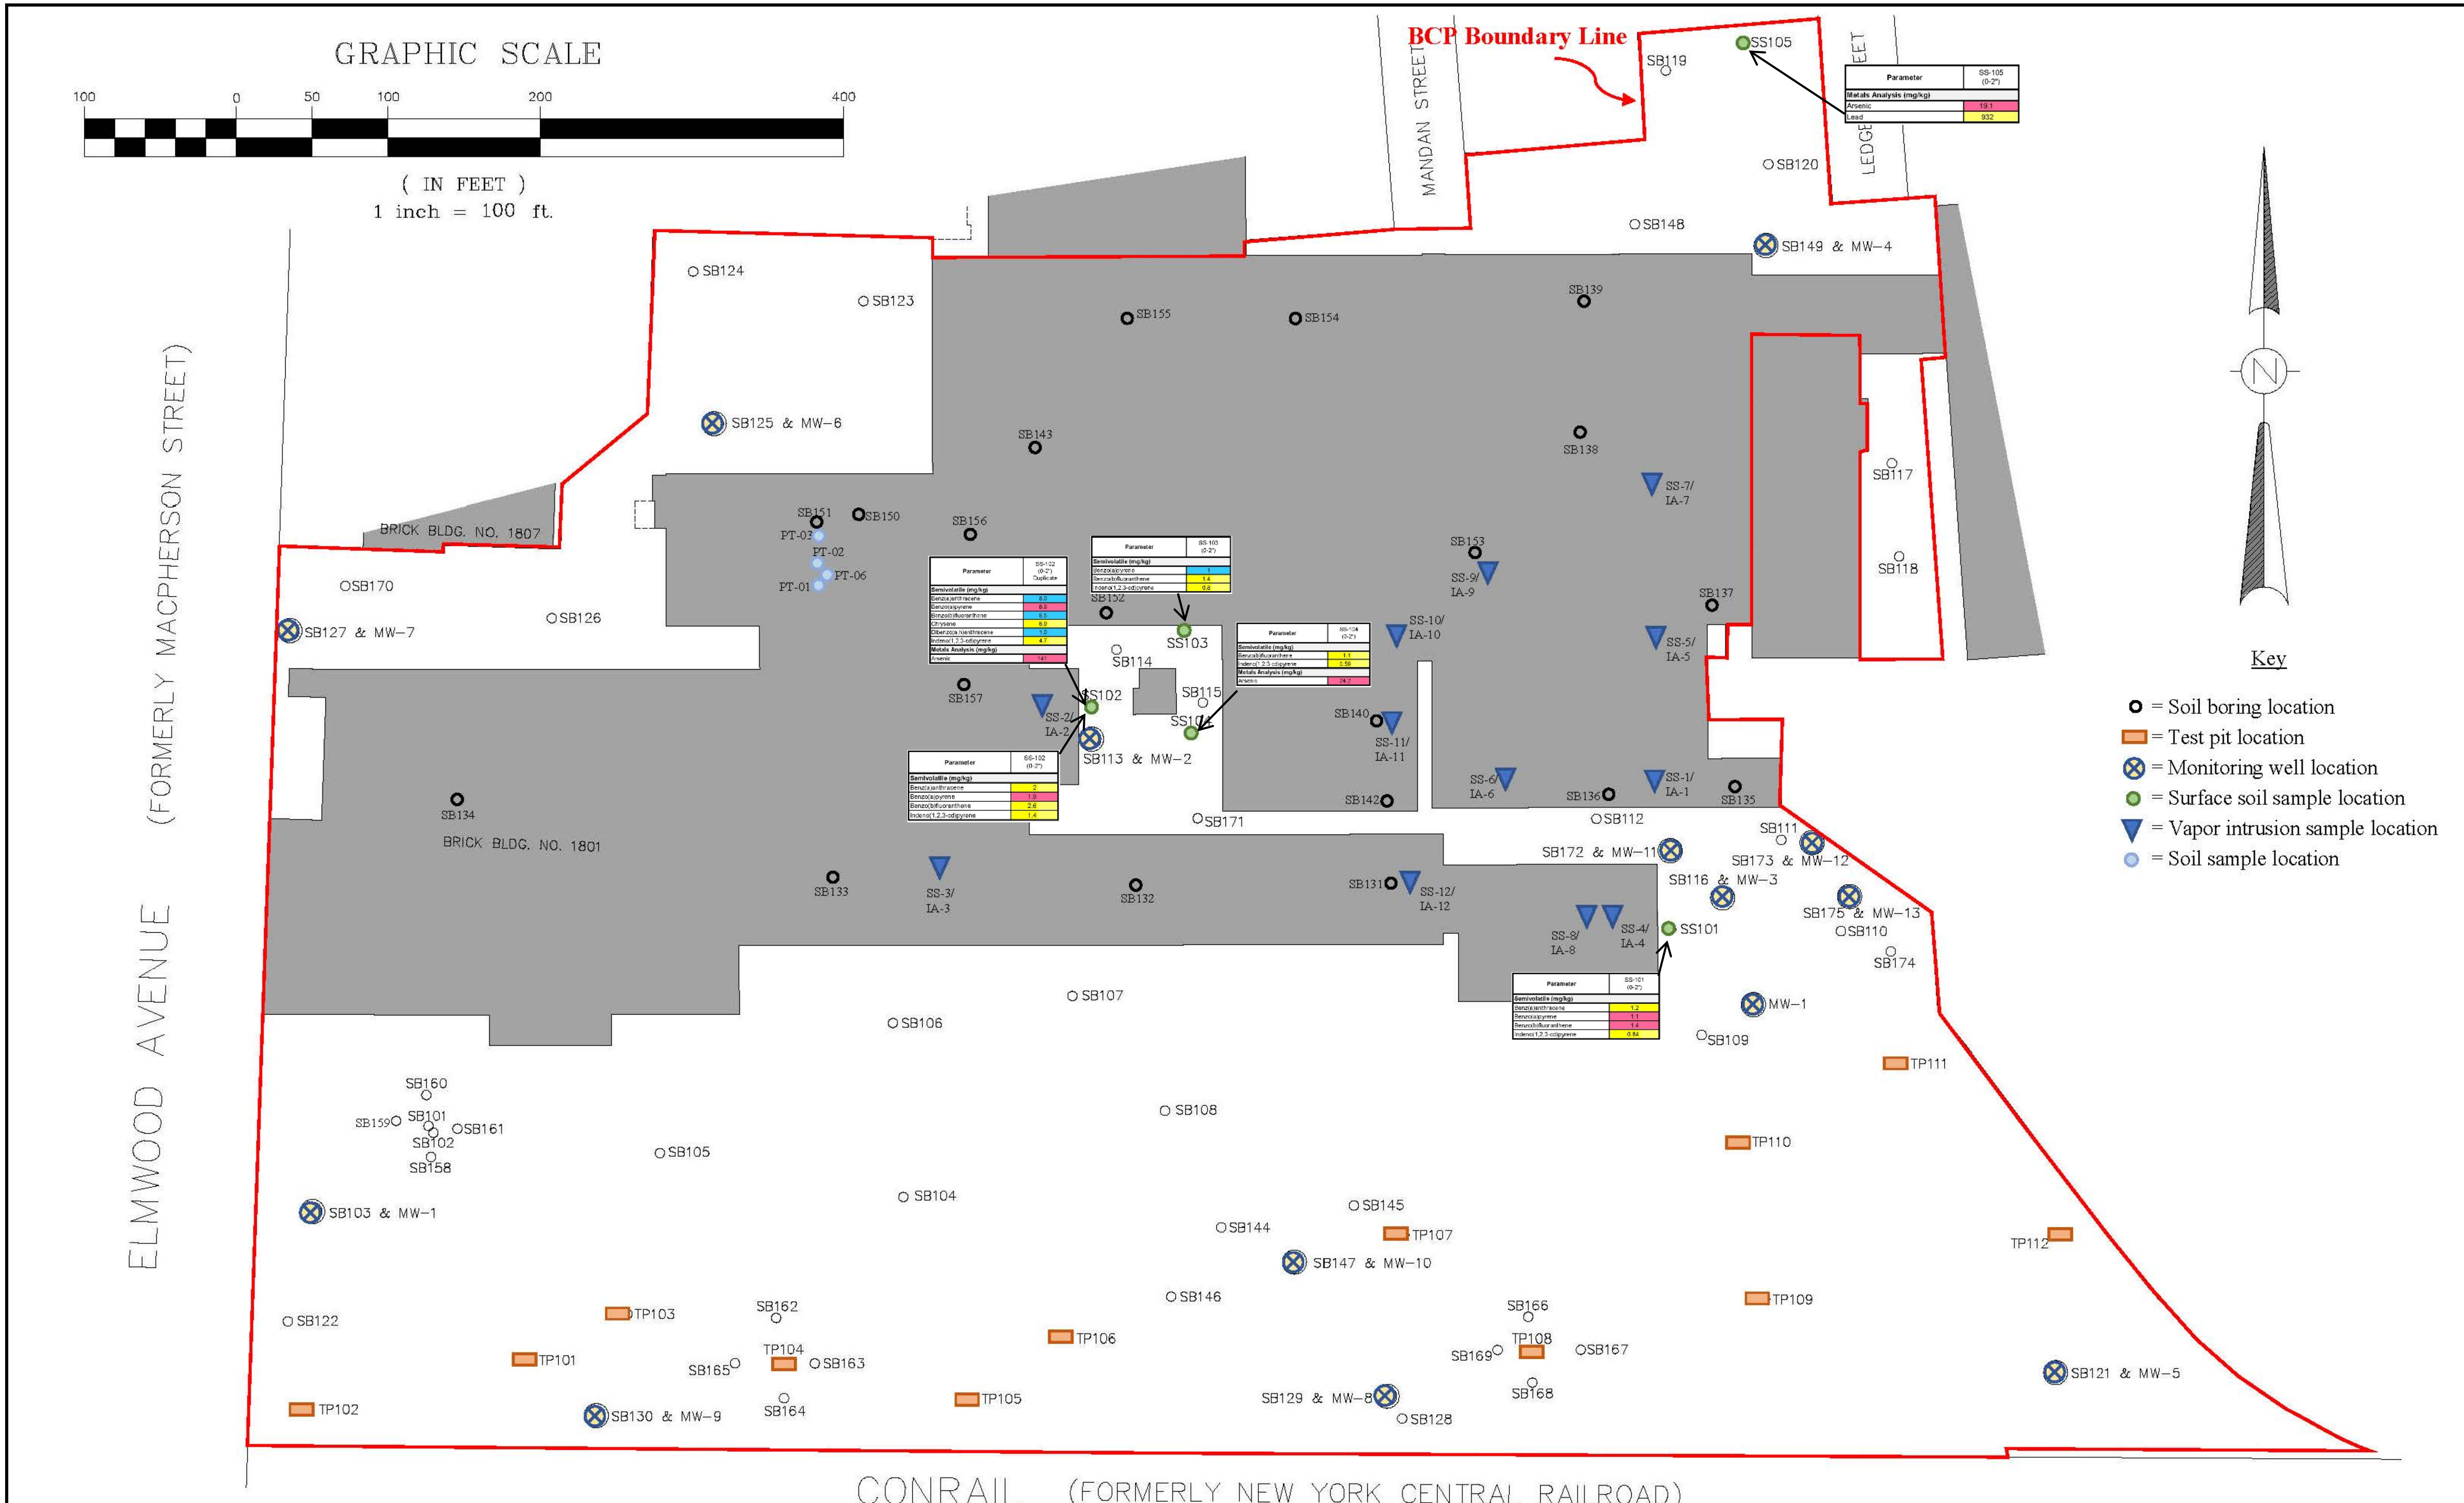
WITTMAN GEOSCIENCES, PLLC	Surface Soil Testing Results exceeded Restricted Residential	DRAWN BY: MMW	SCALE: 1" = 100'	PROJECT: 18-103
	1801 Elmwood, Buffalo, NY	CHECKED BY: MMW	DATE: 05/2019	FIGURE NO: 9

Parameter	SS-105 (0-2")
Metals Analysis (mg/kg)	
Arsenic	19.1
Lead	932

Parameter	SS-102 (0-2") Duplicate
Semivolatile (mg/kg)	
Benz(a)anthracene	8.0
Benzo(a)pyrene	8.9
Benzo(b)fluoranthene	8.5
Chrysene	6.9
Dibenzo(a,h)anthracene	1.0
Indeno(1,2,3-cd)pyrene	4.7
Metals Analysis (mg/kg)	
Arsenic	141
