FINAL REMEDIAL INVESTIGATION –
ALTERNATIVE ANALYSIS REPORT

BROWNFIELD CLEANUP PROGRAM
For
MOD-PAC CORP.
1801 Elmwood, Buffalo 14207
BCP # C915314

Prepared For:
MOD-PAC CORP.
1801-1807 Elmwood Avenue, Buffalo, New York 14207

May 2, 2019

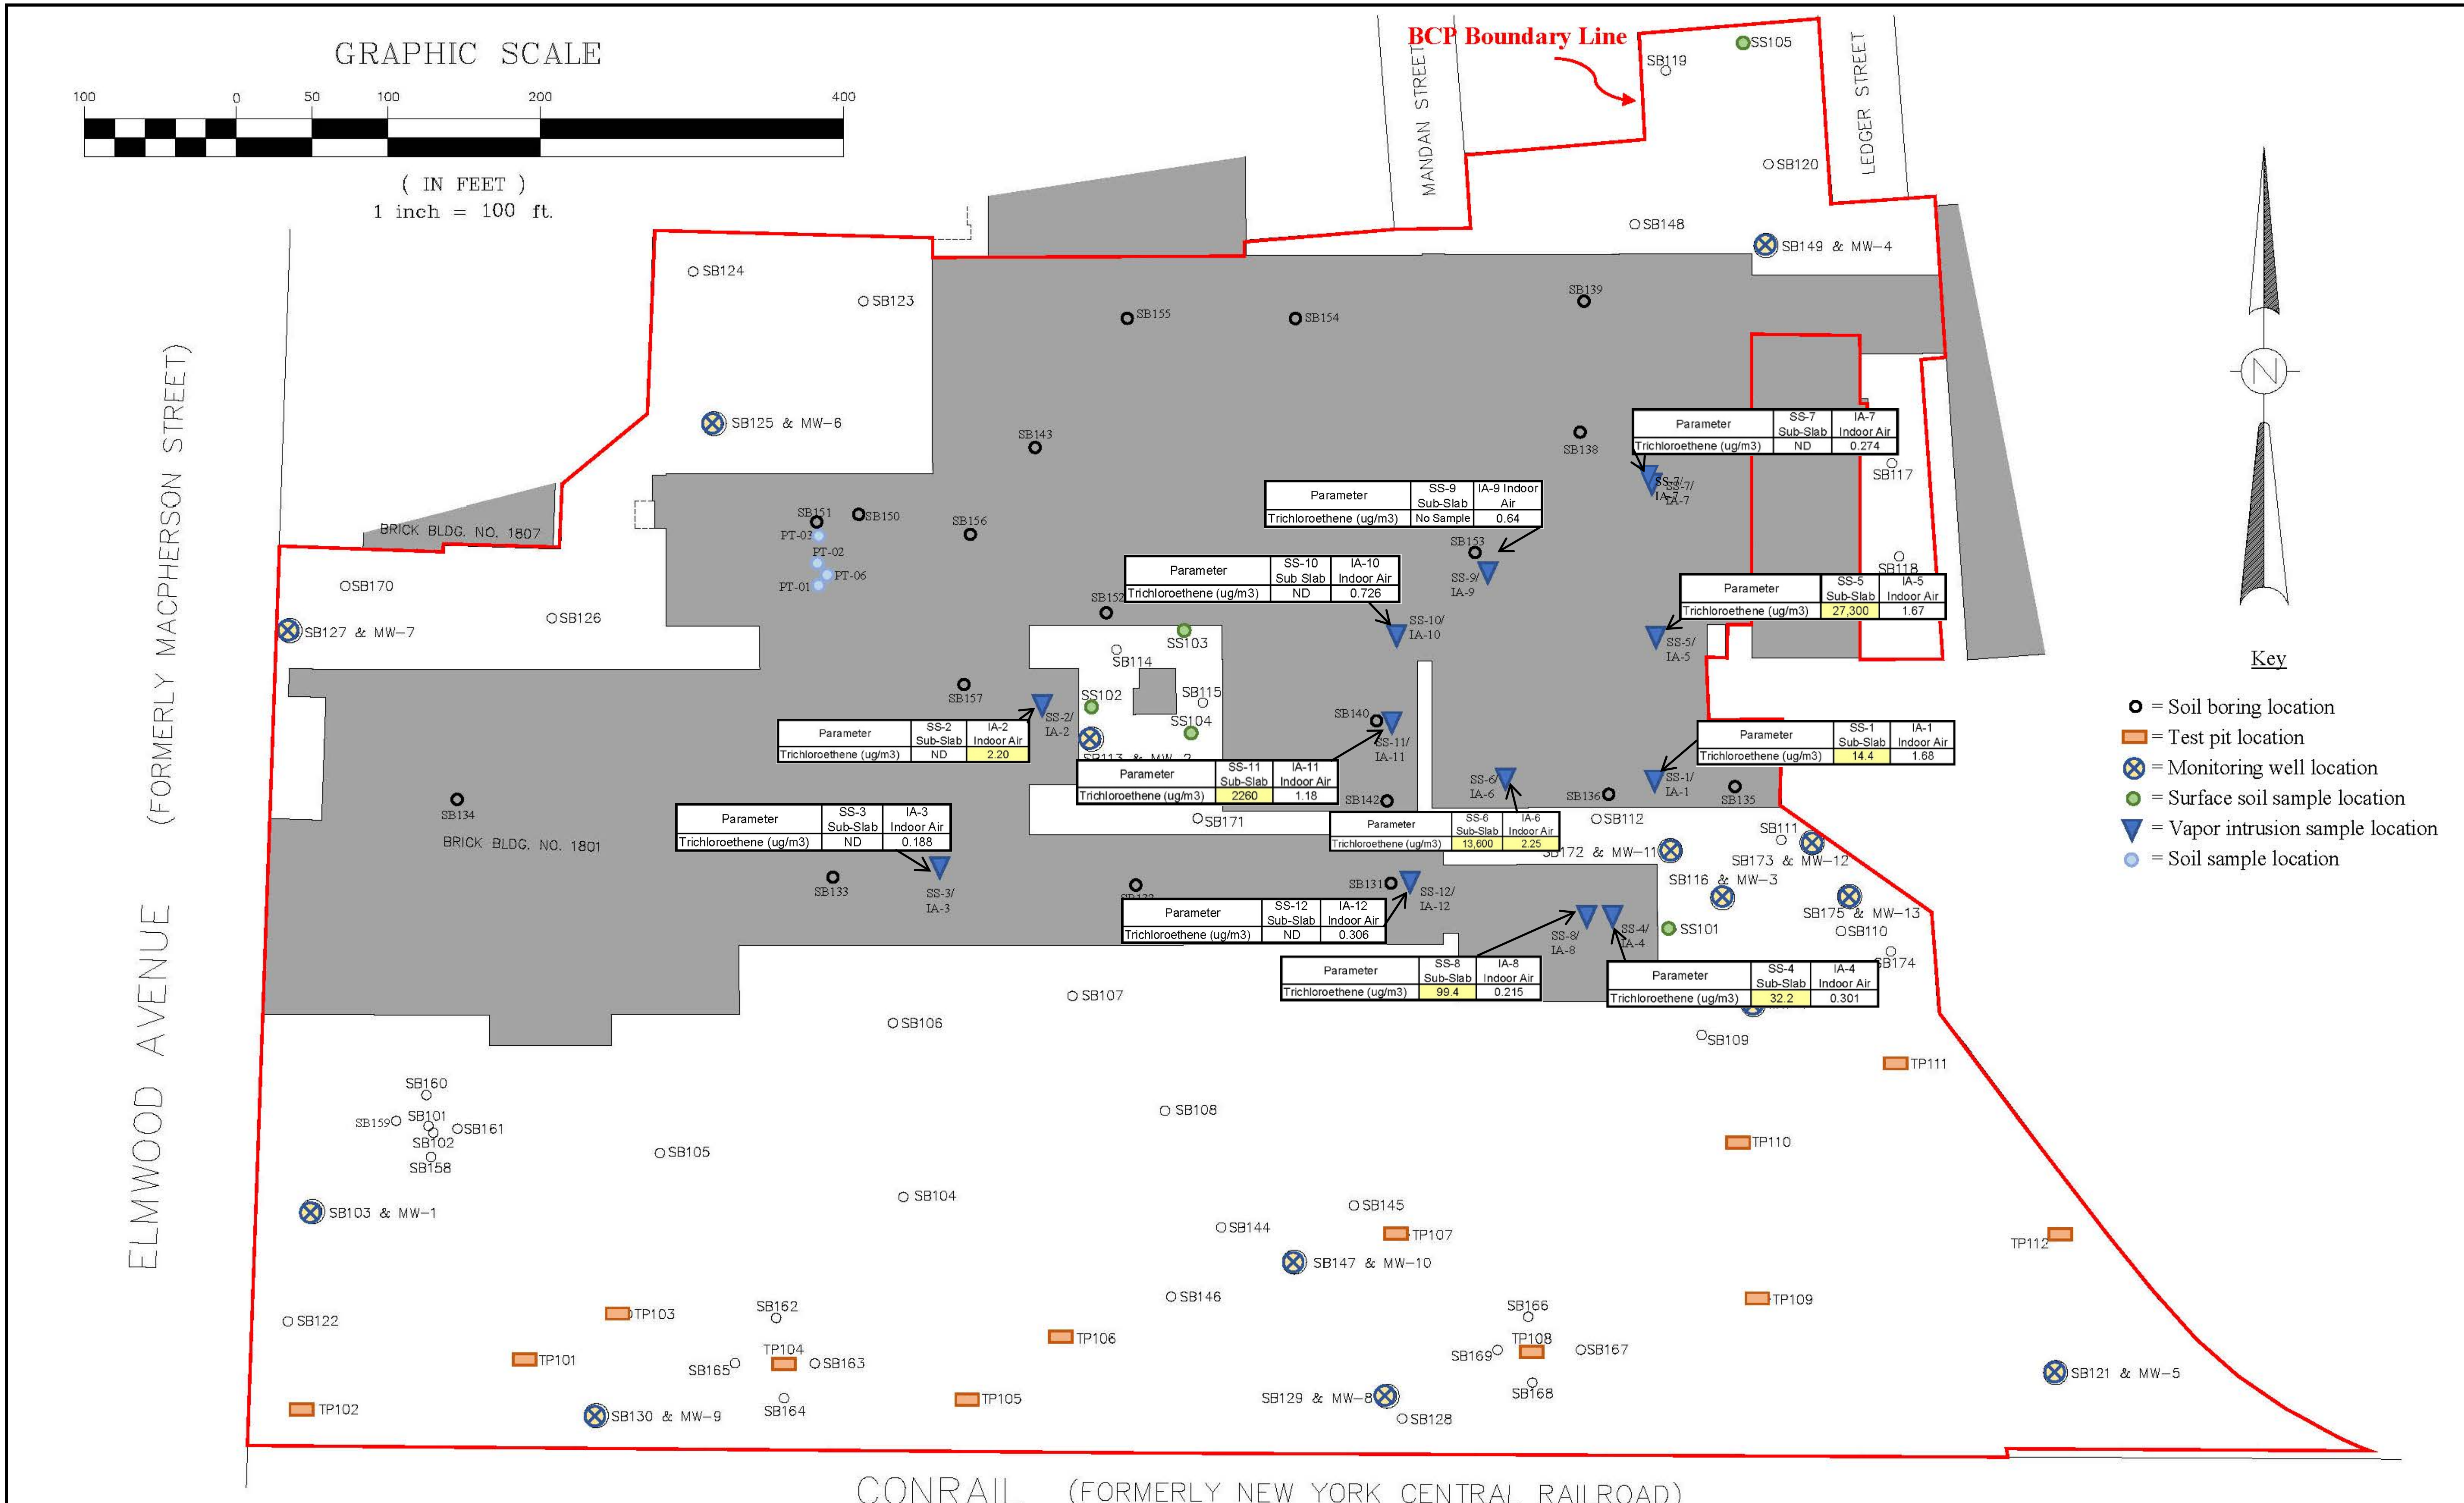
WITTMAN GEOSCIENCES, PLLC	TCE Concentrations in Vapor Intrusion Samples	DRAWN BY: MMW	SCALE: 1" = 100'	PROJECT: 18-103
	1801 Elmwood, Buffalo, NY	CHECKED BY: MMW	DATE: 05/2019	FIGURE NO: 11

Vapor intrusion air samples were analyzed from four sub-slab locations, four ambient air locations and one outdoor location. Vapor intrusion sample results are summarized in Tables 8 and 9. Due to detection of TCE and decision matrix recommending mitigation, additional vapor intrusion sampling was completed in April 2018 and May 2018, in an attempt to delineate the area requiring mitigation.
