Lakeside Village Apartments

65-67 Lake Avenue

FINAL ENGINEERING REPORT

NYSDEC Site Number: C915344

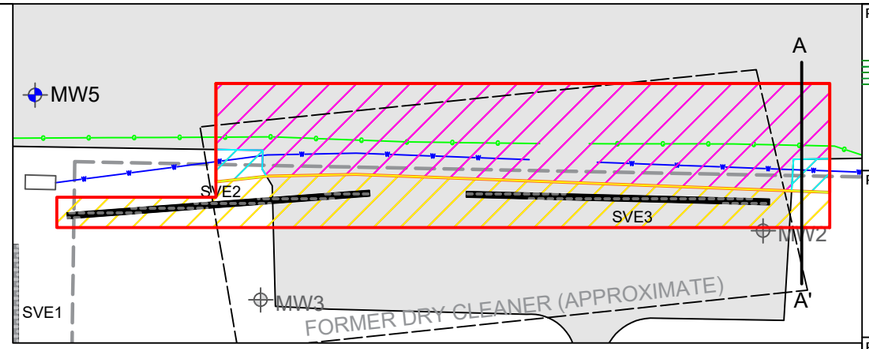
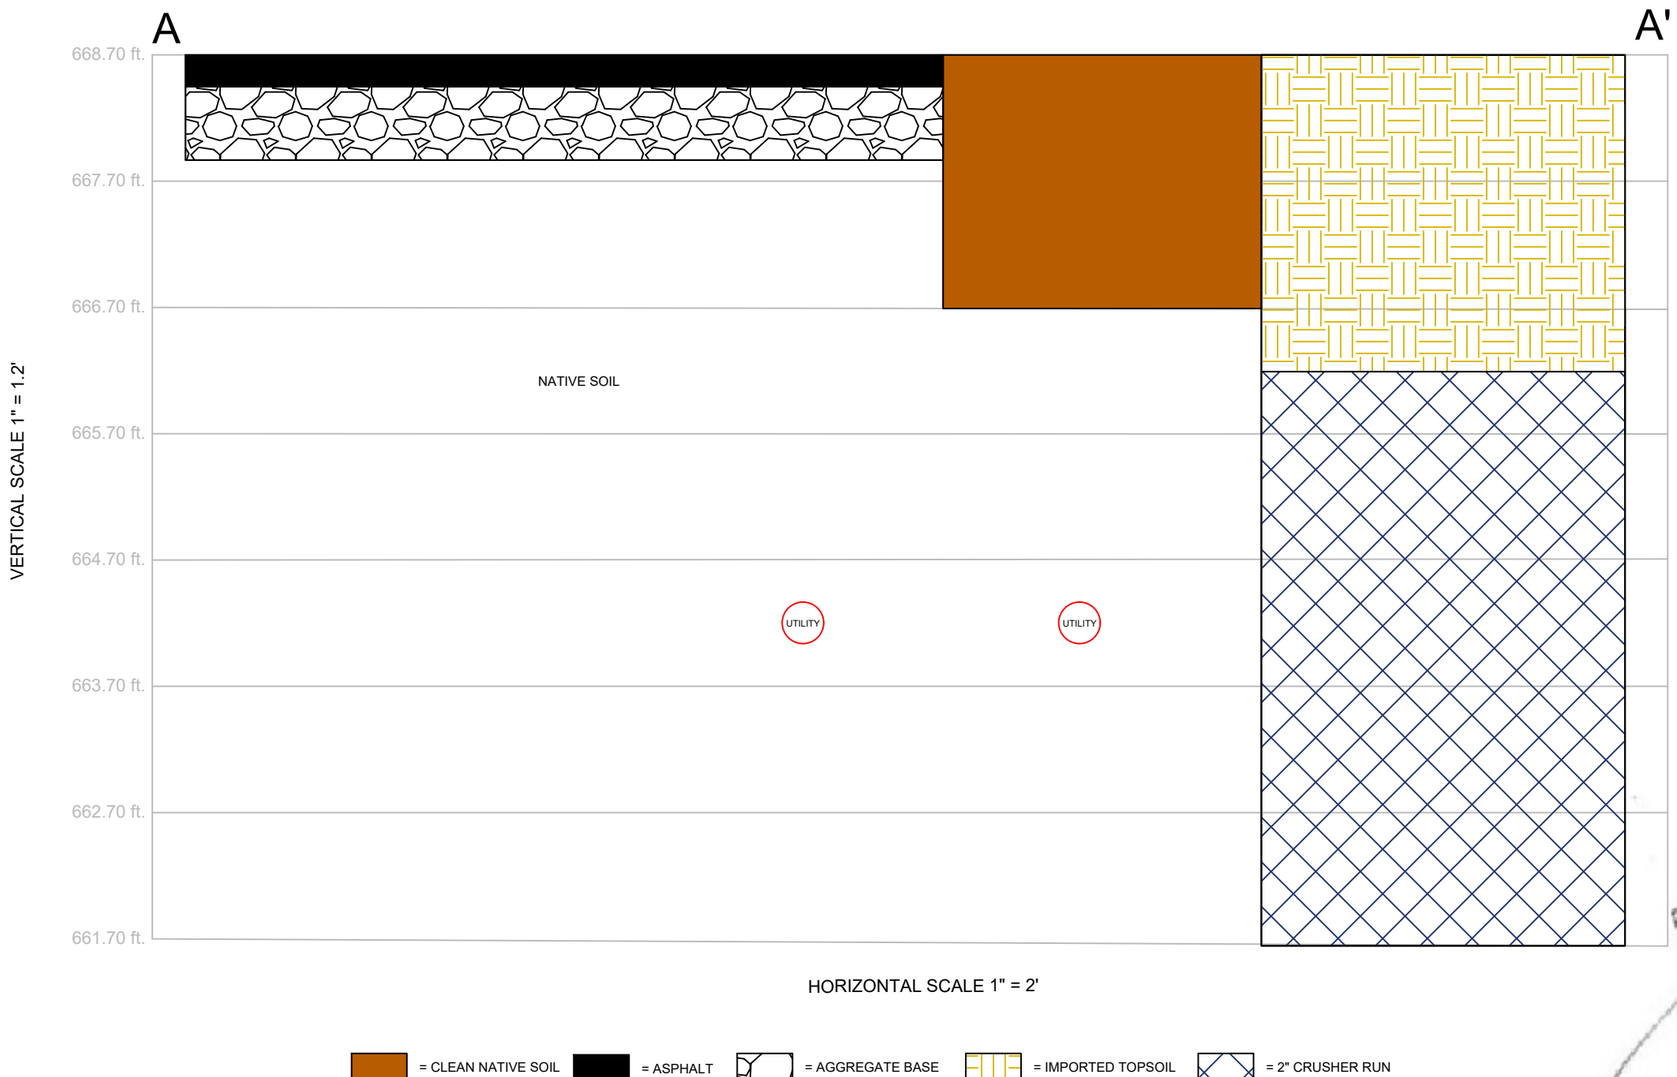
FIGURE:
9

Exposure to remaining contamination in soil/fill at the Site is prevented by a soil cover system placed over the Site within the Track 4 Cleanup Area. This cover system is comprised of asphalt pavement and in areas that are unpaved, a minimum of 24 inches of clean soil as shown in **Figure 9** and the soil cover cross section included as **Figure 10.** As shown in **Table 5**, analytical results of soil samples SB401 and SB402 collected within the unpaved areas indicate that soil meets SCOs for unrestricted use. The Track 4 Cleanup Area also includes approximately 570 square feet of the remedial excavation area, which is now comprised of clean backfill to a depth of 7 feet bgs.

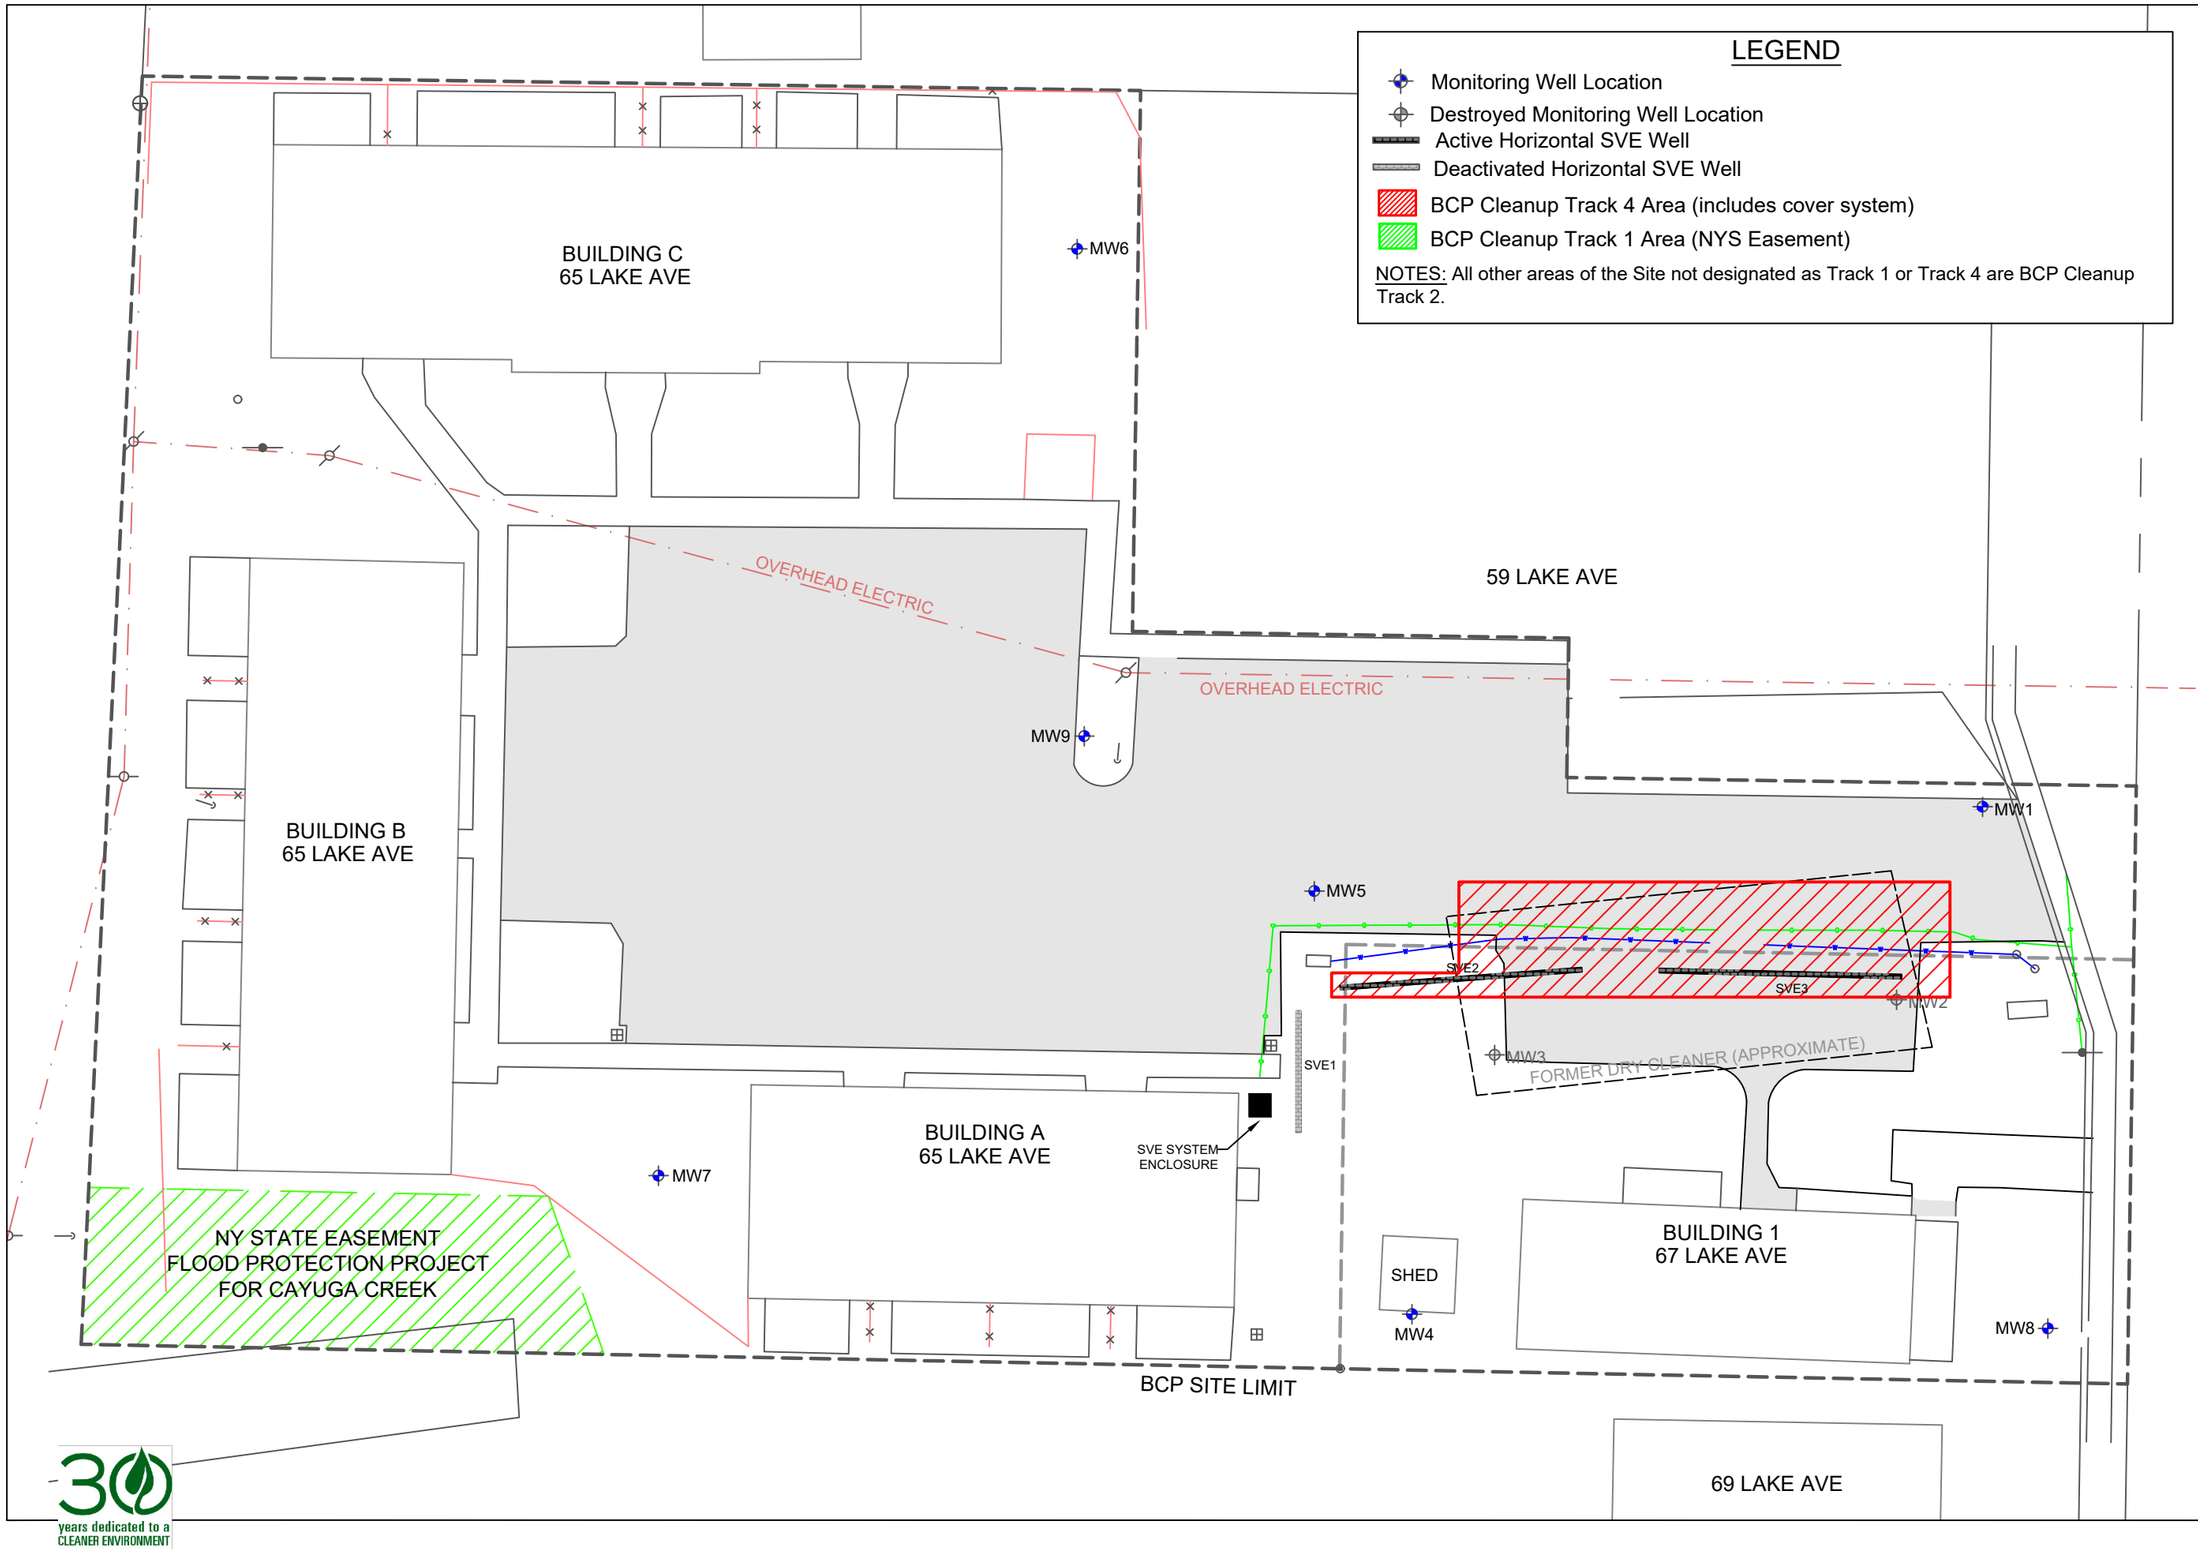
FIGURE: 11

ICs identified in the Environmental Easement will not be discontinued without an amendment to or extinguishment of the Environmental Easement. The IC boundaries are shown on **Figure 11**. These ICs include:

- The potential for vapor intrusion must be evaluated for any buildings developed in the area within the IC boundaries noted on **Figure 11**, and any potential impacts that are identified must be monitored or mitigated;

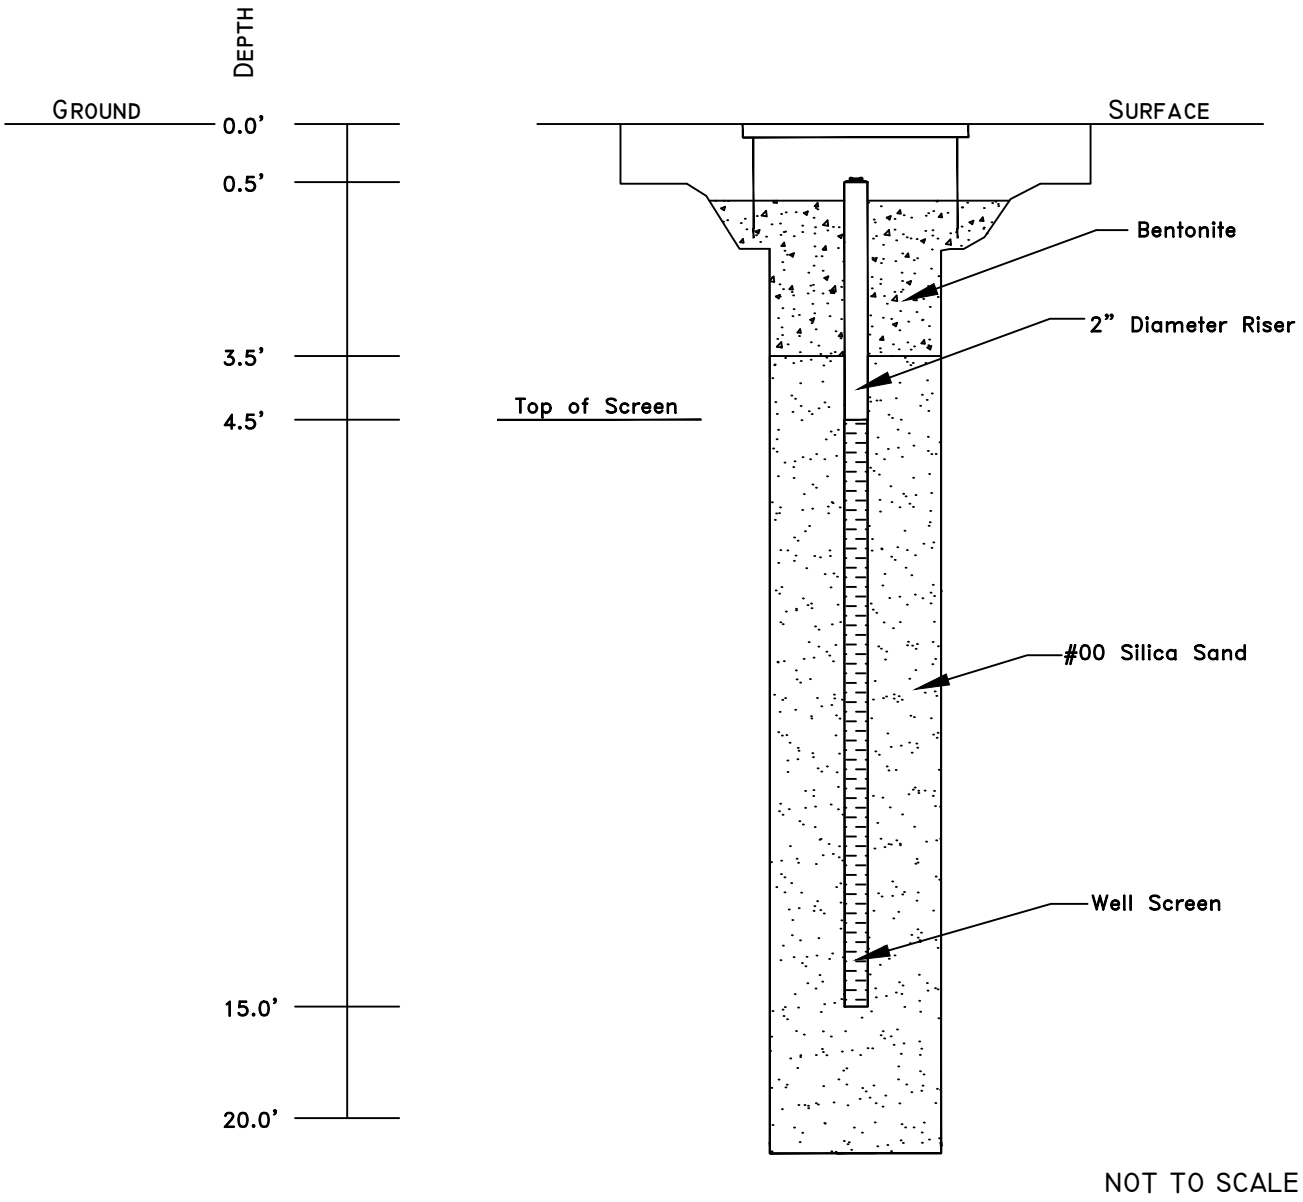
NOTE: Monitoring well was destroyed during excavation activities on September 27, 2023.

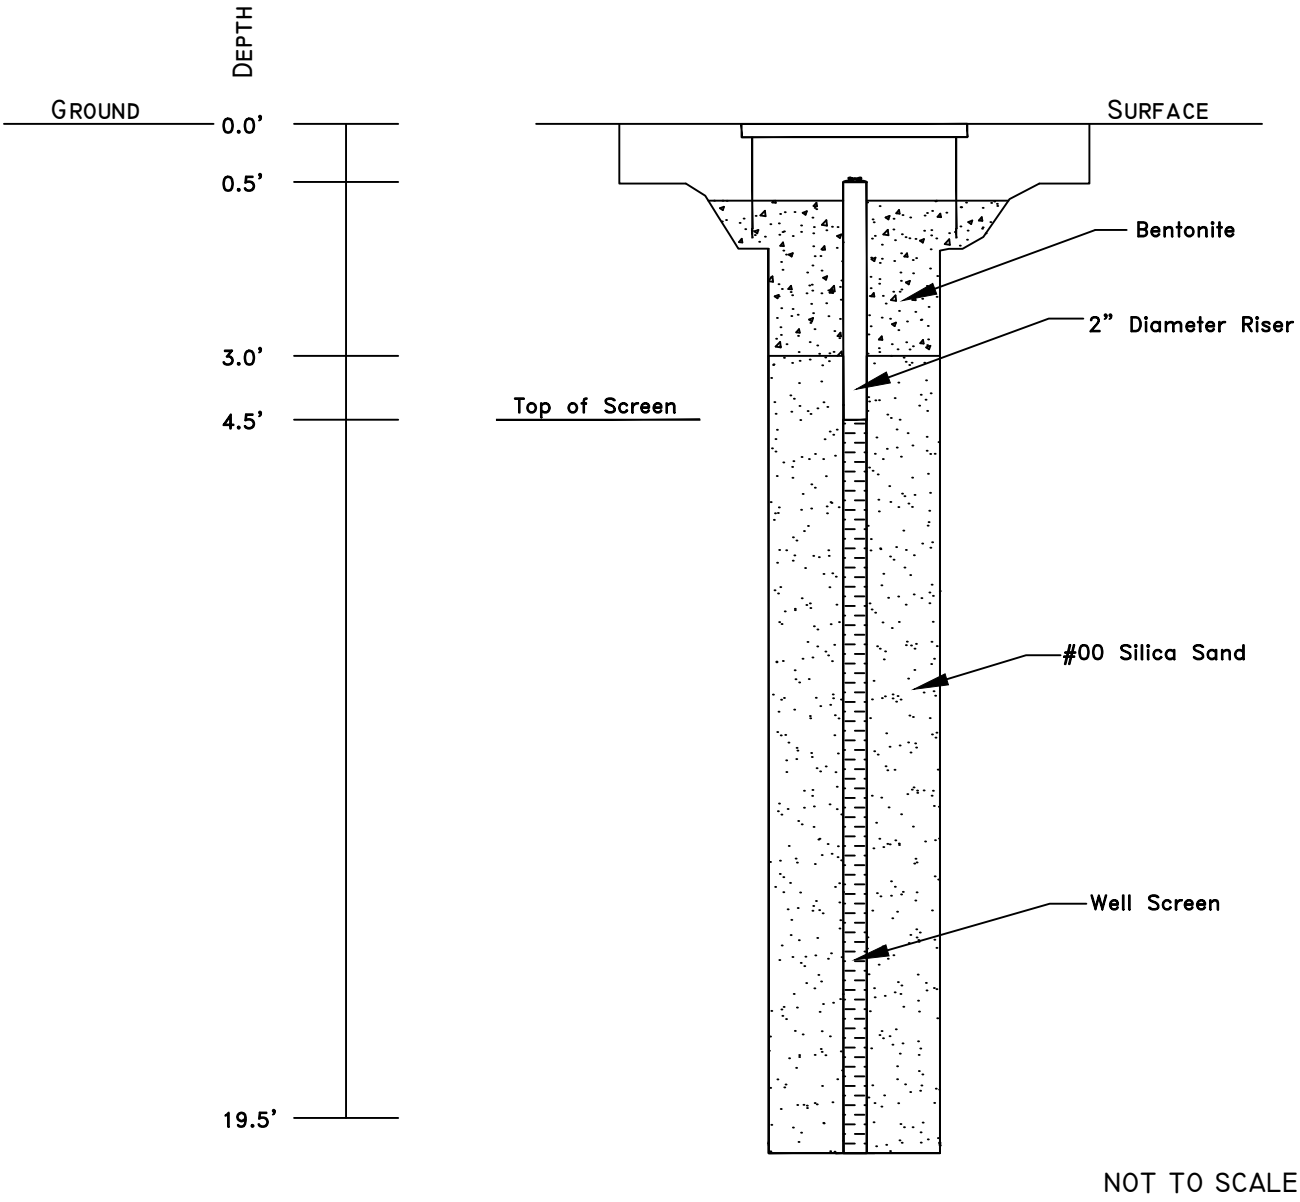
NOTE: Monitoring well was destroyed during excavation activities on September 26, 2023.
