FORMER PILGRIM VILLAGE
SENIOR APARTMENTS
TAX MAP ID NO.: 100.71-3-1.11 (PORTION OF)
BUFFALO, NEW YORK 14209

Final Engineering Report

NYSDEC Site Number: C915363

December 2022

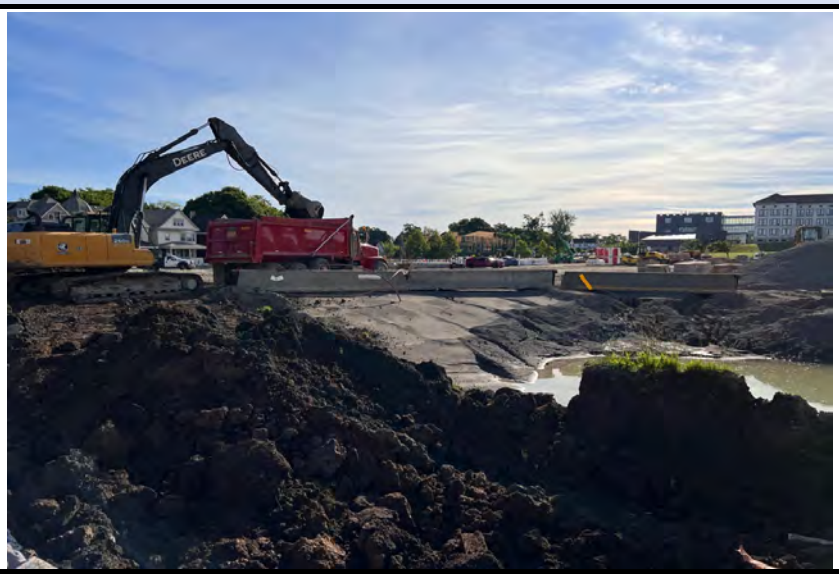
Photo 1

Facing Northeast - Location of contaiminated soil excavation.
