Phase I
Environmental Site Assessment

Pilgrim Village- Sublots 3, 4, and 5
903 and 951 Ellicott Street
Buffalo, New York 14209

LaBella Project No. 2231229
Award/Client Project No. N/A

March 24, 2023

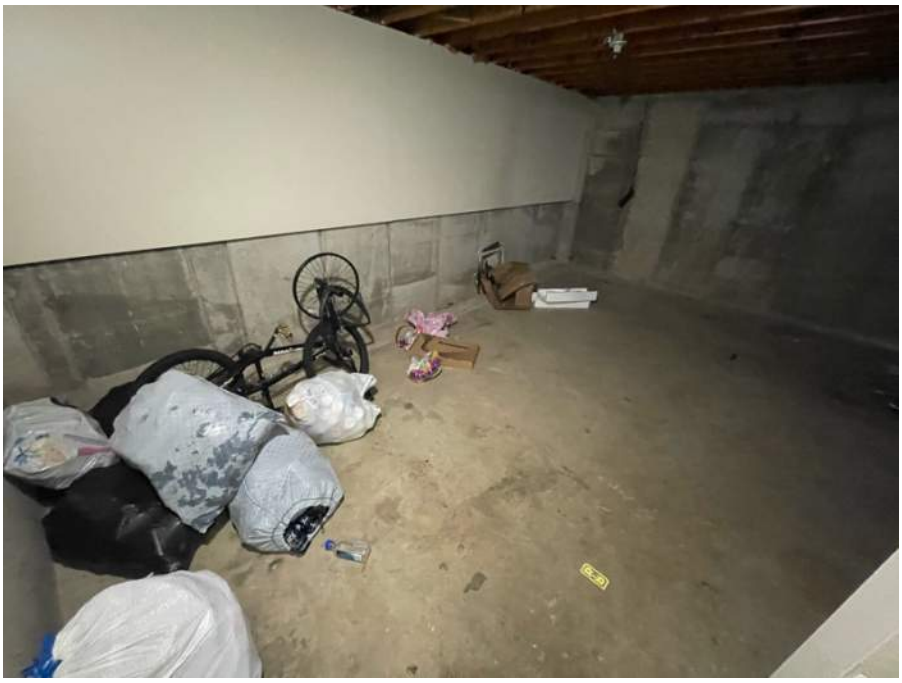
Photo 8 : Subject Building 1 - Representative basement

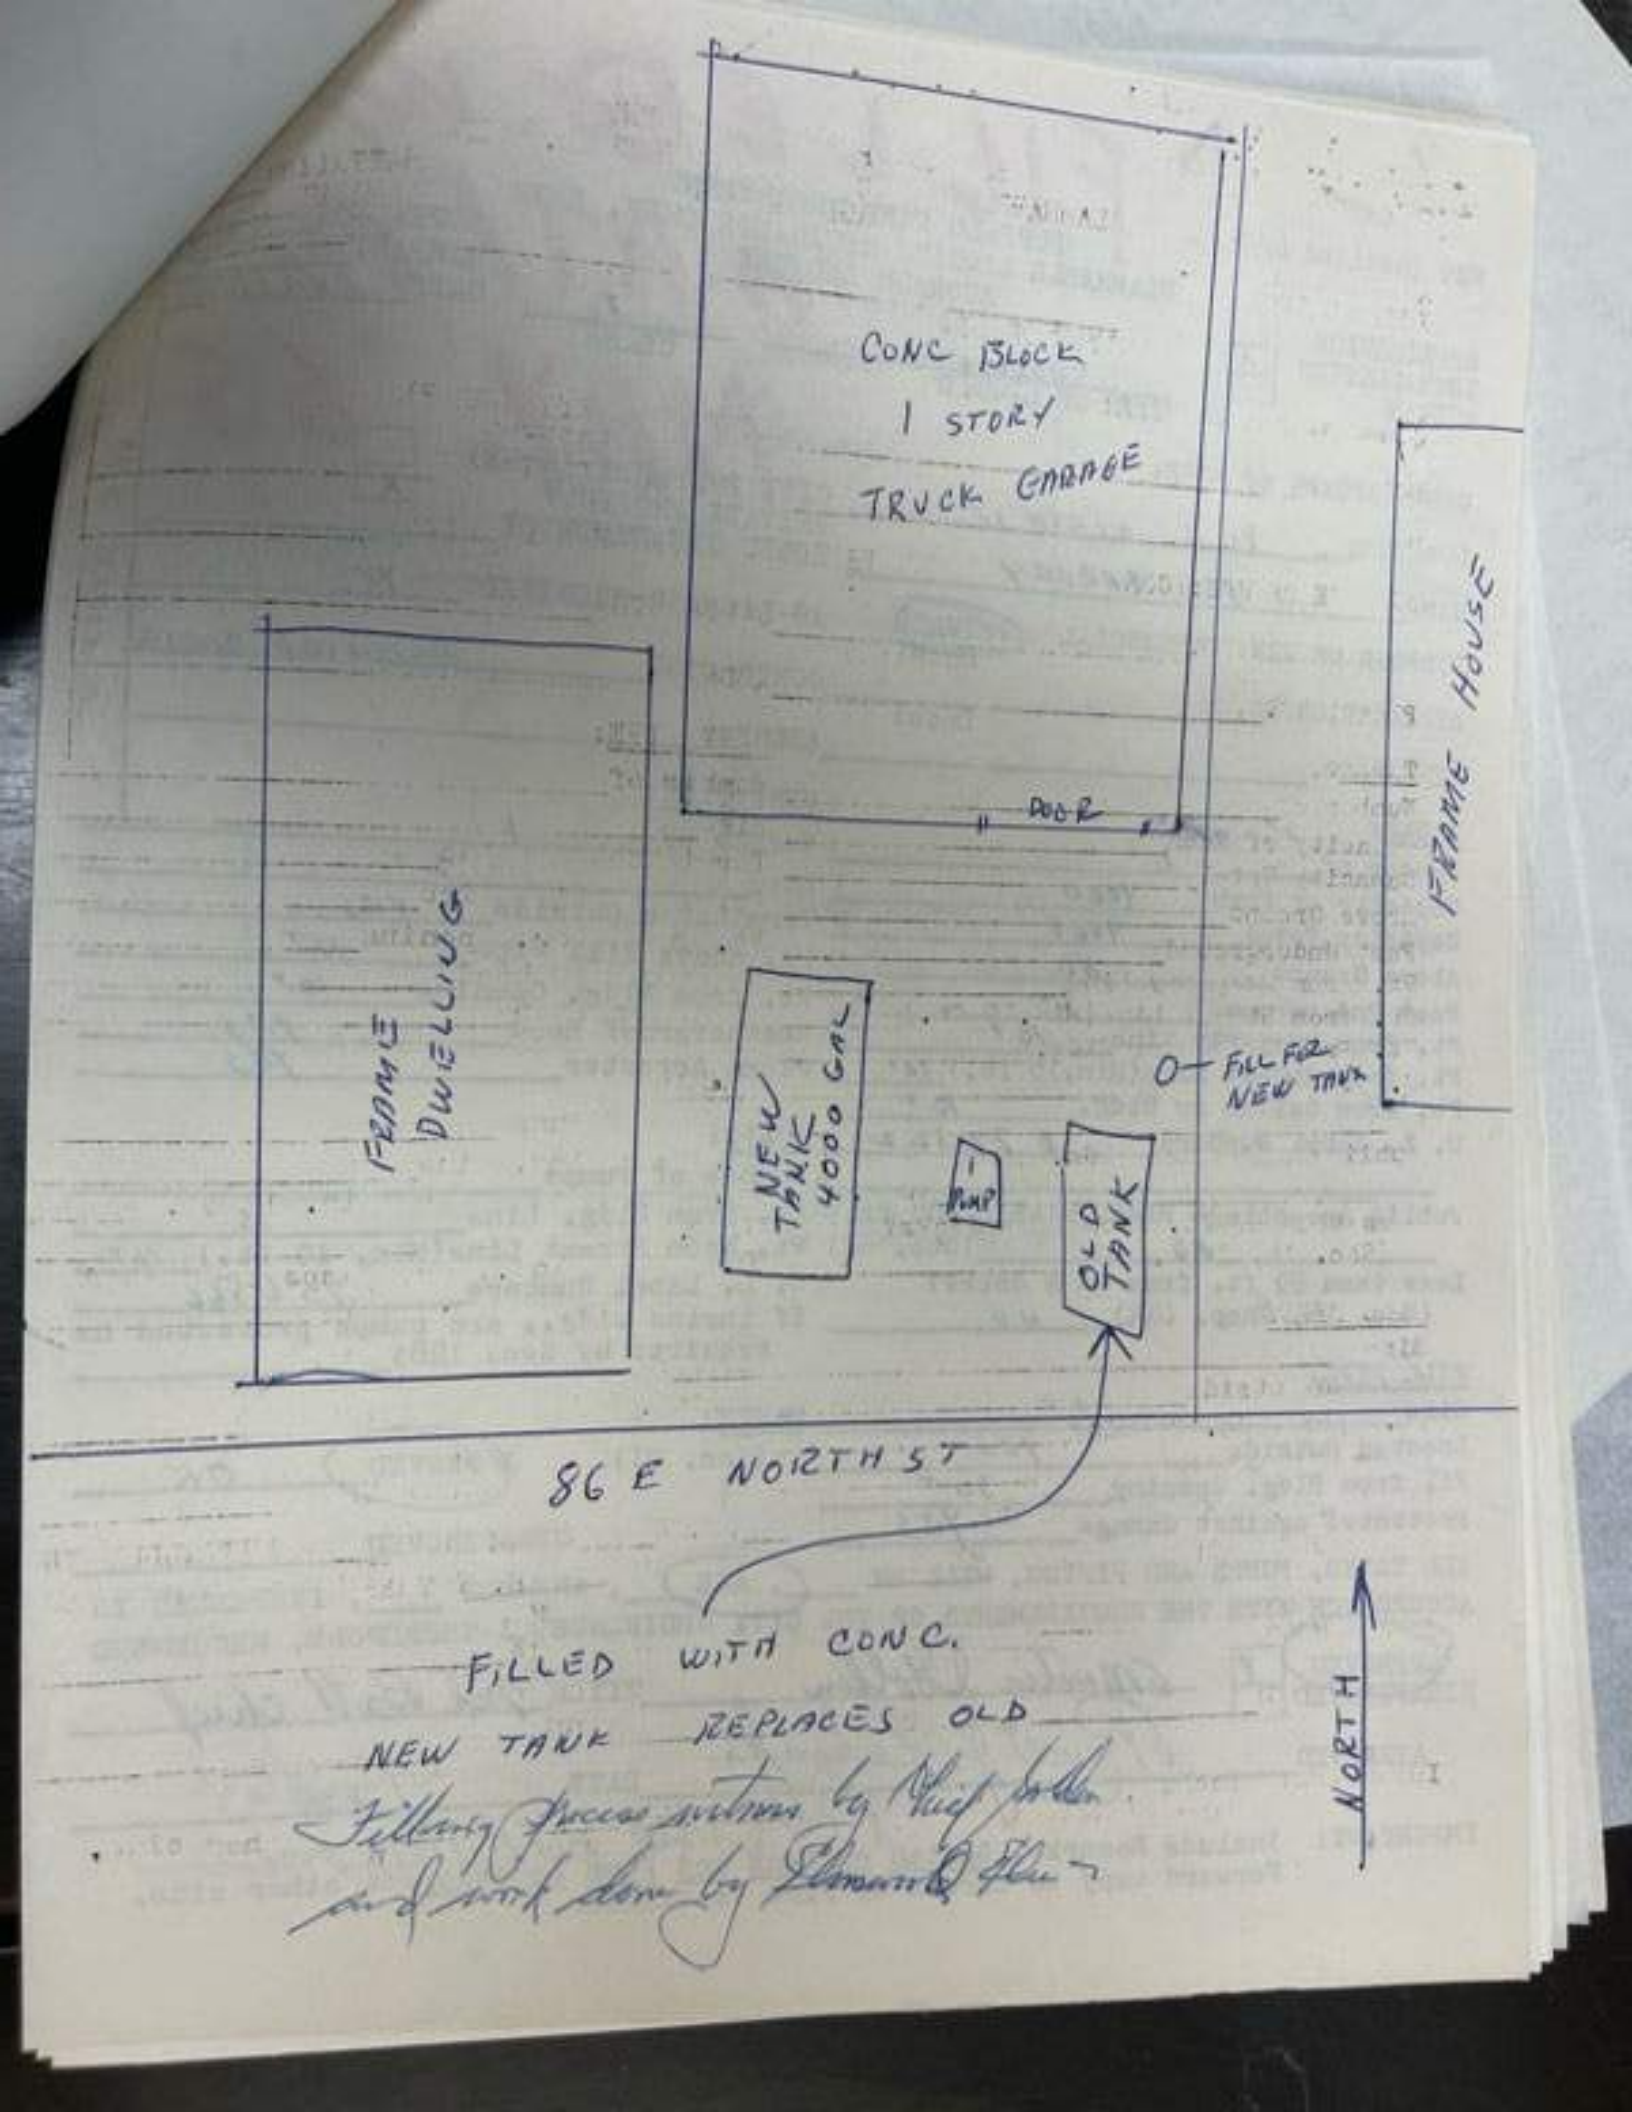
CONC BLOCK
1 STORY
TRUCK GARAGE
DOOR
FRAME HOUSE
FRAME DWELLING
NEW TANK 4000 GAL
PUMP
OLD TANK
FILL FOR NEW TANK
86 E NORTH ST
FILLED WITH CONC.
NEW TANK REPLACES OLD
Filling process written by Chief Inspector
and work done by Edmund O Flaherty
NORTH
