9 November 2012
File No. 36795-027/029

Subject: Sub-Slab Depressurization Systems Pilot Testing Report
Interim Remedial Measures (IRM) Work Plan
Buildings 7 and 8 BCP Sites # C932138 / C932139
200 Upper Mountain Road
Lockport, New York

Pre-Design Investigation (PDI) - Sub-Slab Depressurization Systems/ Interim Remedial Measures (IRM) Work Plan

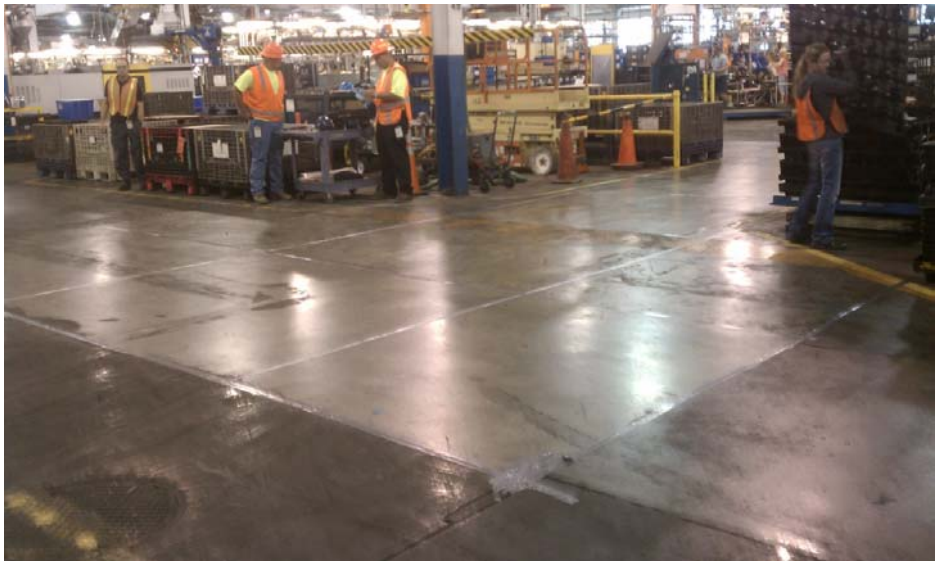
Sub-grade features such as utility piping and conduits (i.e., vertical roof drains and associated conductors), equipment or building foundations, floor penetrations, or imperfections in the concrete surface in the form of cracks or abutting flooring systems, may also contribute to preferential air flow pathways. These apparent air-flow preferential pathways or obstructions are evidenced by the non-radial vacuum influence contours that appear to align with known sub-slab features. One area affected by these potential conditions was the Building 7-West location in which several large cracks and seams in the concrete were observed proximal to the test pit area.

A simple field test was conducted by temporarily sealing these cracked areas with sealing tape and measuring the vacuum influence range under the taped areas and at target VM points. The results of the field test indicated that an increase in VM point readings from 0.062-inches to 0.074-inches at point E-1 and from 0.044-inches to 0.070-inches in point W-1, and the cracked area ranged from no measurable readings to exceeding the upper micro-manometer range of 2-inches W.C. after sealing, suggesting that the limited vacuum influence could be due to these types of floor surface conditions.

1. Vacuum data collected at points E-1 and W-1 after temporary sealing of observed cracks and seeams in existing concrete at areas North, East, and West of the test pit. Vacuum measurement under temporary sealant was measured at >2.000 inches W.C. (limits of micromanometer) at approximately 6-feet South of column L49.

Bldg 7-West Concrete Floor with Cracks and Seams

Bldg 7-West Concrete Floor with Temporary Sealing

- In addition, seal visually identified cracks, seams, and other potential short-circuit pathways in the concrete floor for the proposed areas of operation to improve vacuum influence;
