REMEDIAL INVESTIGATION ALTERNATIVES ANALYSIS REPORT

90 HOPKINS STREET SITE

NYSDEC Site E915181
90 Hopkins Street
Buffalo, New York

JULY 2014

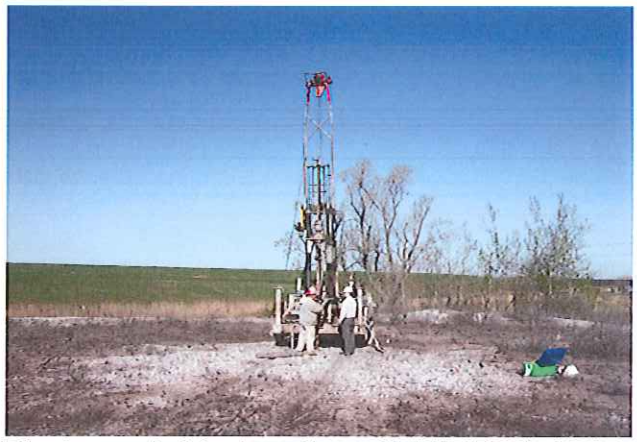
Long-Term Effectiveness and Permanence – The removal of the lime material, debris pile and select impacted soil/fill, together with ICs and ECs will achieve long term effectiveness and permanence under the commercial re-use scenario. The SMP will include: an excavation work plan to address any impacted soil/fill encountered during future development and maintenance activities; groundwater monitoring plan; and a Site-wide Inspection program will be necessary to assure that the Institutional Controls placed on the Site have not been altered and remain effective. As such, this alternative is expected to provide long-term effectiveness and permanence.
