ENGINEERING INVESTIGATIONS AT INACTIVE HAZARDOUS WASTE SITES

PHASE I INVESTIGATION

Hanna Furnace — Site No. 915029

City of Buffalo — Erie County

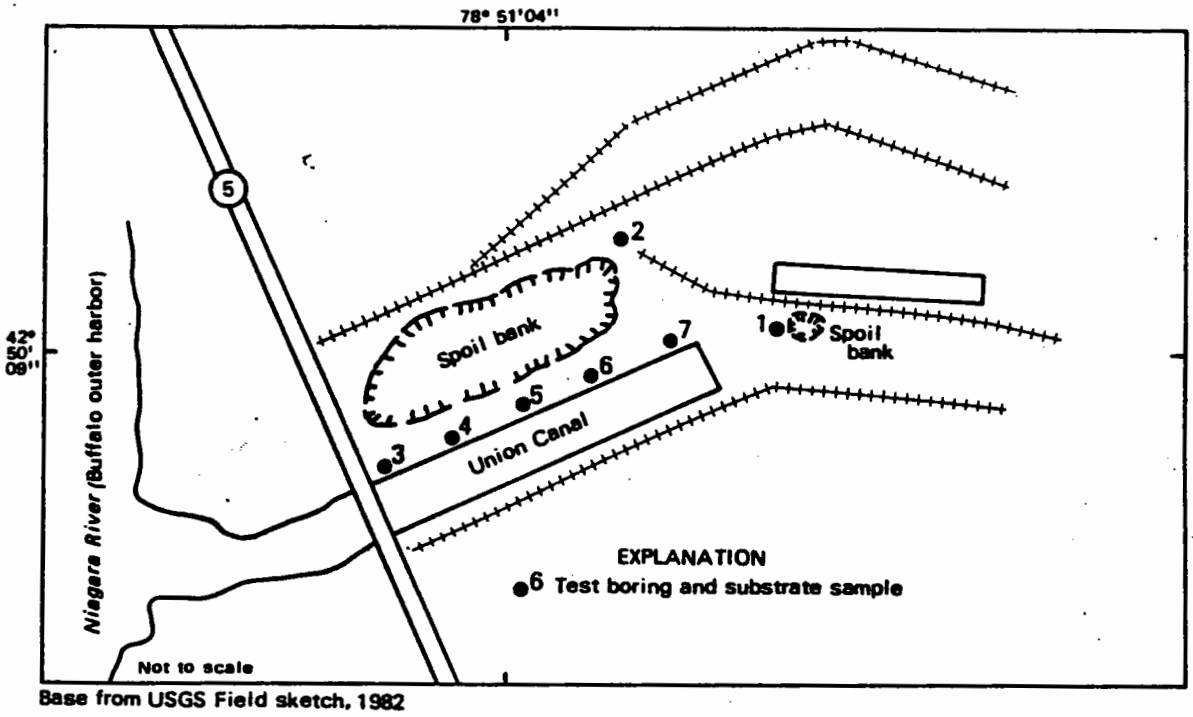
Figure A-5. Location of sampling holes at Hanna Furnace Corporation, site 135, Buffalo.

Soil samples from well borings were analyzed on 2 August 1982 by the USGS. With the exception of one sample which may not have been collected on the disposal site, all of the soil samples had concentrations of chromium, copper, lead and iron which did not exceed background concentrations (USGS, 1983). Figure V-2 shows the sample locations.

Constituents	Sample number and depth below land surface (ft)		
	5 (6)	6 (5.5)	7 (10)
Chromium	4,000	10,000	3,000
Copper	11,000	28,000	12,000
Iron	4,200,000	6,000,000	5,000,000
Lead	30,000	30,000	10,000

†† Exceeds concentrations in samples from undisturbed soils in the Buffalo area. Undisturbed soils were not analyzed for iron.
